Geotechnical Assessment

Project: Inclined Lift
12 Sunrise Road, Palm Beach NSW

REF: AG 20277
5 November 2020

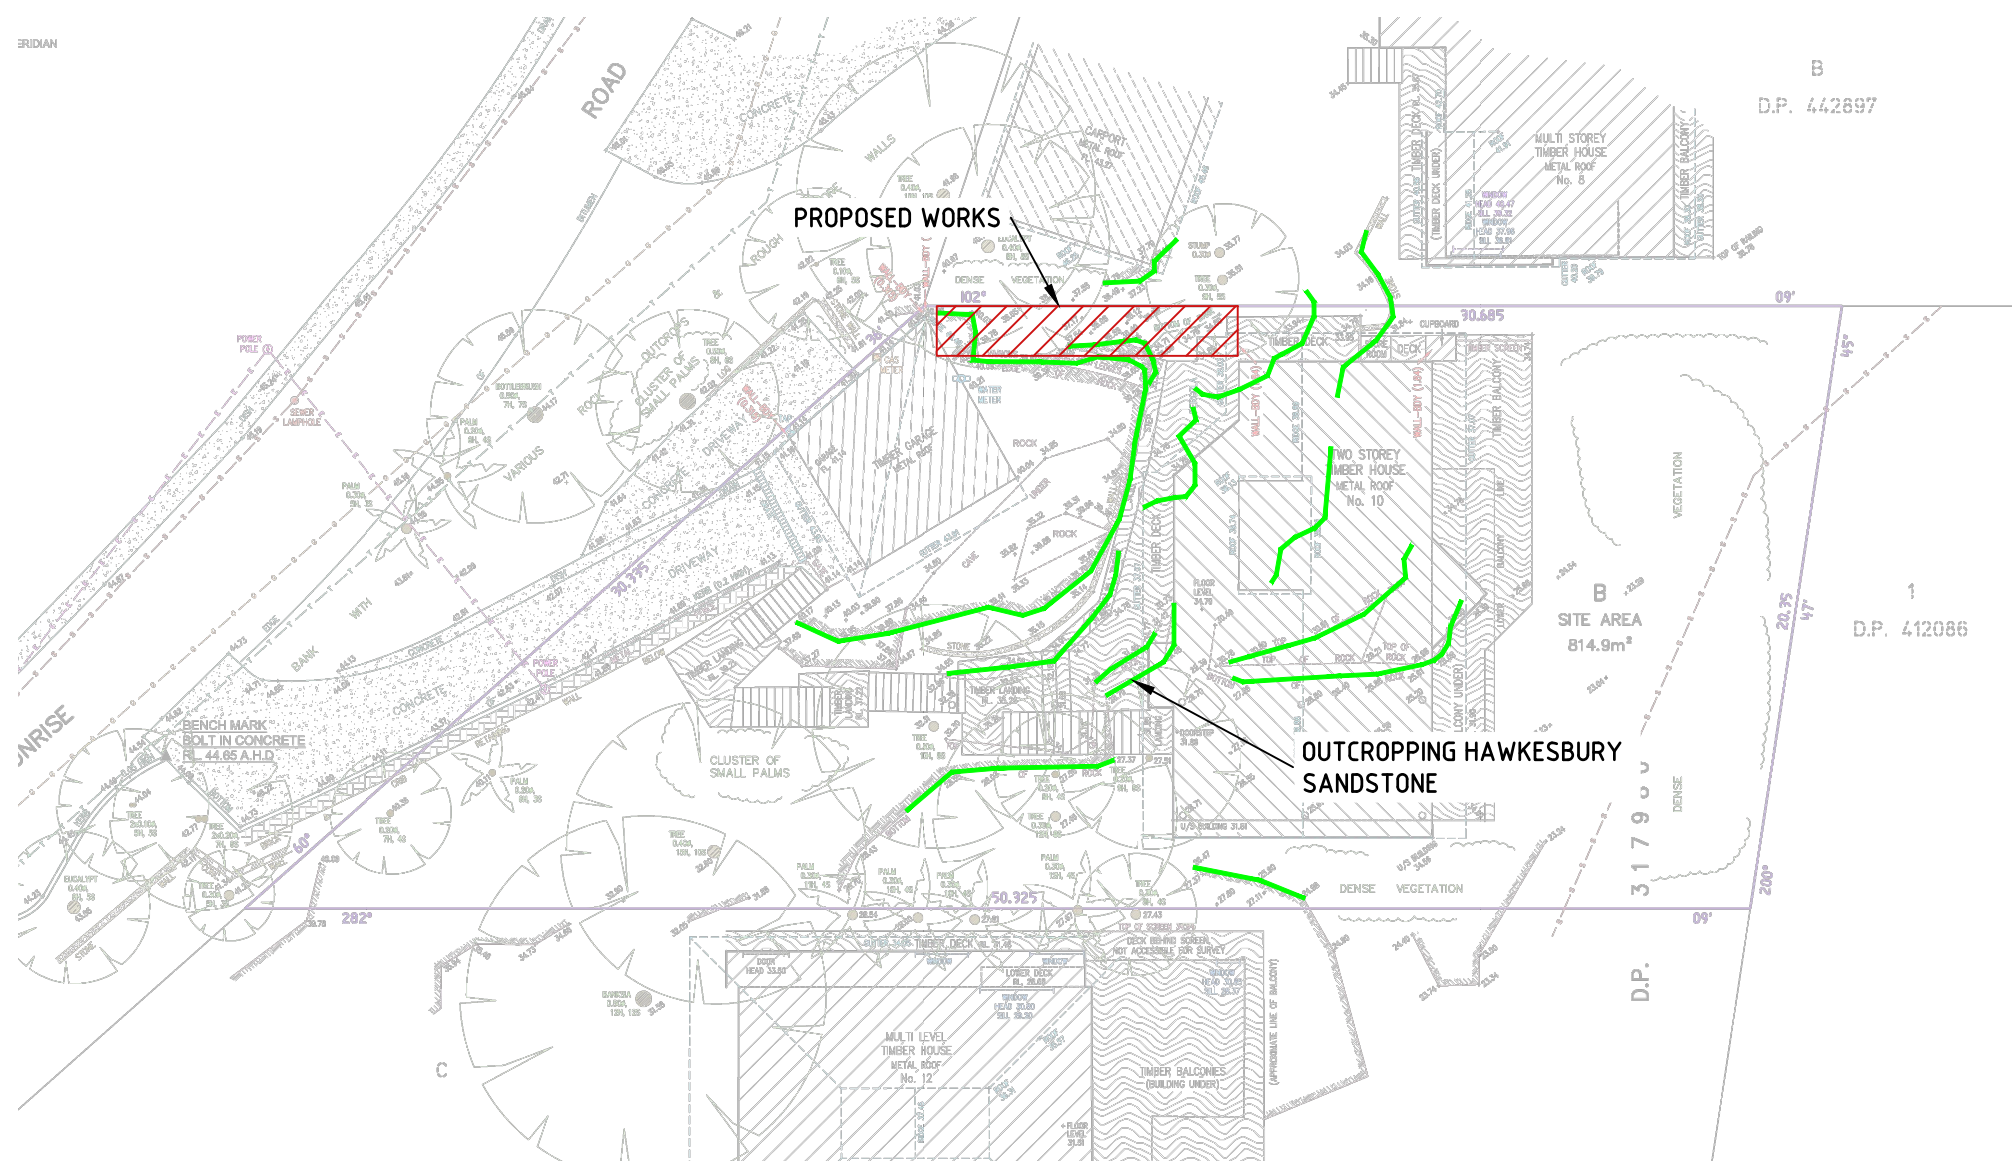
Site Plan | Testing Locations

INTERPRETED SUBSURFACE SECTION ONLY.
ACTUAL GROUND CONDITIONS MAY VARY.

- SHALLOW UNCONTROLLED FILL
- SANDY CLAY/CLAYEY SAND
- HAWKESBURY SANDSTONE
