“GROWING MY WAY”

Construction Impact & Management Statement

November 2020

Site:	Lot 5 in DP 16260 1 Yachtview Avenue NEWPORT, NSW
Client:	Paul Godfrey & Vanessa Naderi c/ Michael Finch 1 Yachtview Avenue NEWPORT, NSW 2106
Author:	Kyle A Hill Registered (Arb Aus #1884) Practising & Consulting Arborist Post Graduate Certificate in Arboriculture, Uni of Melb Diploma of Horticulture-Arboriculture TAFE, Grow SA Certificate of Horticulture, TAFE Certificate Advanced Tree Care TAFE Founder -Growing My Way Tree Services (1977) Member of International Society of Arboriculture Member of Arboriculture Australia

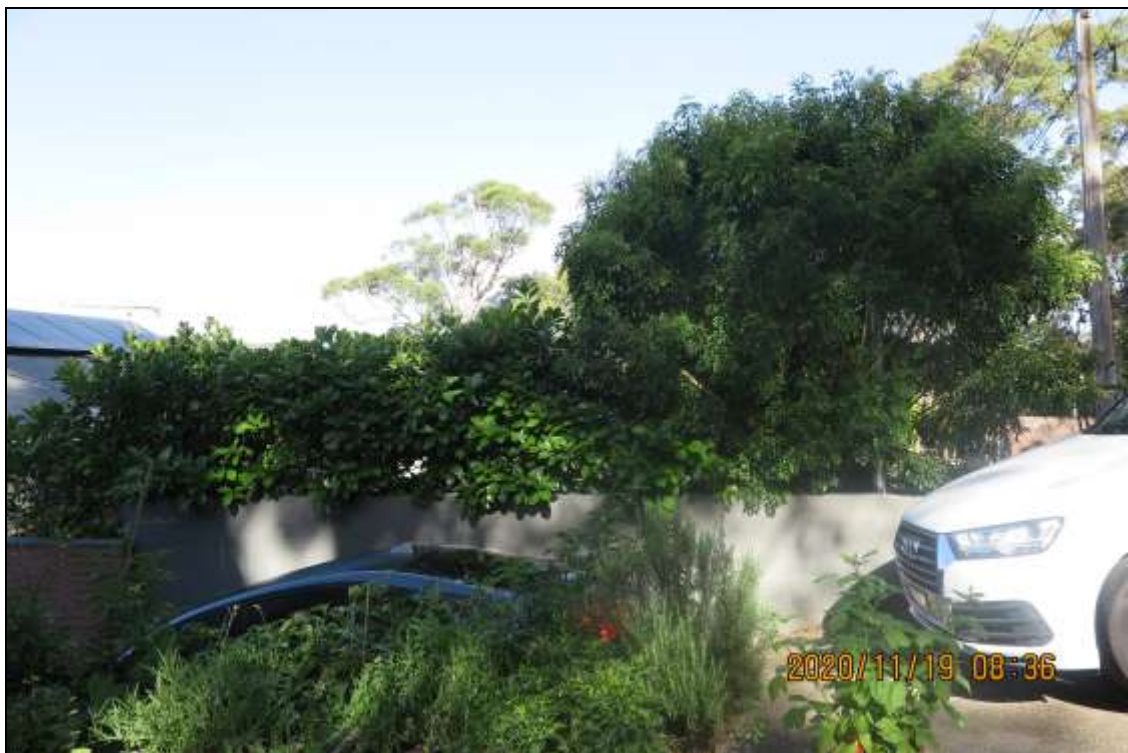
Figure 7: Illustrates adjoining property trees/shrubs. Note: existing damage to common boundary masonry retaining wall/subject site concrete driveway.
