Report Title: Geotechnical Report 13 Minkara Road, Bayview

Report Date: 3/6/19

GEOTECHNICAL INVESTIGATION:

New Shed, Tennis Court, Carport, and Awning at **13 Minkara Road, Bayview**

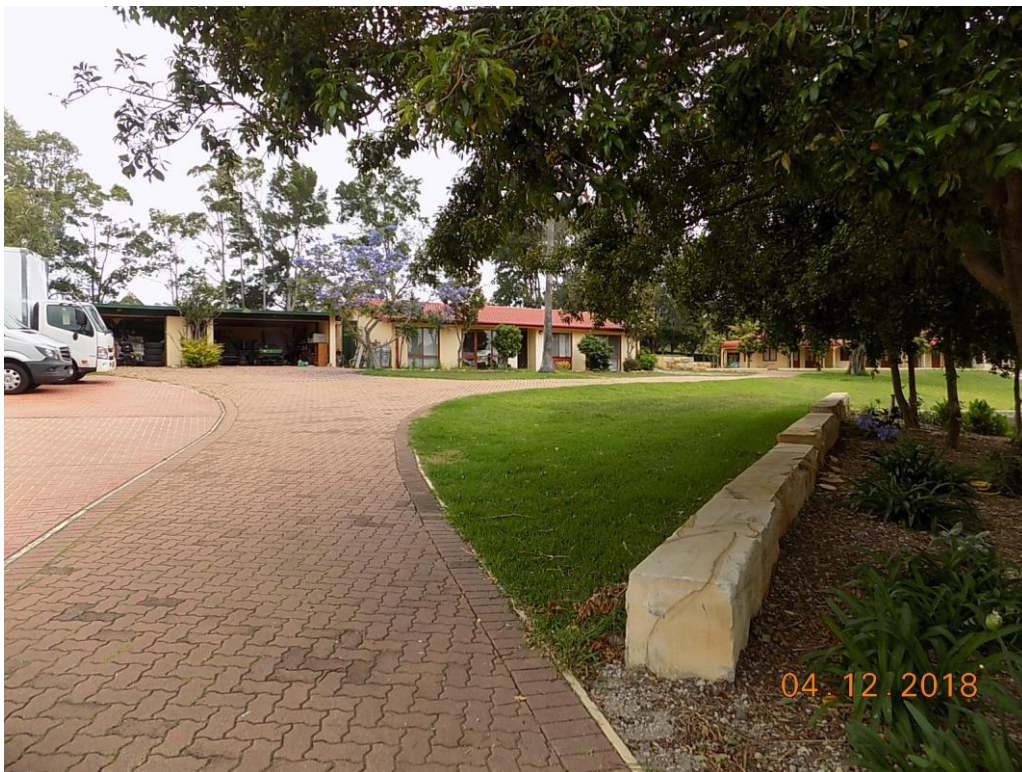
Photo 1

- 2.3** At the road frontage, a long brick driveway runs across the slope to the property (Photo 1). The driveway runs to a parking area on the E side of the site, garages on the E side of the office (Photo 2), and to a carport and parking area on the uphill side of the house (Photo 3). A dam has been constructed in the SE corner of the

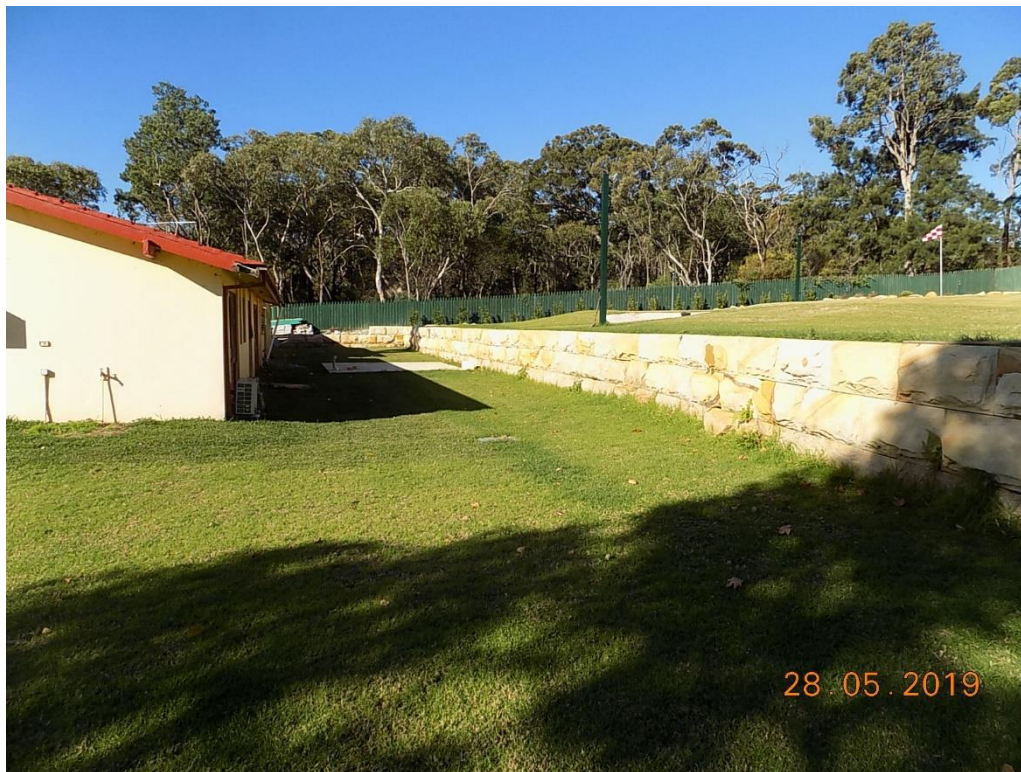
Photo 4

property (Photo 4). The dam recently went through the council approval process that involved this firm and it is currently considered stable. An excavation has been made in the slope for the house and office buildings. The cut is supported by a stable ~1.5m high sandstone block retaining wall (Photo 5). A pool has been cut into the slope to the W of the house (Photo 6). The water level of the pool indicates no ground movement has occurred in the shell of the pool since its construction. A creek runs down and under the W side of the property (Photo 7). A stable timber outbuilding has been constructed in the SW corner of the property (Photo 8). A large lawn area encompasses the majority of the downhill side of the property (Photo 9). Another dam has been constructed near the entrance to the property that will be removed as part of the proposed works (Photo 10). Competent Medium Strength Sandstone outcrops above this dam (Photo 11). The earthworks for the proposed tennis court (including a cut and fill) had already been completed prior to our first inspection (Photo 12). The earthworks were subject to a separate approval process and are currently considered stable.

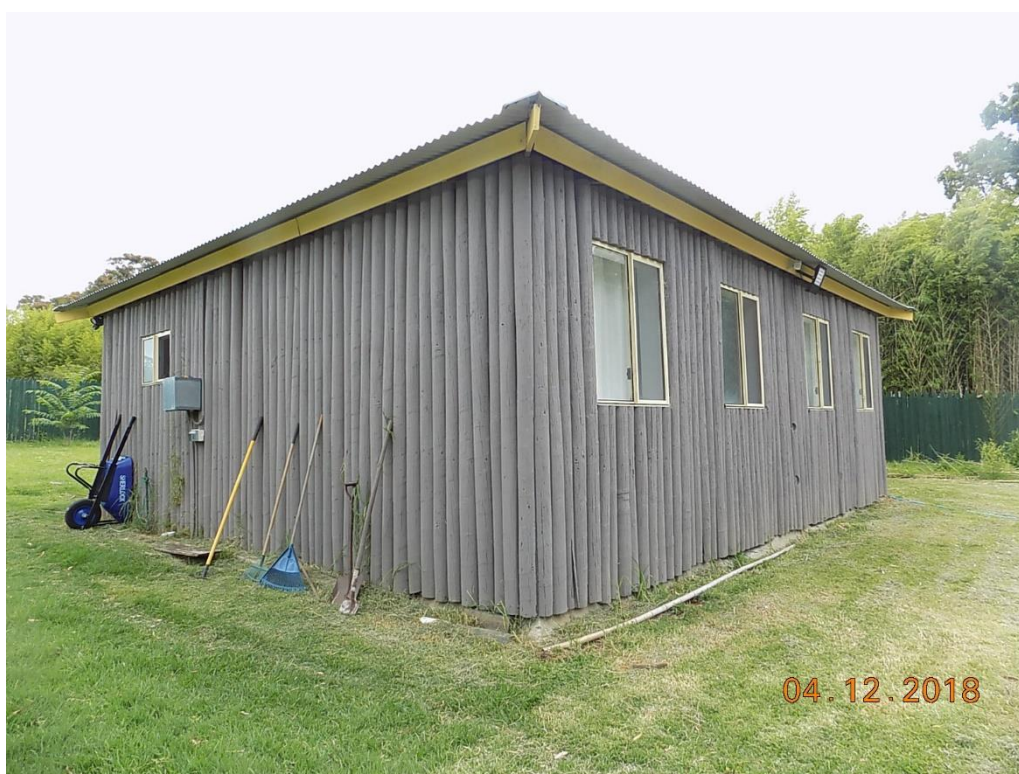
Photo 7

Ground water seepage is expected to move over the buried surface of the rock and through the cracks. As a creek flows down the W side of the block (Photo 7), we expect groundwater seepage to be slightly higher across the block as slope seepage will move toward the creek. Due to the slope and elevation of the block, the water table is expected to be many metres below the base of the proposed excavation.

There is fall to the creek that runs down the W side of the property (Photo 7). Roof water from the development is to be piped to the creek through any tanks that may be required by the regulating authorities. A diffuser is to be installed at the outlet of any new stormwater pipes that divert stormwater to the creek channel.
