Project name 2A WEST ST, BALGOWLAH	Project Number:	Responsible:	Date: 7/08/2019
--	-----------------	--------------	---------------------------

WSA assessment

Date: 7/08/2019	Asset owner's job ref.: 202379'2781	Asset Owner:	Operator : CRAIG PICKUP	Section number: 1	Pipe Asset Id: SW 1
Time of inspection: 12:27:00	Cleaning: not cleaned	Standard: WSA 05-2008 2.2	LRP Inside Face of the Wall	Conduit Unit Length	Method of Inspection Television Camera

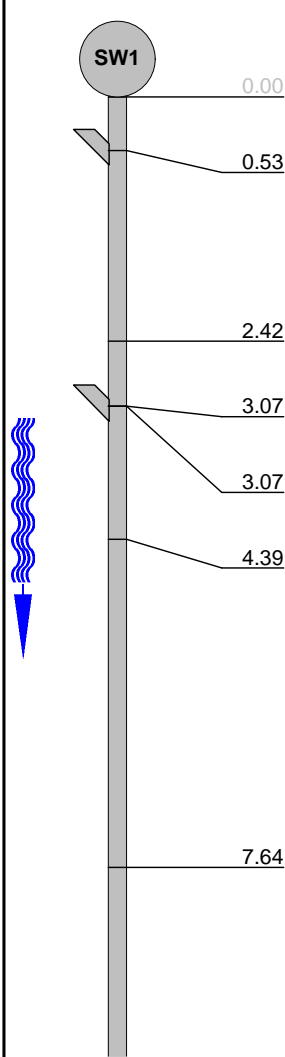
0.00	Circumferential fracture , width 0.5mm , from 1 to 5 o'clock	1_1_4_A.JPG
		0.53	Connection, poor workmanship, connection appears to be open , diameter 150mm	1_1_5_A.JPG
		2.42	S1 Longitudinal fracture , width 0.5mm , at 1 o'clock, Start	1_1_6_A.JPG
		3.07	E1 Longitudinal fracture , width 0.5mm , at 1 o'clock, End	
		3.07	Connection, poor workmanship, connection appears to be open , diameter 150mm	1_1_8_A.JPG
		4.39	Breaking, some pieces are missing, at joint, length of break 100, exposed reomesh, at 12 o'clock	1_1_9_A.JPG
		7.64	Finish node, grated inlet pit, Nodename: SW2
