## 29 Wandeen Road, Clareville

### Comments on Updates to Plans

## **GEOTECHNICAL INVESTIGATION:**

### **Alterations and Additions at 29 Wandeen Road, Clareville**

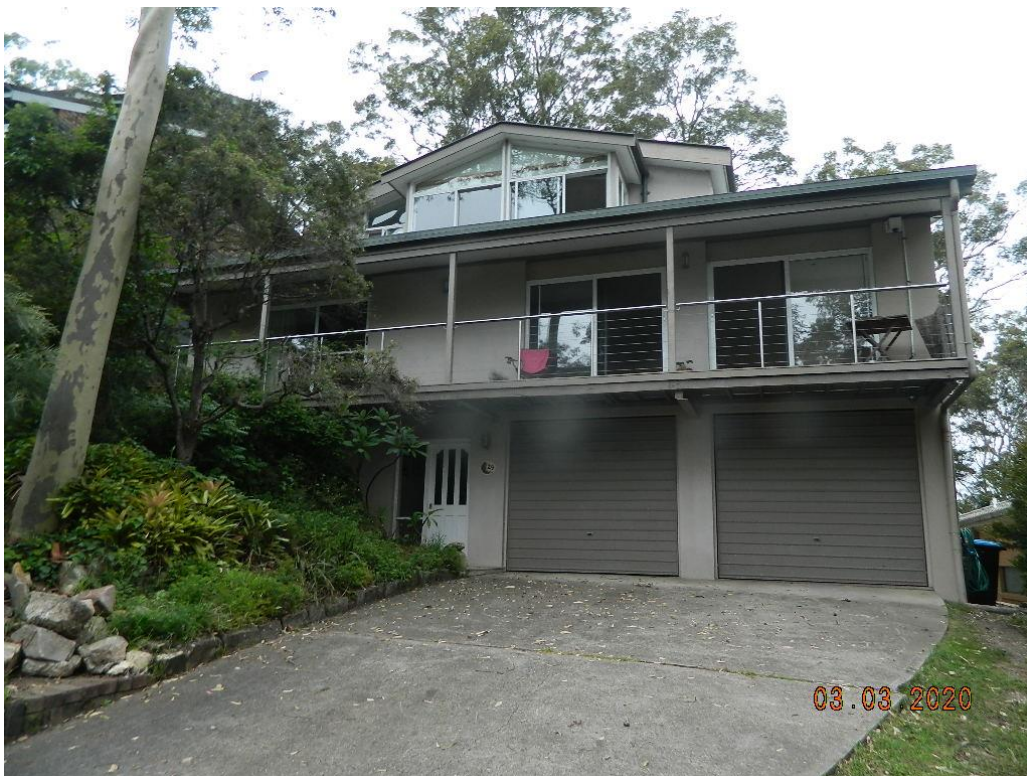
Photo 2

**2.3** At the road frontage a concrete driveway cuts across the slope and leads to a double garage under the house. Low stable sandstone stack rock and keystone retaining walls line the slope either side of the driveway (Photo 1). The part three storey rendered masonry house is supported by masonry walls and a concrete slab (Photos 2 & 3). The external supporting walls are in good condition and show no significant signs of movement.

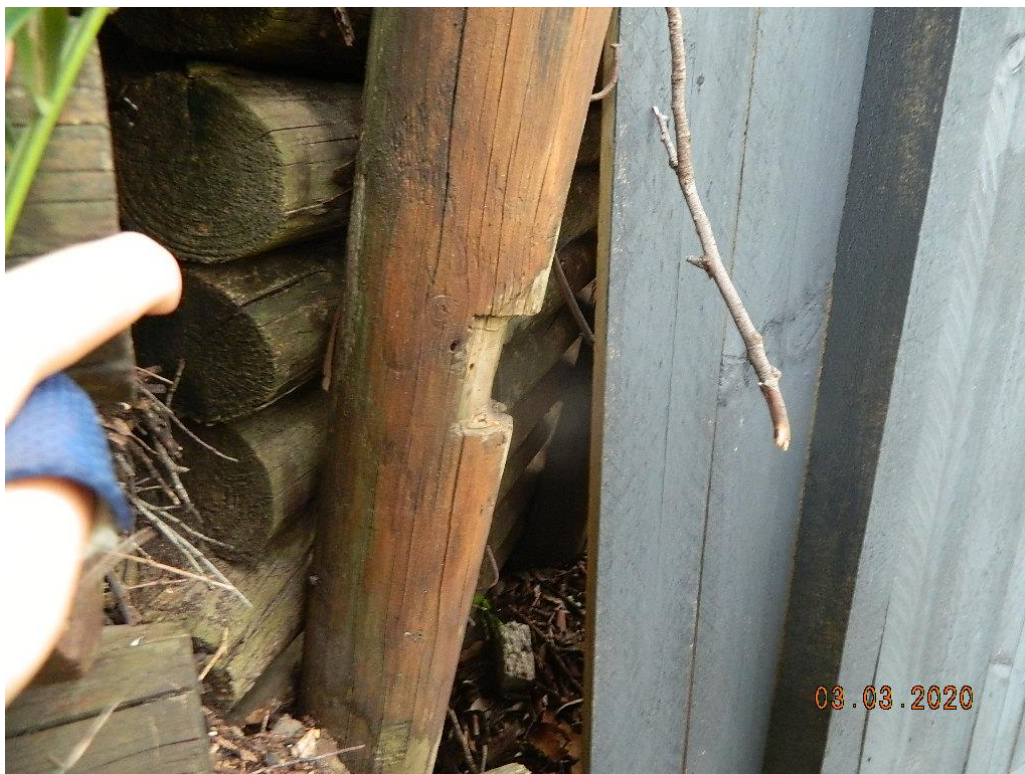
Photo 6

A  $\sim 0.6\text{m}$  high timber retaining wall supports a cut for the downhill property to the W along part of the W common boundary (Photo 4). A  $\sim 1.6\text{m}$  high timber retaining wall supports a cut in the slope next to the house along part of the E common boundary. Where the wall changes direction and extends onto the neighbouring property the supporting soldier post is tilting (Photos 5 & 6) some  $10^\circ$  from vertical. Due to its location the wall poses no significant threat to life or property. See '**Section 16** Ongoing maintenance.

The timber retaining wall (Photo 5 & 6) is to be monitored by the owners on an annual basis or after heavy prolonged rainfall events, whichever occurs first. A photographic record these inspections is to be kept. Should further movement occur the wall is to be remediated so it meets current engineering standards. We can carry out these inspections upon request.

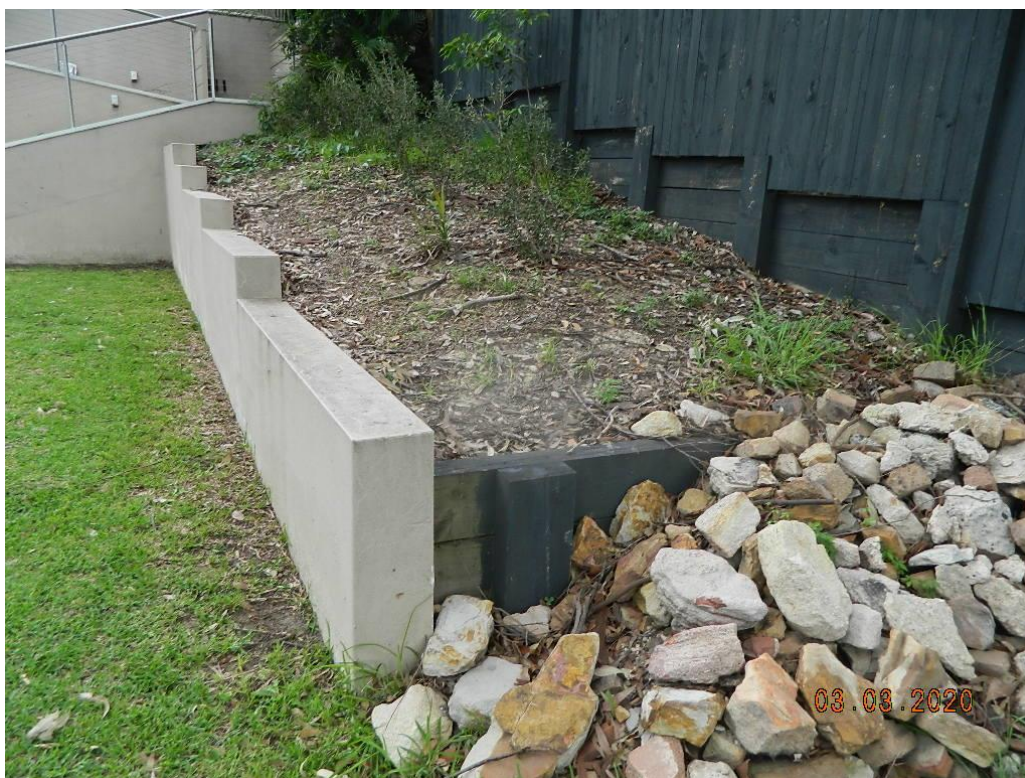
Photo 8

A cut and fill in the slope provides a near level lawn which extends from the S side of the house (Photo 7). Above the lawn a stable masonry retaining wall up to  $\sim 1.4\text{m}$  high supports the cut (Photo 8). The lawn drops away to the S where the fill batter merges into the natural slope (Photos 9 & 10).
