7 Cooleena Road, Elanora Heights

GEOTECHNICAL INVESTIGATION:

Subdivision and Driveway at **7 Cooleena Road, Elanora Heights**

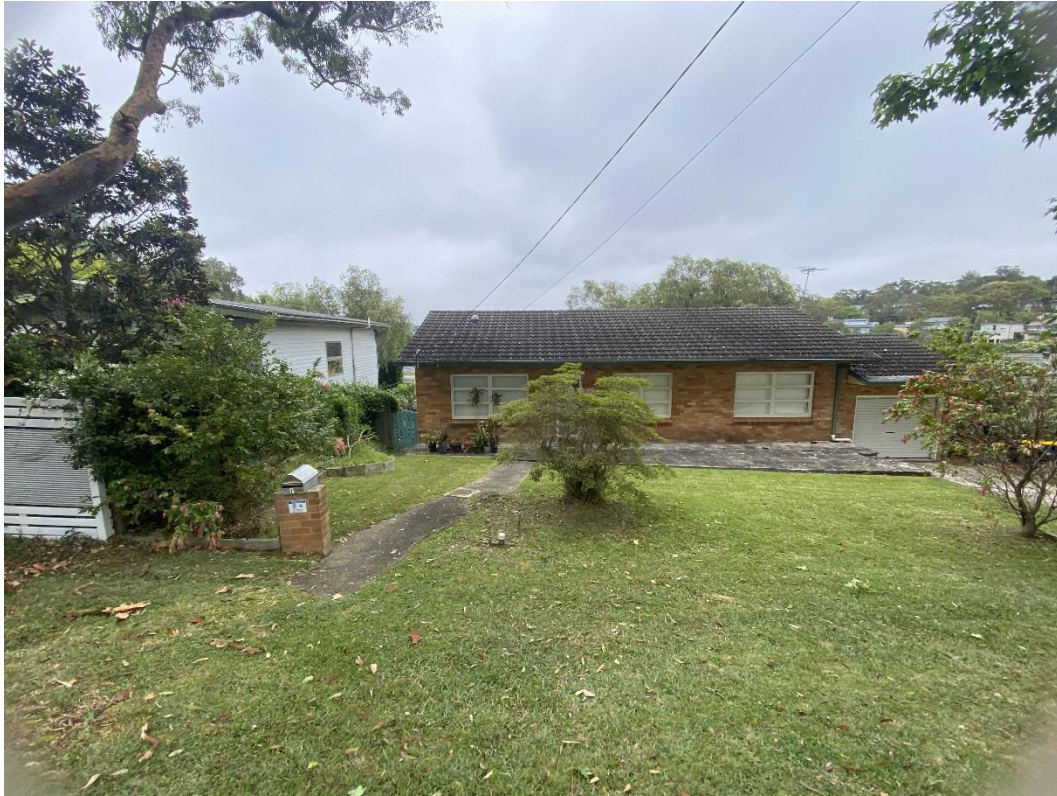
Photo 1

- 2.3** At the road frontage, a concrete driveway runs down the slope to a garage attached to the W side of the house (Photo 1). The garage will be demolished as part of the proposed works. Between the road frontage and the house is a gentle to moderately sloping lawn area (Photo 2). The part two-storey house is supported on brick walls and sandstone block walls (Photo 3). The visible external walls show no significant signs of movement. Access to the foundation space was not available at the time of this inspection. A level lawn area that extends off the downhill side of the house is supported by a low retaining wall. This wall was covered in dense vegetation

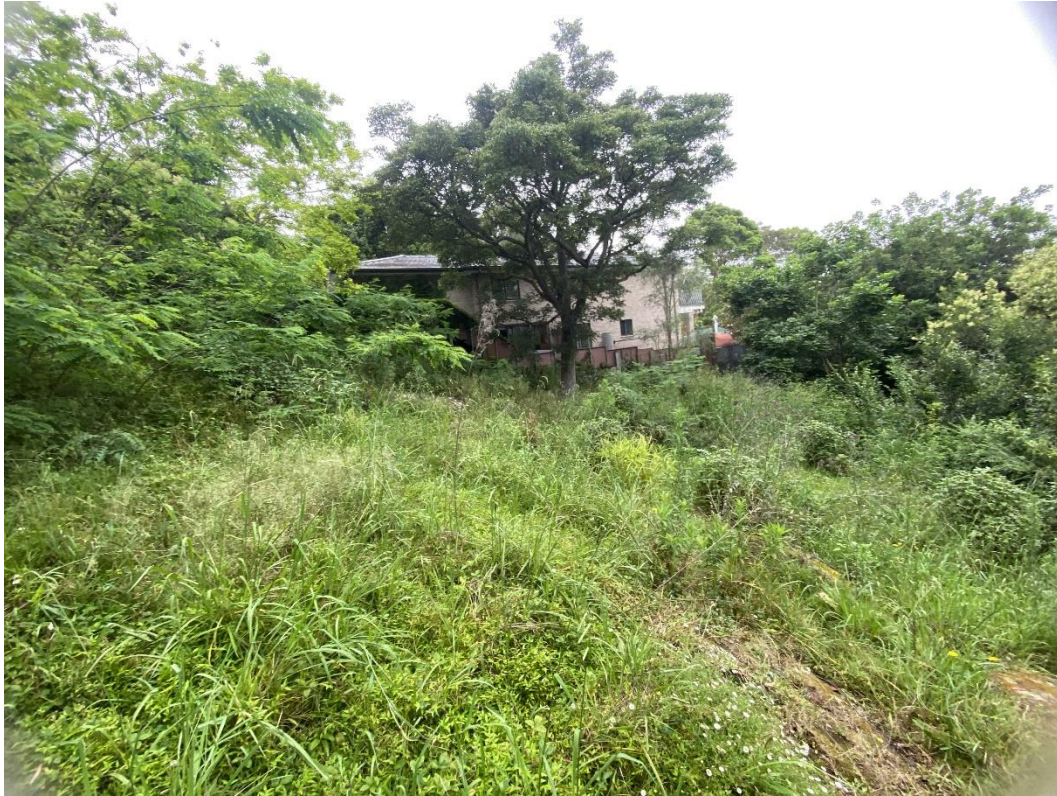
Photo 5

and could not be assessed. However, it was observed to be directly supported on outcropping Medium Strength Sandstone (Photo 4). A second ~2.5m high Medium Strength Sandstone rockface outcrops and steps down the property below this wall (Photo 5). This outcropping rock is undercut to 1.0m and extends onto the neighbouring property. Given the thickness of the cantilever arm with no visible defects, it is considered stable. A moderately sloping overgrown lawn area extends to the lower common boundary (Photo 6). Several floaters are embedded in this slope in stable positions (Photo 7).

No geotechnical hazards were observed beside the property. The moderately graded slope that falls across the property and continues above and below is a potential hazard (**Hazard One**). The undercut rock face (Photo 5) failing and toppling onto the slope below is a potential hazard (**Hazard Two**). The vibrations from the proposed excavation are a potential hazard (**Hazard Three**). The proposed excavation is a potential hazard until retaining walls are

HAZARDS	Hazard One	Hazard Three	Hazard Three
TYPE	The moderate slope that falls across the property and continues above and below failing and impacting on the proposed works.	The undercut rock face (Photos 5) failing and causing damage to the property below.	The vibrations produced during the proposed excavation impacting on the surrounding structures.
LIKELIHOOD	'Unlikely' (10^{-4})	'Rare' (10^{-5})	'Possible' (10^{-3})
CONSEQUENCES TO PROPERTY	'Medium' (12%)	'Major' (60%)	'Medium' (15%)
RISK TO PROPERTY	'Low' (2×10^{-5})	'Low' (6×10^{-5})	'Moderate' (2×10^{-4})
RISK TO LIFE	8.3×10^{-7} /annum	8.3×10^{-7} /annum	5.3×10^{-7} /annum
COMMENTS	This level of risk is 'ACCEPTABLE'.	This level of risk is 'ACCEPTABLE'.	This level of risk to property is 'UNACCEPTABLE'. To move risk to 'ACCEPTABLE' levels, the recommendations in Section 12 are to be followed.
