GEOTECHNICAL INVESTIGATION:

New House at **45 Oxford Falls Road, Beacon Hill**

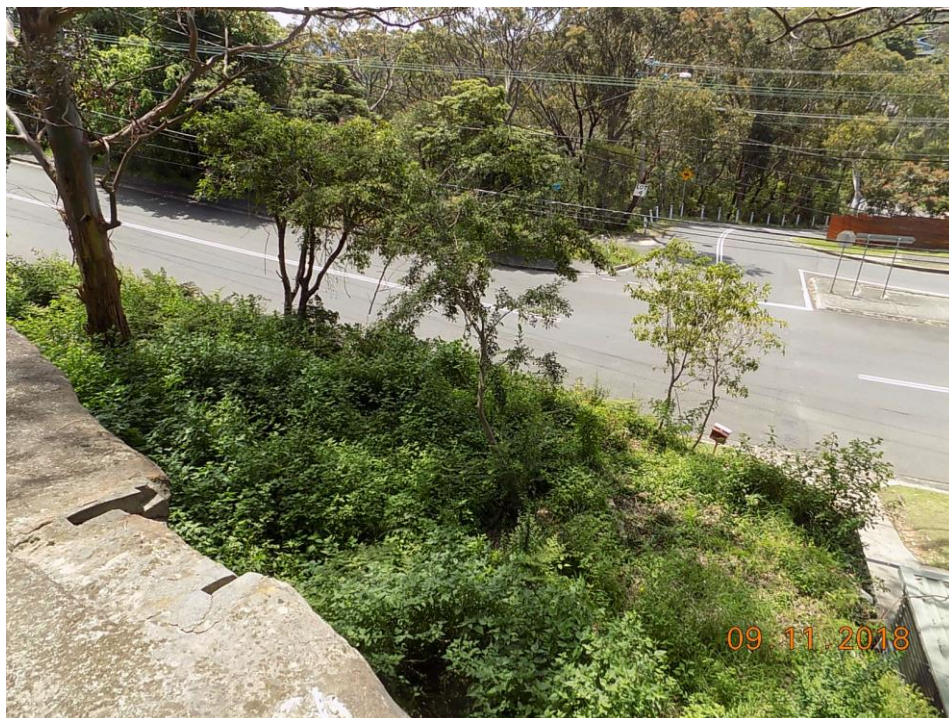
Photo 1

HAZARDS	Hazard One	Hazard Two	Hazard Three
TYPE	The sandstone cliff face above the carport failing and impacting on the proposed works (Photo 1).	The vibrations produced during the proposed excavations impacting on the cliff and supporting walls of the neighbouring carport.	The proposed excavations collapsing onto the work site before retaining walls are in place.
LIKELIHOOD	'Rare' (10^{-5})	'Possible' (10^{-3})	'Possible' (10^{-3})
CONSEQUENCES TO PROPERTY	'Major' (40%)	'Medium' (15%)	'Medium' (15%)
RISK TO PROPERTY	'Low' (6×10^{-5})	'Moderate' (2×10^{-4})	'Moderate' (2×10^{-4})
RISK TO LIFE	9.96×10^{-6} /annum	5.3×10^{-7} /annum	8.9×10^{-6} /annum
COMMENTS	This level of risk is 'ACCEPTABLE'.	This level of risk to property is 'UNACCEPTABLE'. To move risk to 'ACCEPTABLE' levels the recommendations in Section 12 are to be followed.	This level of risk to life and property is 'UNACCEPTABLE'. To move the risk to 'ACCEPTABLE' levels the recommendations in Section 13 are to be followed.
