Re: Geotechnical Assessment

Project No: KFMGR-240309-Rv01

Address: 78 Mccarrs Creek Road, Church Point NSW 2105

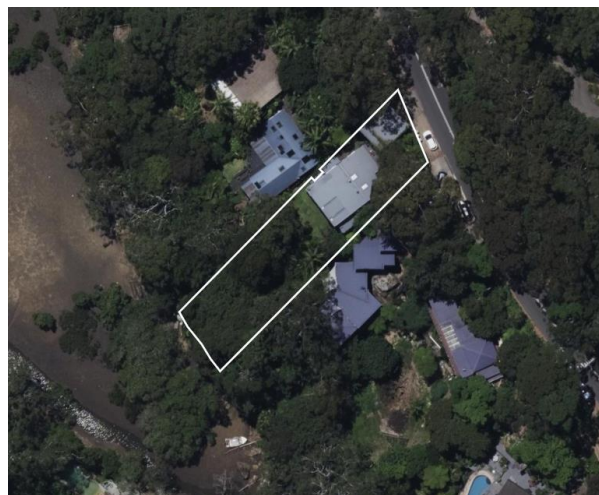
Figure 1. Site Plan

KFM Geotech (KFM) was engaged by Mr. Iman Ahmadian to carry out a geotechnical assessment of the site for the proposed retaining wall design at 78 Mccarrs Creek Road, Church Point NSW 2105. The site is bordered by residential properties to the south, north, and west, and Mccarrs Creek Road is located to the northeast. The site descends sharply from the roadside, presenting a striking slope that cascades towards the sea. The proposed development includes constructing a new retaining wall adjacent to the roadside to ensure structural stability and aesthetic integration. The height of the existing retaining wall is approximately 1.3-1.5m. As previously mentioned, the site has undergone significant earthworks, evident in the visible cuts and fills that have shaped the terrain. A timber retaining wall had initially been installed to manage the pressure of the roadside fill materials, though its condition now necessitates enhancement for long-term functionality.
