Report Title: Geotechnical Report 1742 Pittwater Road, Bayview

## **GEOTECHNICAL INVESTIGATION:**

### **New Pool and Boatshed at 1742 Pittwater Road, Bayview**

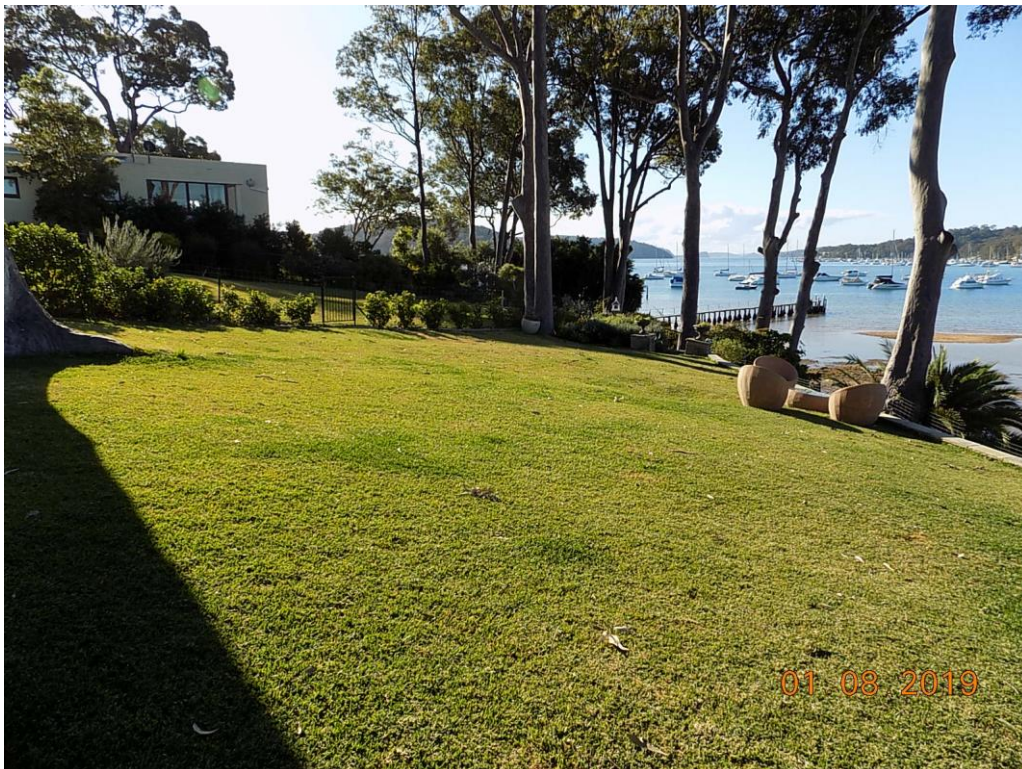
Photo 4

- 2.3** At the road frontage, a concrete driveway runs to a garage attached to the uphill side of the house and to a carport on the uphill side of the property (Photos 1 & 2). The part two-storey framed and clad house is recently constructed and in good condition (Photo 3). A gently sloping lawn extends off the downhill side of the house (Photo 4). At the NE end of the block, the bank that descends to the waterfront is landscaped with flagging walls and low rockeries (Photos 5 & 6). An old dilapidated pool and surrounding paving is located at the toe of the bank (Photo 7). The retaining walls and pool will be demolished as part of the proposed works. A stone and concrete
