## **GEOTECHNICAL INVESTIGATION:**

### **Alterations and Additions at 4 Curra Close, Frenchs Forest**

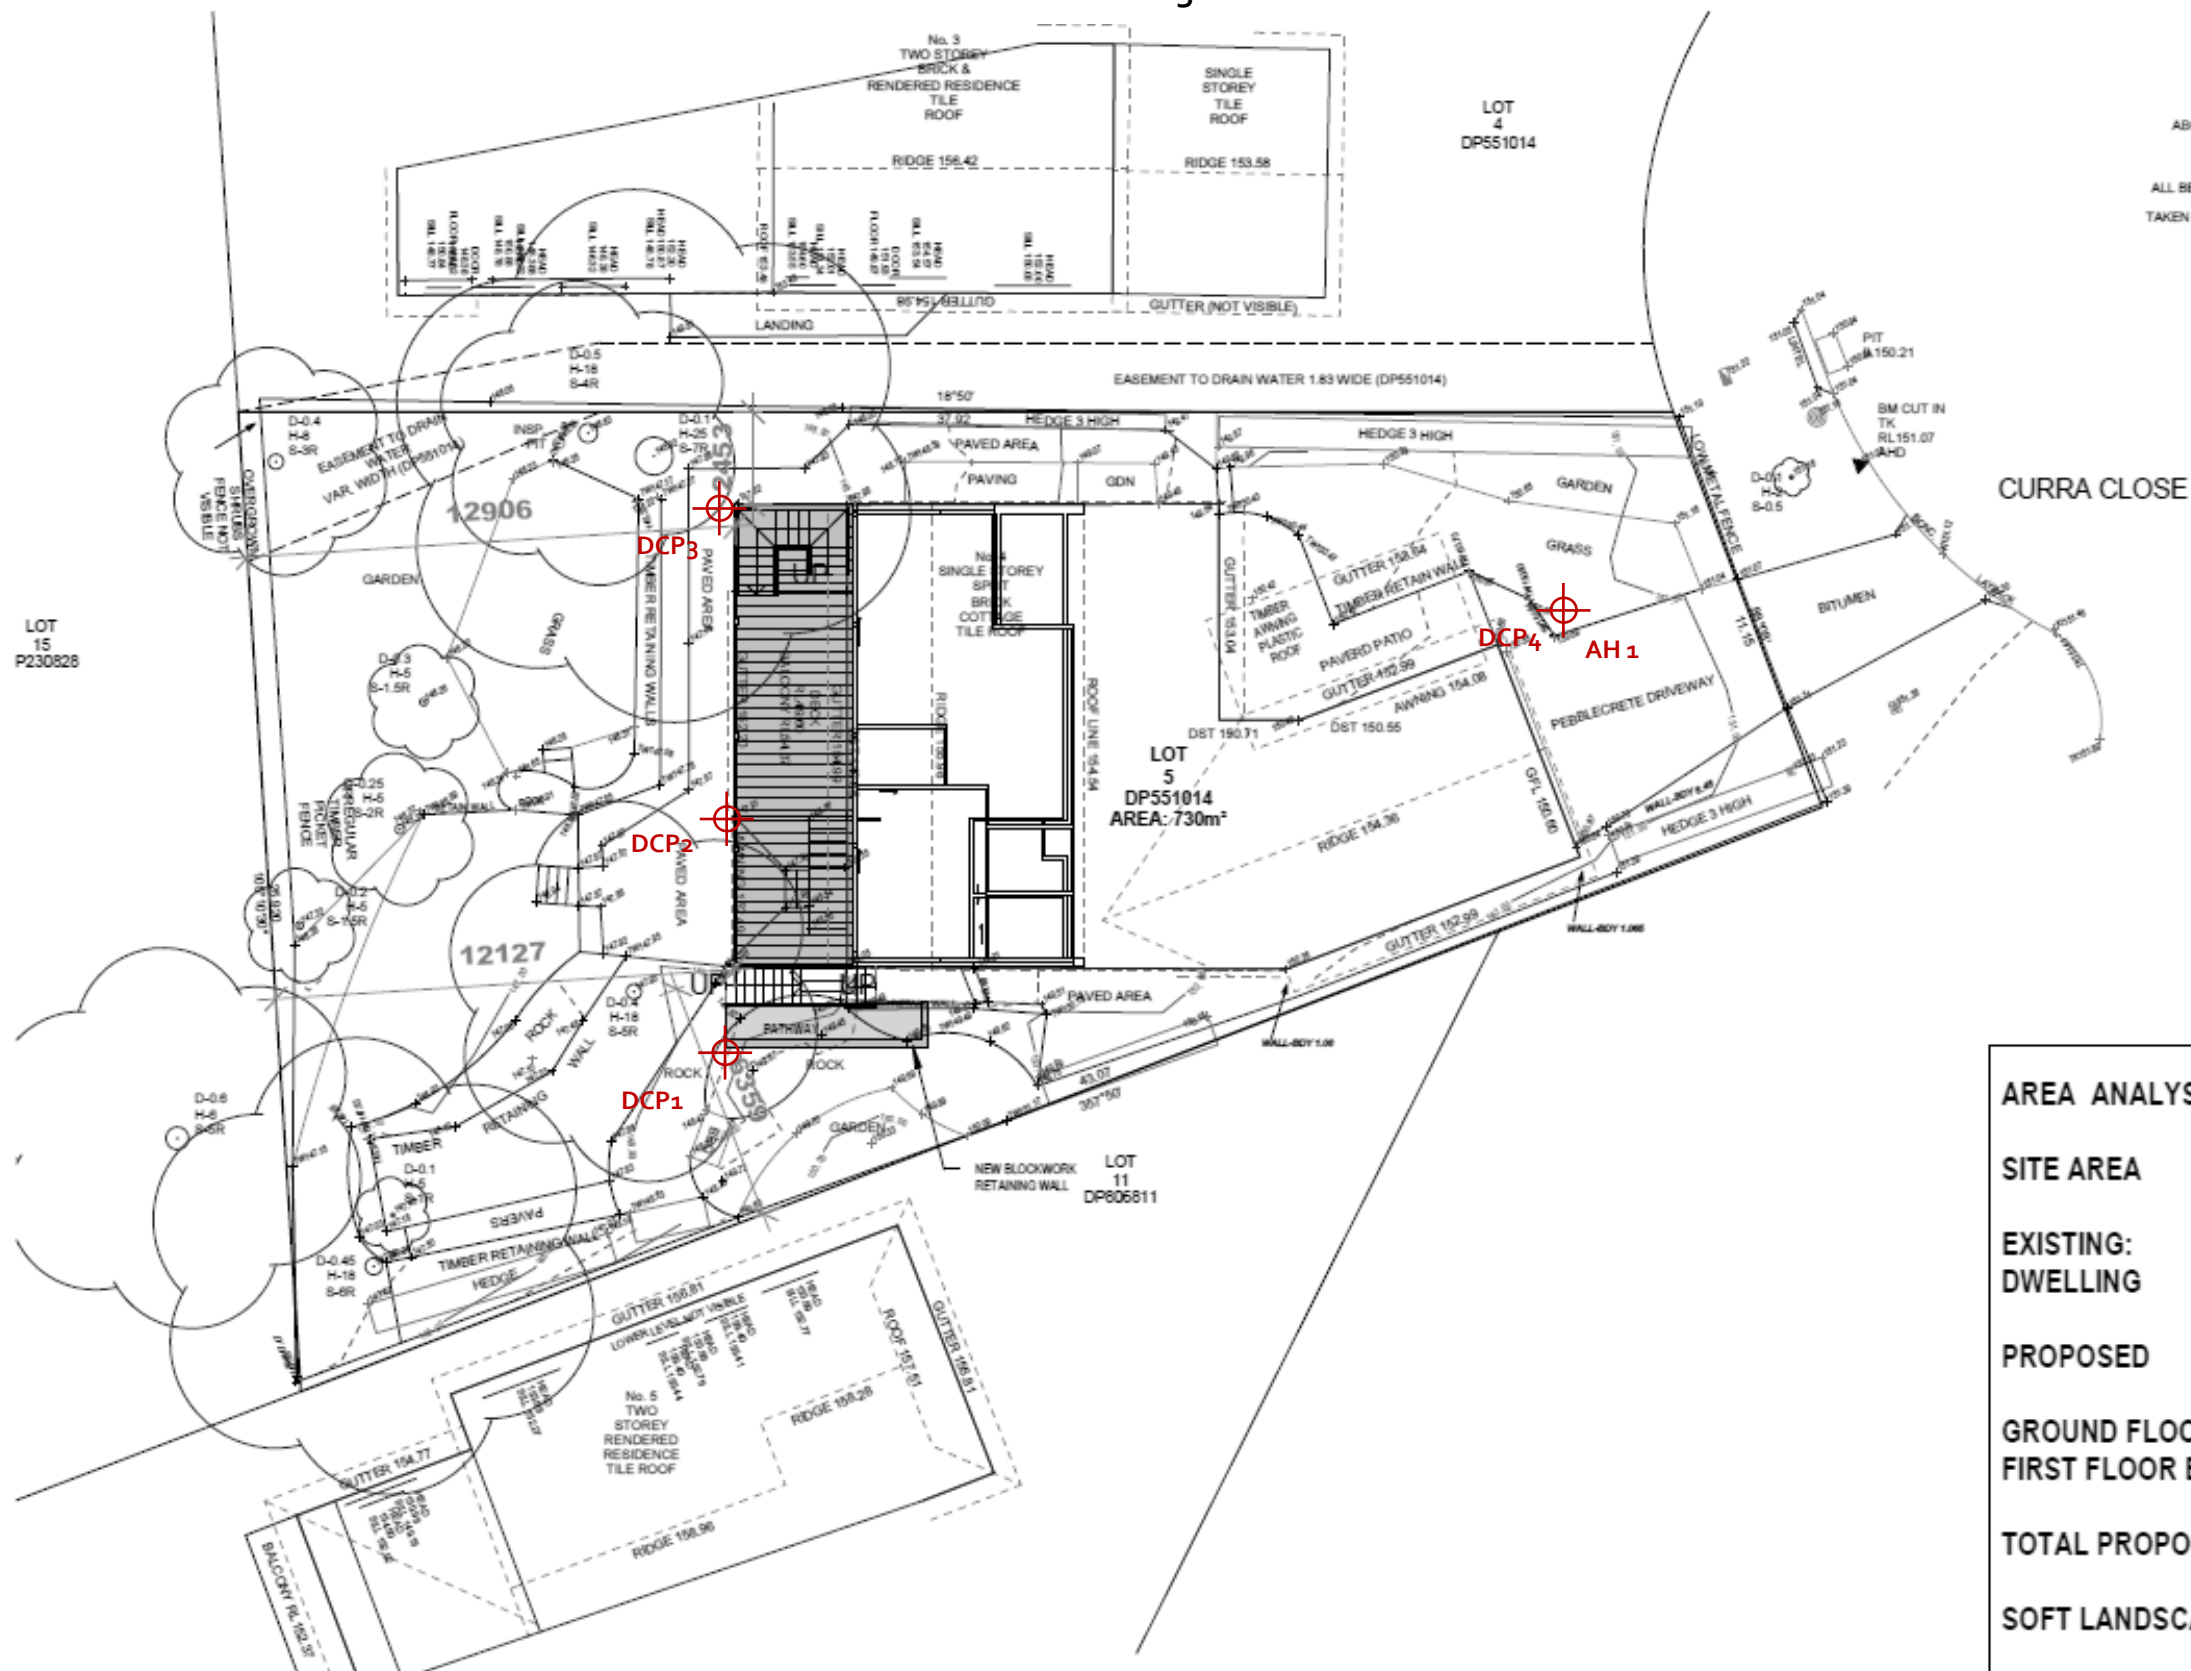
# SITE PLAN – showing test locations

NOTE: DRAINAGE TO BE CONNECTED TO EXISTING HOUSE FROM PROPOSED NEW DOWN PIPES FOR NEW BALCONY ROOF.

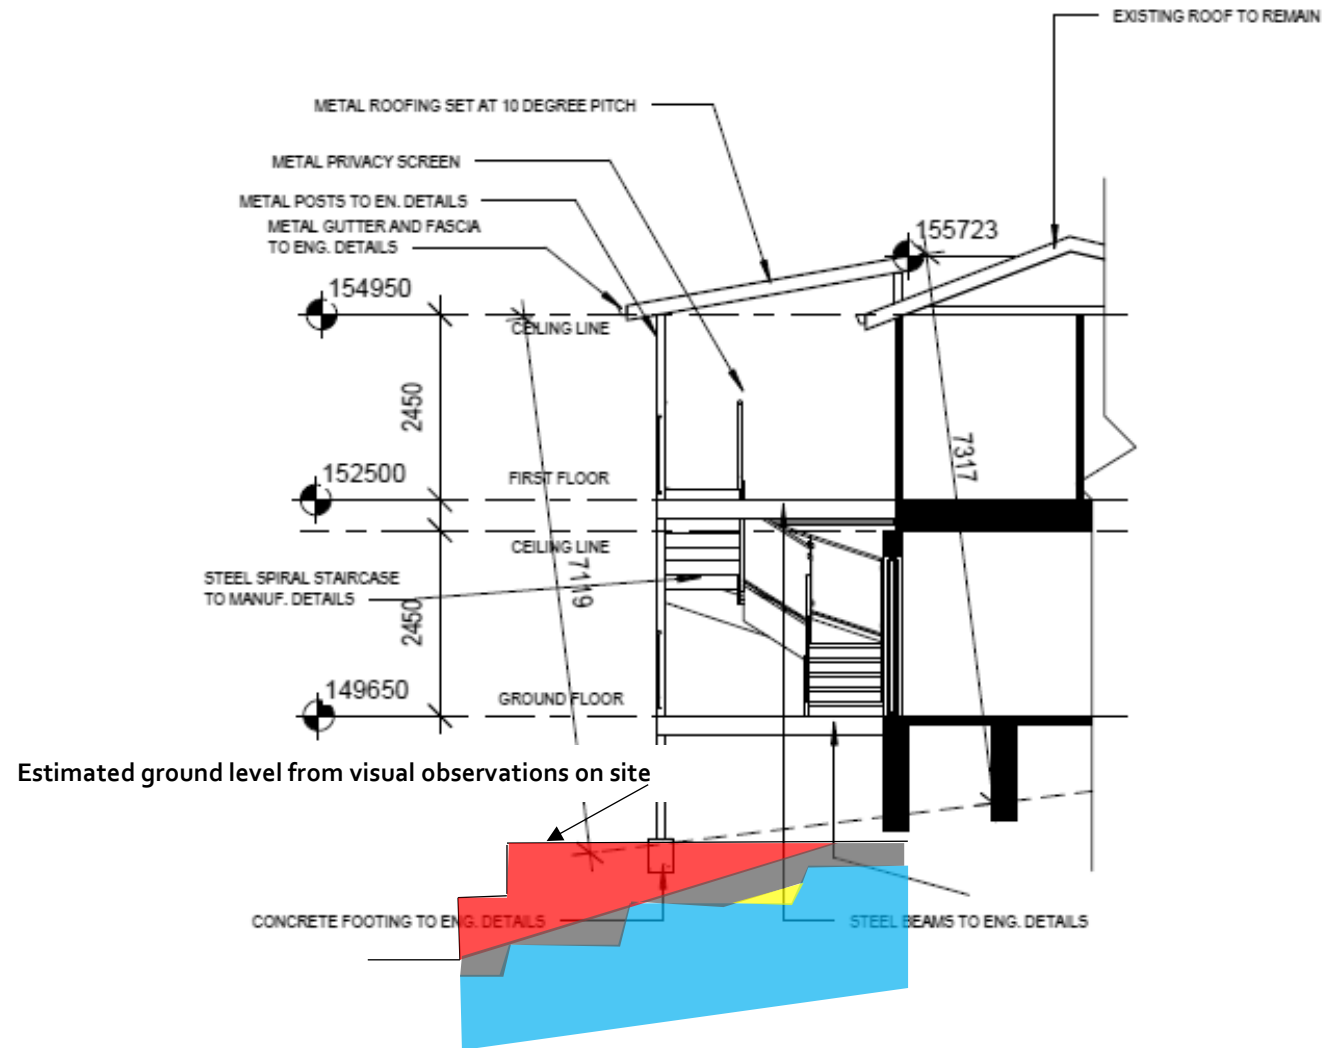
SECTION A-A

- Fill
- Topsoil
- Sand – Loose
- Hawkesbury Sandstone – Medium Strength
