Report Title: Geotechnical Report <b>29 Wandeen Road, Clareville</b>
Report Date: <b>15/10/24</b>
Author: <b>BEN WHITE</b>
Author's Company/Organisation: <b>WHITE GEOTECHNICAL GROUP PTY LTD</b>

## **GEOTECHNICAL INVESTIGATION:**

### **Alterations and Additions at 29 Wandeen Road, Clareville**

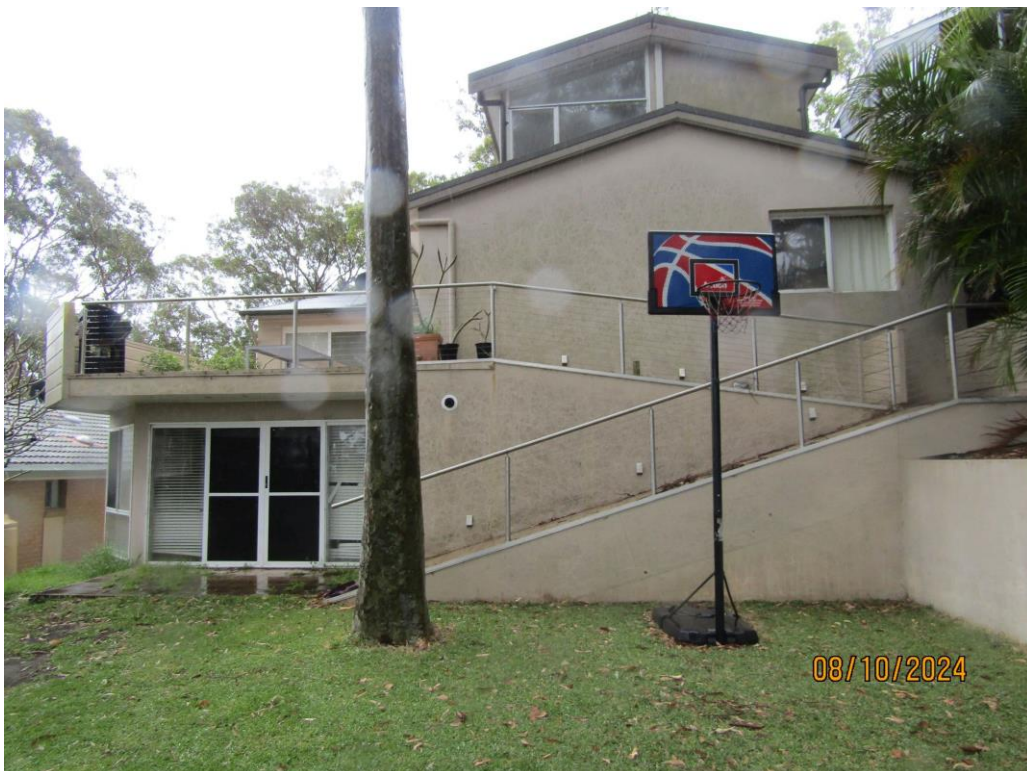
Photo 3

and timber retaining walls support a cut and fill for the driveway and landscaping (Photos 1 & 2). The part three storey rendered masonry house with garage is supported on brick walls, concrete block walls, brick piers, and a concrete slab (Photos 1 & 3). The supporting walls show no significant signs of movement and the supporting piers stand vertical (Photo 4). A cut up to ~1.5m high in the foundation space of the house has exposed Very Low to Low Strength Rock (Photos 5 & 6). The cut batter is unsupported but appears to be currently stable.
