GEOTECHNICAL INVESTIGATION:

New Pool at 6B Trentwood Park, Avalon Beach

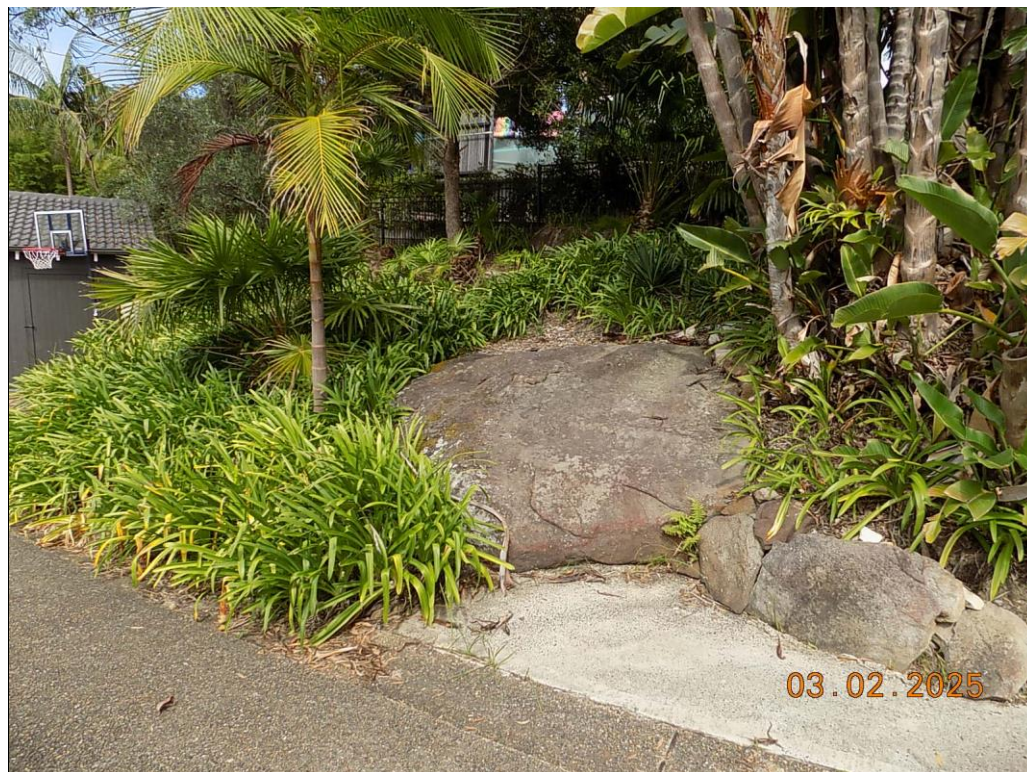
Photo 1

- 2.3** The property is accessed by a shared concrete driveway. The driveway continues to a brick parking area on the uphill side of the house (Photo 1). On the uphill side of the driveway, sandstone boulders were observed to be embedded in stable positions (Photo 2). A steeply graded fill batter provides a level platform for the driveway (Photo 3). The upper portion of the fill is densely vegetated and currently considered stable. The fill batter is supported at the base by two stable low sandstone flagging retaining walls which step up to a combined ~1.0m in height (Photo 4). These walls will be demolished as part of the proposed works. A cut for the

- ~0.6m from the supporting timber posts of the decking which extends off the NE side of the house (Photo 6)
- ~4.1m from the concrete driveway uphill from the proposed excavation (Photo 1).
