GEOTECHNICAL RISK MANAGEMENT POLICY FOR PITTWATER FORM NO. 1 – To be submitted with Development Application

Development Application for Reform Projects Pty Ltd
Name of Applicant
Address of site 1102-1106 Barrenjoey Road, Palm Beach, NSW
Declaration made by geotechnical engineer or engineering geologist or coastal engineer (where applicable) as part of a geotechnical report
I, Jarett Mones on behalf of JK Geotechnics Pty Ltd
(Insert Name) (Trading or Company Name)
on this the 25 May 2022 certify that I am a geotechnical engineer or engineering geologist or coastal engineer as defined by the Geotechnical Risk Management Policy for Pittwater - 2009 and I am authorised by the above organisation/company to issue this document and to certify that the organisation/company has a current professional indemnity policy of at least \$10million.
l: Please mark appropriate box
have prepared the detailed Geotechnical Report referenced below in accordance with the Australia Geomechanics Society's Landslide Risk Management Guidelines (AGS 2007) and the Geotechnical Risk Management Policy for Pittwater - 2009 am willing to technically verify that the detailed Geotechnical Report referenced below ha

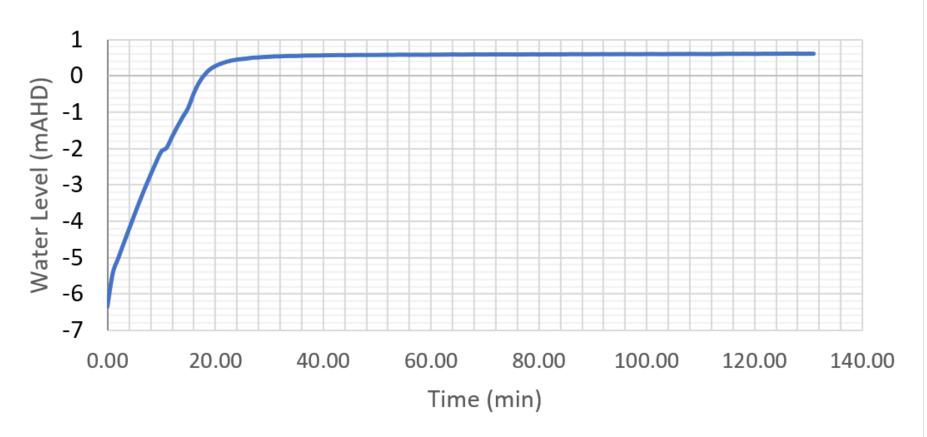
Report No. 33618YJ Figure No. 7

To assess realistic coefficients of permeability for the soils and the weathered bedrock, two pump-out tests were completed in BH101 and BH102. Data loggers were installed in both boreholes during testing to allow accurate measurement of groundwater recharge. The results of these tests are presented in Figures 7 and 8. At the time of testing, the infiltration zone encompassed the soils (generally silty sand and clayey sand including fill) and extremely to moderately weathered bedrock in BH101 and generally highly weathered to moderately weathered bedrock in BH102.
