Report Title: Geotechnical Report 45 Hillcrest Avenue, Mona Vale  
Report Date: 27/1/21  
Author: BEN WHITE  
Author's Company/Organisation: WHITE GEOTECHNICAL GROUP PTY LTD

## **GEOTECHNICAL INVESTIGATION:**

New Pool and Landscaping at **45 Hillcrest Avenue, Mona Vale**

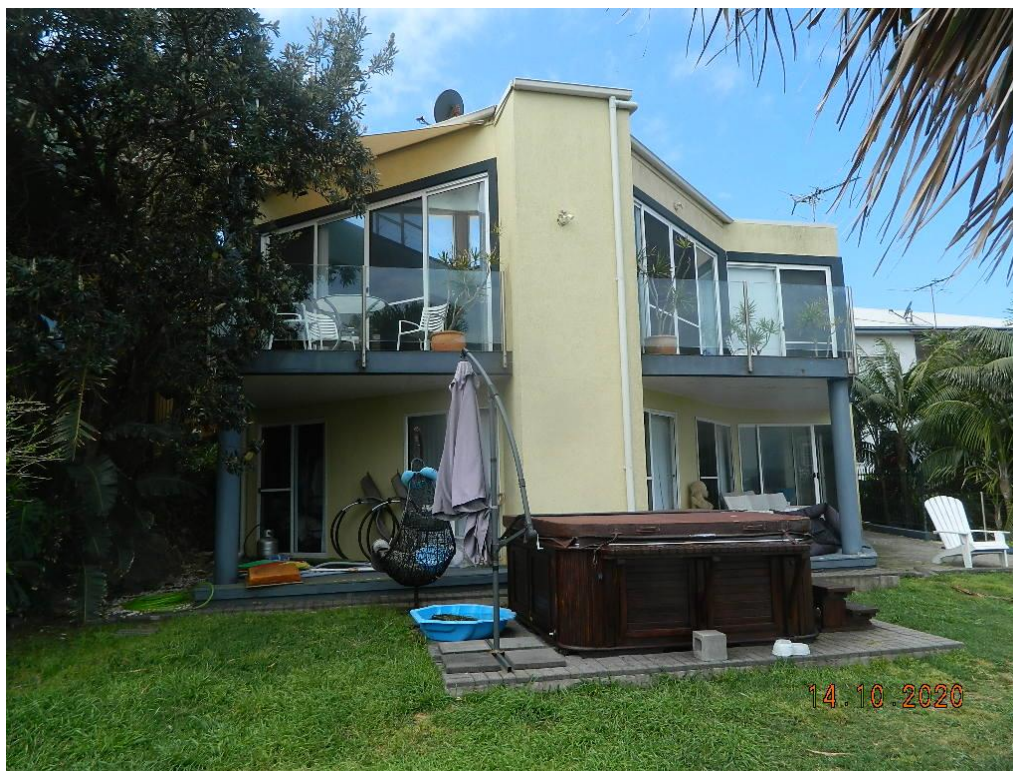
Photo 3

- 2.3** At the road frontage a concrete driveway runs down the slope to a garage attached to the house (Photos 1 & 2). Between the road frontage and the house is a garden area. The fill for the garden area is supported by a low rendered masonry retaining wall. The part two storey rendered house is supported by rendered walls (Photos 2 & 3). The external supporting walls show no significant signs of movement. The cut on the N side of the house is supported by a low sandstone flagging retaining wall and a stable sandstone block retaining wall up to ~1.6m high (Photo 4). Fill provides level lawn areas on the downhill side of the house (Photos 5 & 6). The fill is
