Arboricultural Impact Assessment

252 Hudson Parade Clareville

Prepared by Alex Austin

April 2023

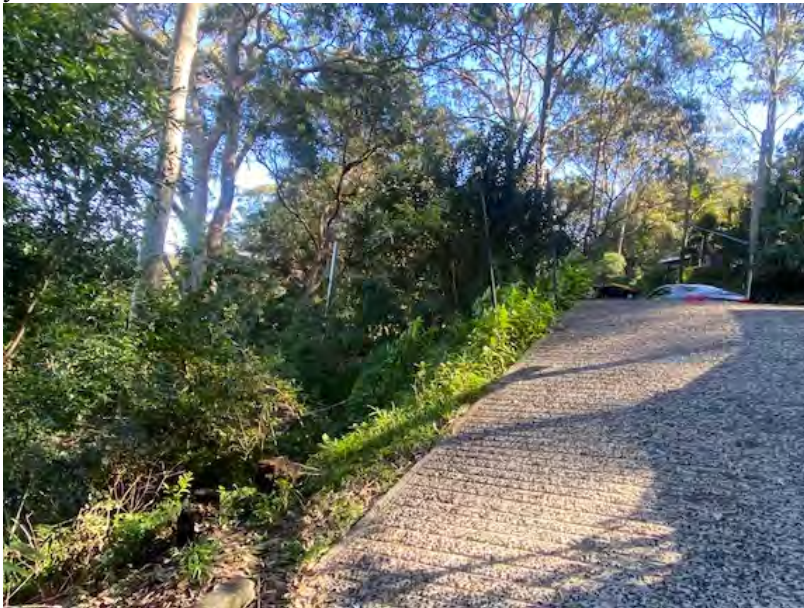
Figure 5: The Hudson Parade end of the site depicting the steep slope onsite and the trunk of Tree 35 *Corymbia maculata* (Spotted gum). (Source: Austin 27th July 2022).

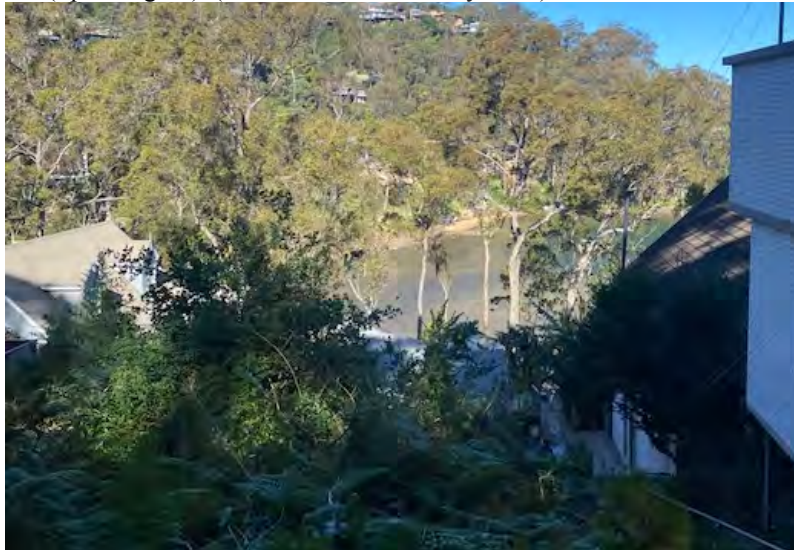
Figure 6: The dense shrubs covering the middle of the block can be observed. (Source: Austin 27th July 2022).

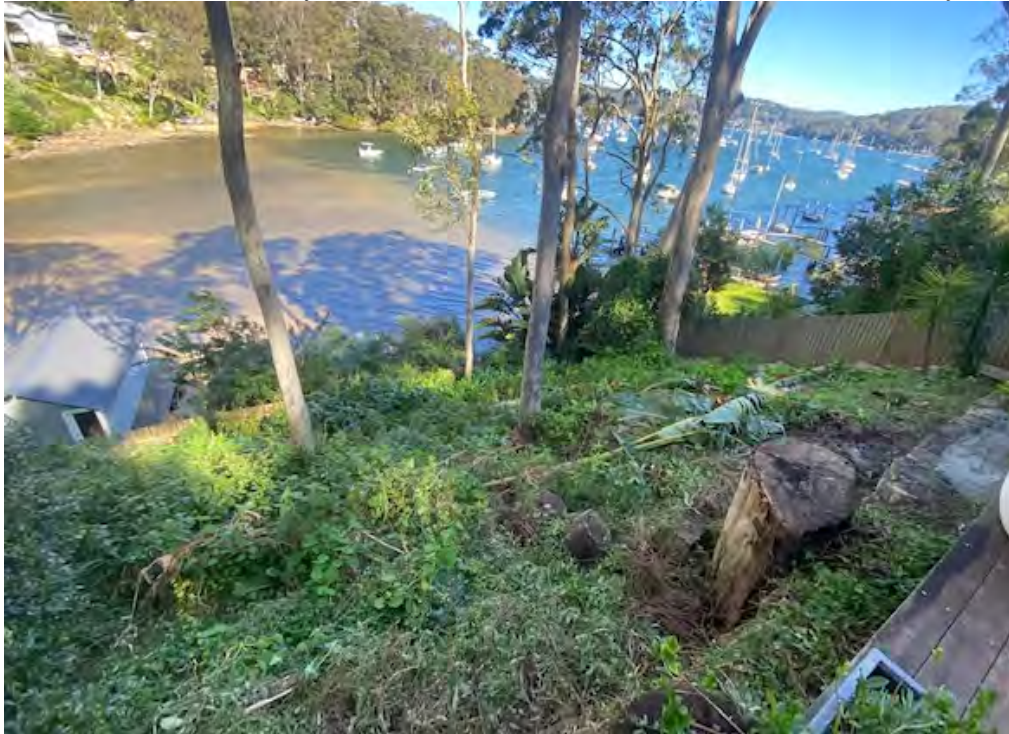
Figure 8: The western side of the rear garden with the retaining walls separating site trees from works. (Source: Austin 27th July 2022)

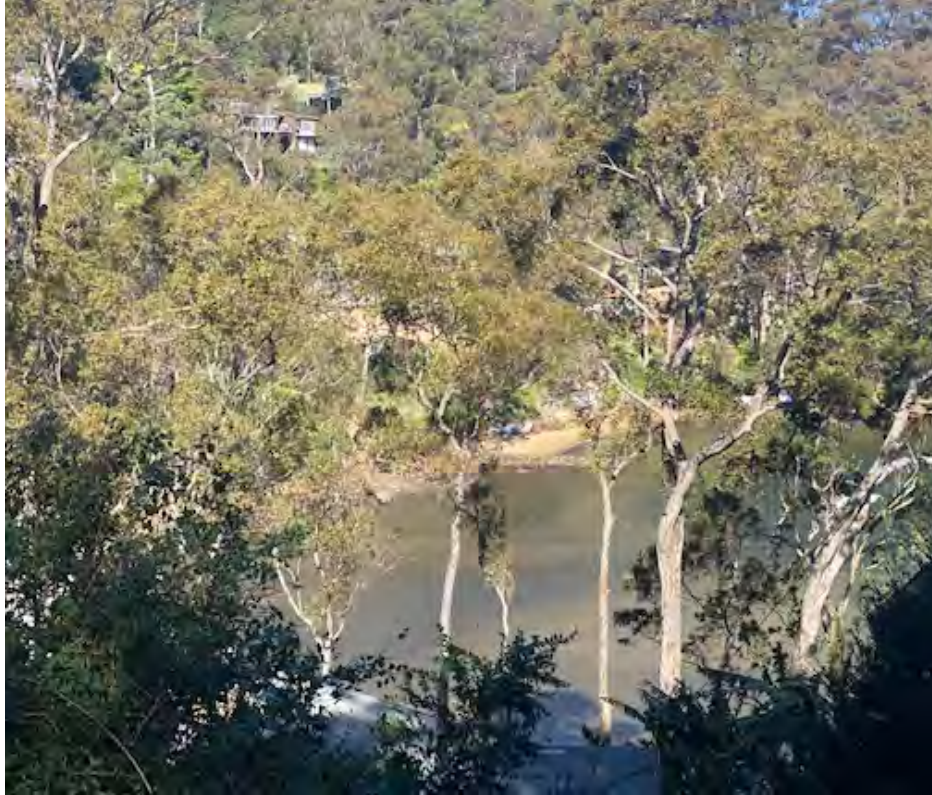
Trees 41- 44 *Corymbia maculata* (Spotted gums) are located on the water front and have intertwining canopies. Trees 41- 44 are of B retention value.

Figure 15: Trees 40 - 48 *Corymbia maculata* (Spotted gums) viewed from the middle of the site.. (Source: Austin 27th July 2022)

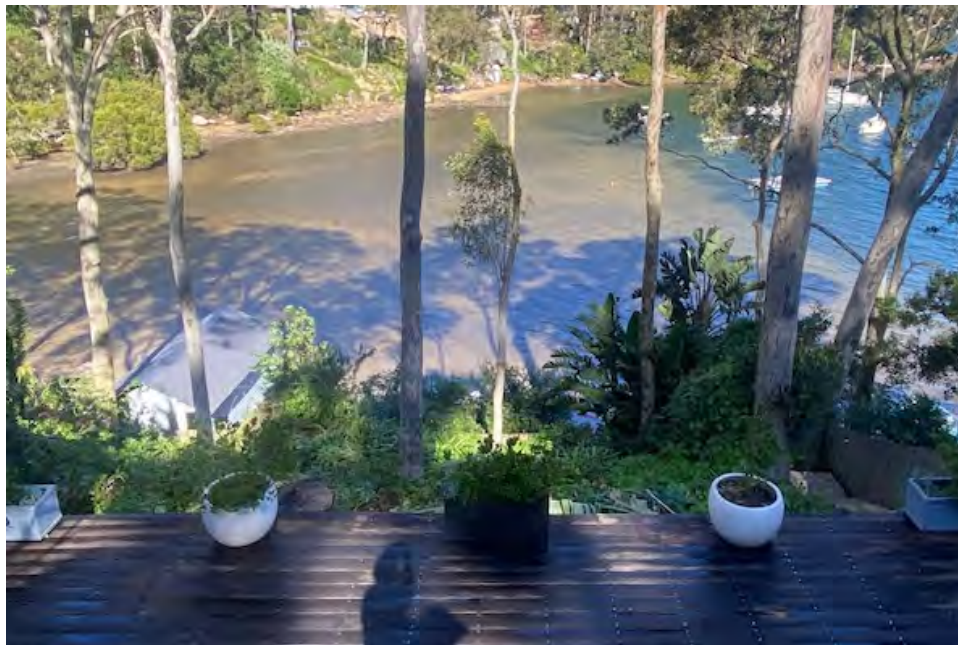
Figure 16: Trees 40 - 48 *Corymbia maculata* (Spotted gums) viewed from the existing back deck. . (Source: Austin 27th July 2022)

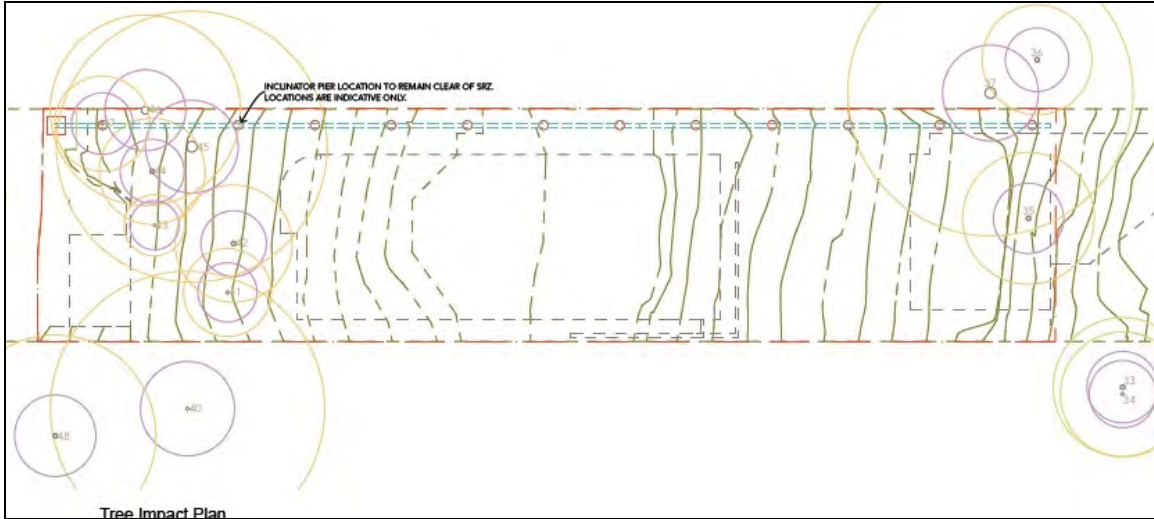
Tree 47 *Corymbia maculata* (Spotted gum) is a B retention Value tree that conflicts with the inclinator path. Considerable unsuccessful attempts were undertaken by the Architect and the Inclinator engineer to incorporate this tree within the design. Tree 47 requires removal to facilitate the inclinator path to the water level. .

Figure 22: The tree impact plan showing the location of the proposed inclinator path. . (Source: Proposed Plans by ANNE ROBSON ARCHITECTURE PTY LTD dated 18/4/23)

Trees 35 & 47 are proposed for removal and should be removed at the beginning of the project (STCA). The trees nominated for retention must not be damaged during the tree removal works.

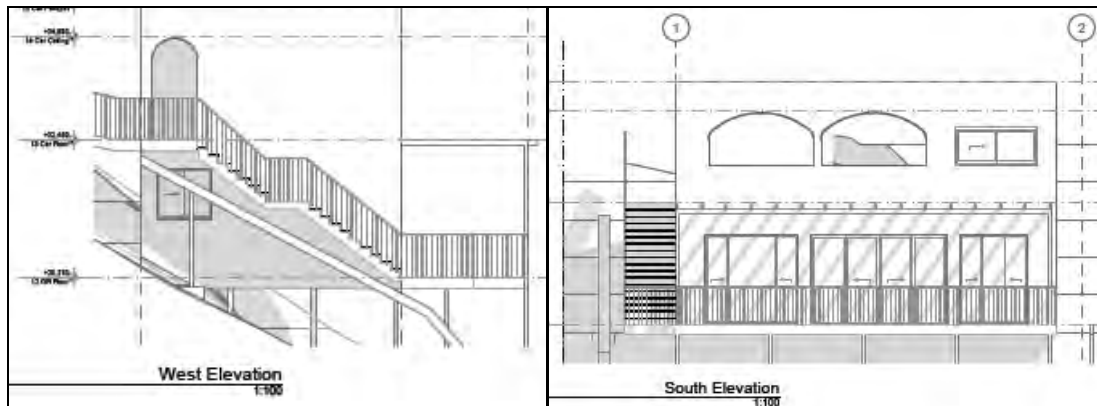
Figures 24 & 25: The suspended steps, inclinator track and minor excavation requirements on the western side of the structure can be observed. (Source: Proposed Plans by ANNE ROBSON ARCHITECTURE PTY LTD dated 29/03/2023)
