Geotechnical Investigation Report

**Proposed Residential Development
888 Barrenjoey Road, Palm Beach NSW**

18 May 2021

12949-GR-1-1

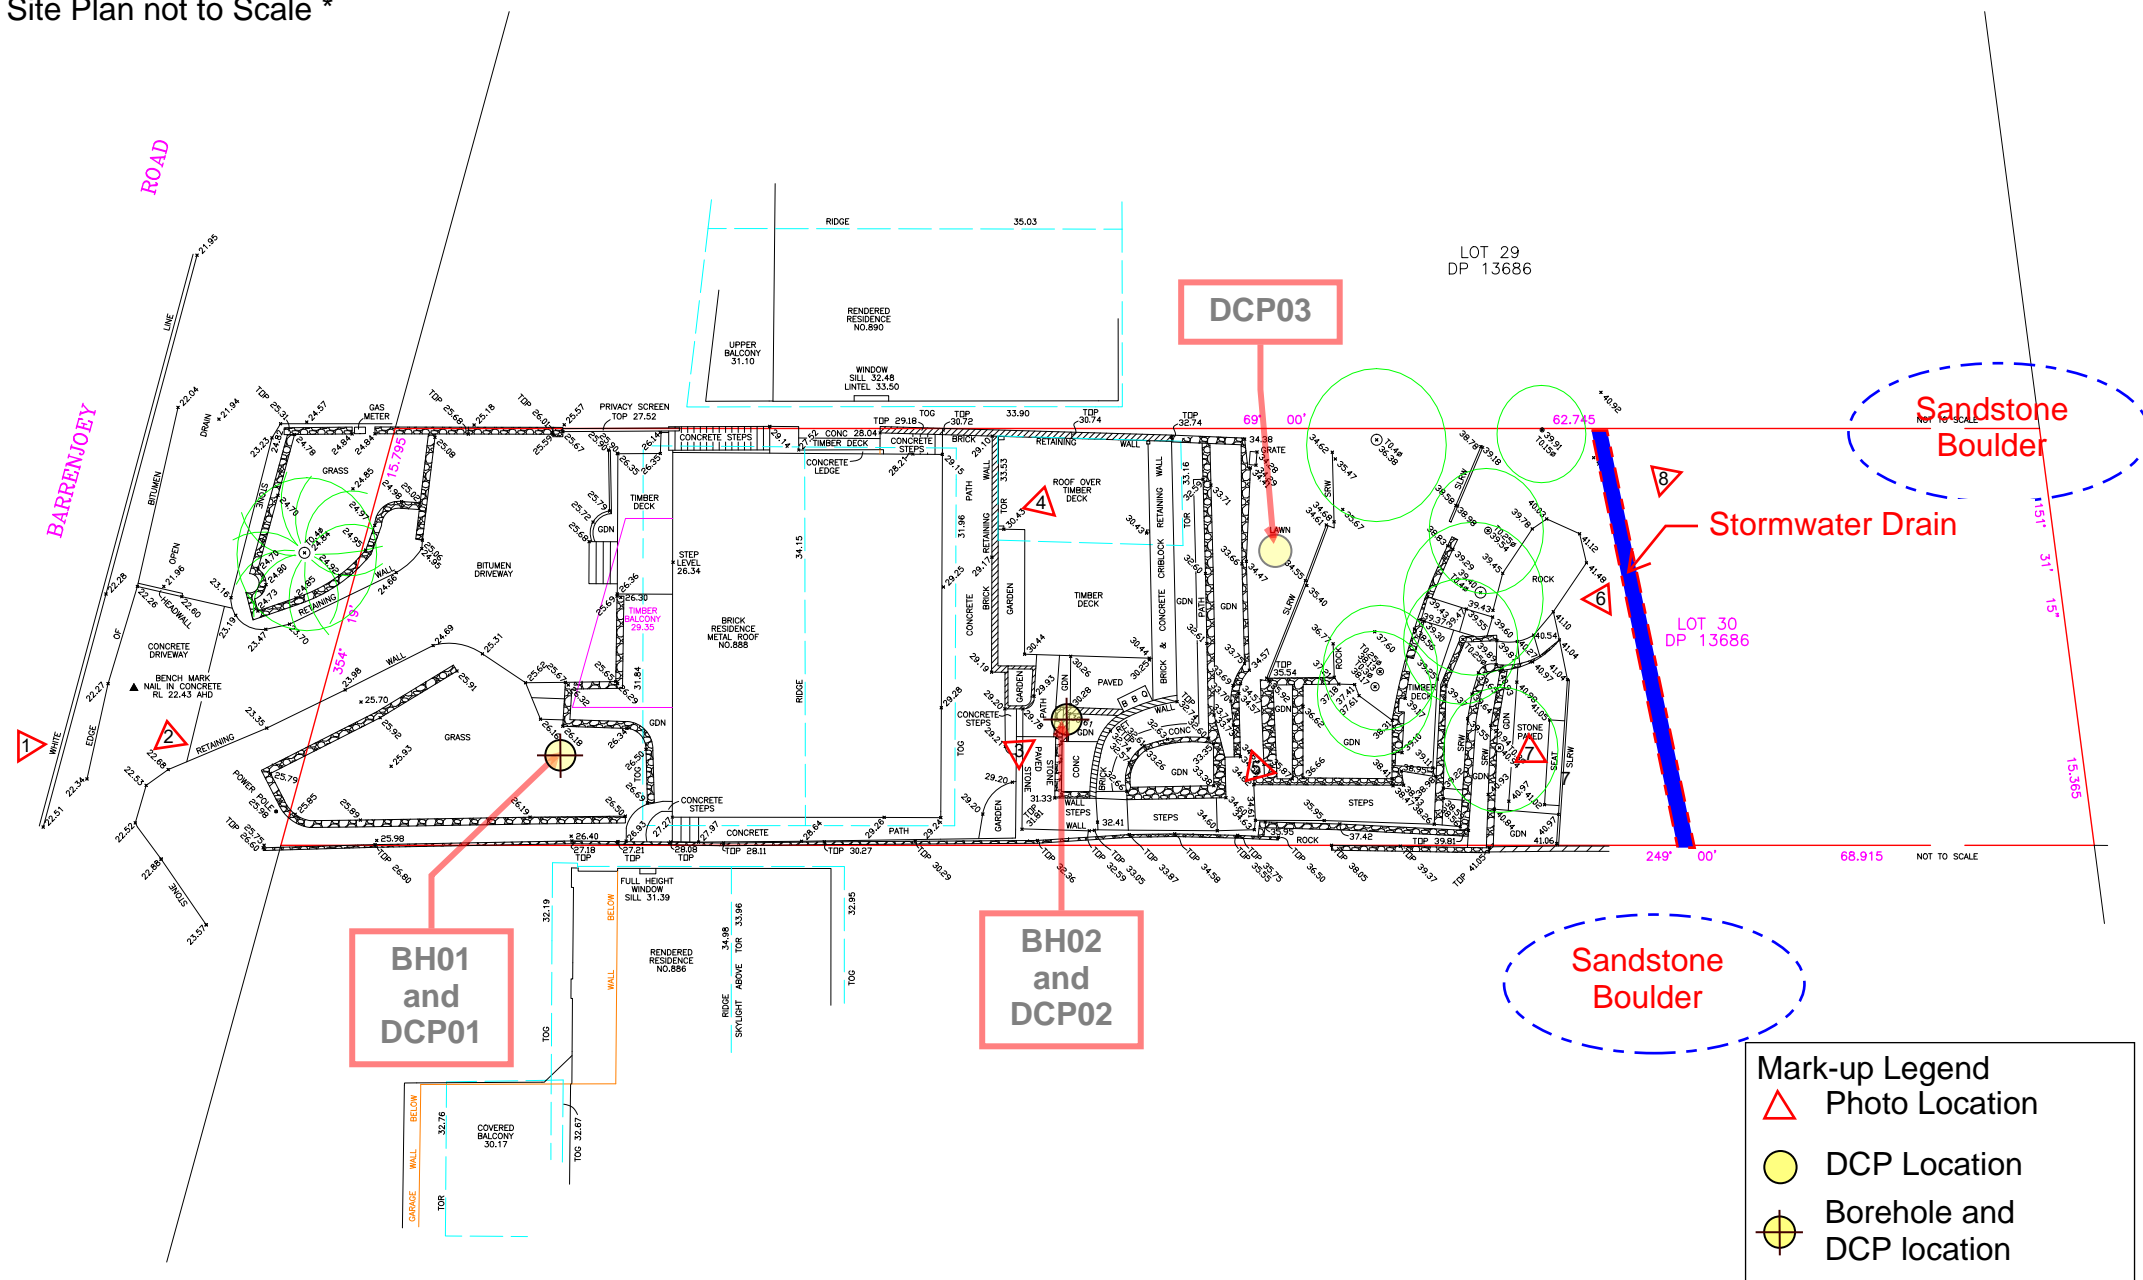
Geotechnical Site Investigation Plan

The geological mapping was confirmed during the fieldwork with numerous sandstone outcrops observed on this and adjacent sites with the location of two major outcrops shown on Drawing 12949-GR-1-A in Appendix B.

Details of the conditions encountered in the test bores are given in the borehole logs in Appendix C and are summarised below. The bores were drilled with a 50mm diameter mechanical soil sampler to a depth of 1.5m with Bore 1 advanced with a 100mm diameter hand auger to a depth of 2.0m. The locations of the test bores are shown on Drawing 12949-GR-1-A in Appendix B.
