**RE: 23 Robertson Road Scotland Island, Arborist Report Addendum**

## **Arborists Impact Assessment Report: 23 and 25-33 Robertson Road, Scotland Island.**

February 16, 2018

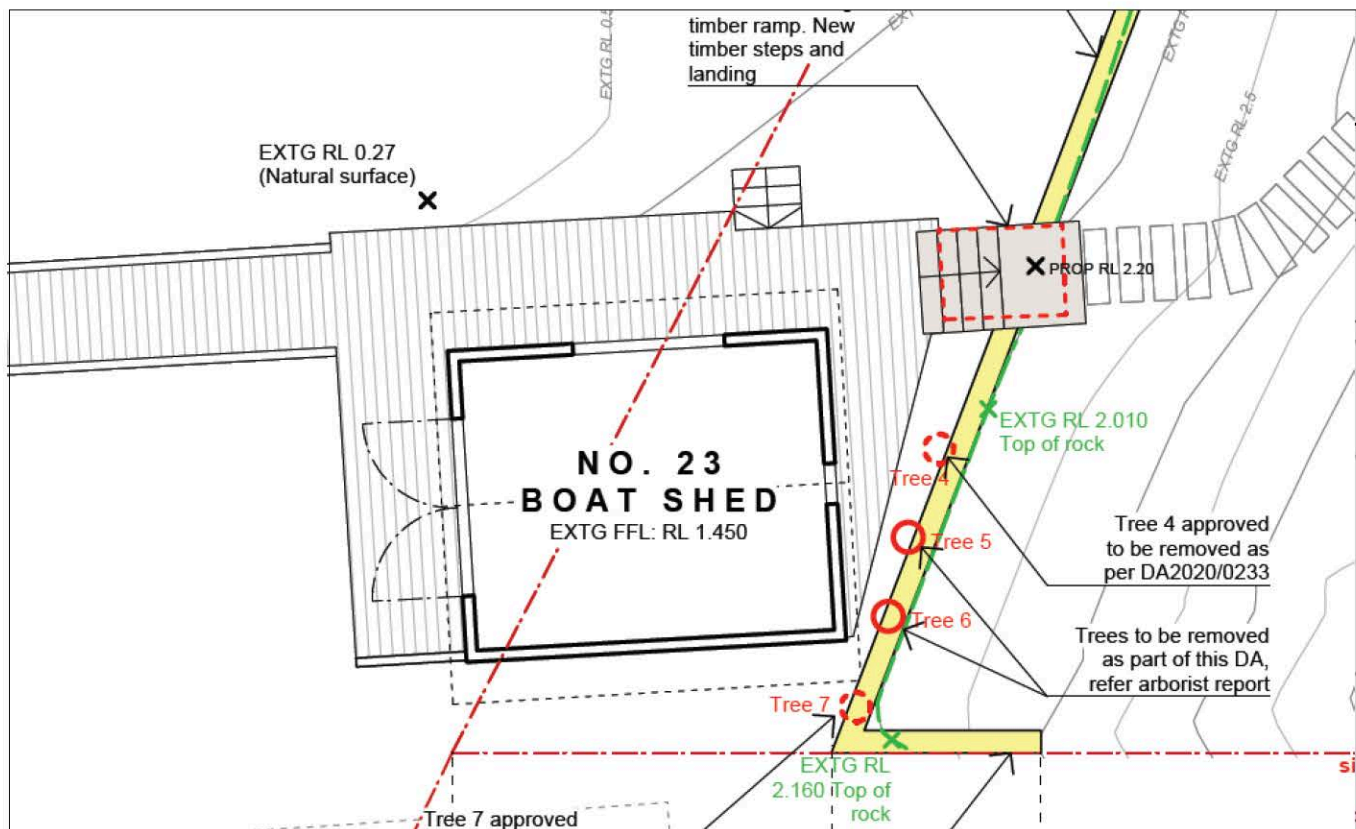
The original AIA report (H2O Consulting group 2018) identifies trees 4 and 7 for removal. However, construction of the seawall will require additional removal of trees 5 and 6 (See extract below).

#### Tree 5

**Summary:** Tree 5 is an *Allocasuarina littoralis* with a moderate sized tree with a height of 11m and DBH of 350mm. The tree is growing below the bank (currently impacted by erosion) and behind shed. At the time of survey, it was noted to be very undermined with buttress roots exposed as a result of the shoreline erosion at the subject site. The tree identifies with the Pittwater Spotted Gum Forest ECC and subsequently is considered to have a high retention value. Although, as a result of erosion and undermining it is considered to have a short (Safe Useful Life Expectancy) SULE and Estimated Life Expectancy (ELE) of 5-15 years as continuing erosion will likely result in the loss of this tree in the near future

#### Tree 6

**Summary:** Tree 6 is a young *Allocasuarina littoralis* tree with a height of 9m and DBH of 110mm. The tree is growing with a slight lean on top and near the edge of the bank, which is being impacted by active erosion and at risk of failure from the ongoing bank erosion. The tree identifies with the Pittwater Spotted Gum Forest ECC and subsequently is considered to have a high retention value. The tree is considered to be a Young tree under the SULE tree assessment framework. The ELE of the tree is considered to be short (5-15 years) as continuing erosion will likely result in the loss of this tree in this period if not addressed.

**Recommendation:** Remove Tree 5 to accommodate the seawall. The seawall will stabilise the bank and minimise potential for ongoing impacts to the adjacent EEC. Replace the tree with additional plantings that align with the Pittwater Spotted Gum Forest ECC on the subject site.

**Recommendation:** Remove Tree 6 to accommodate the seawall. The seawall will stabilise the bank and minimise potential for ongoing impacts to the adjacent EEC. Replace the tree with additional plantings that align with the Pittwater Spotted Gum Forest ECC on the subject site.

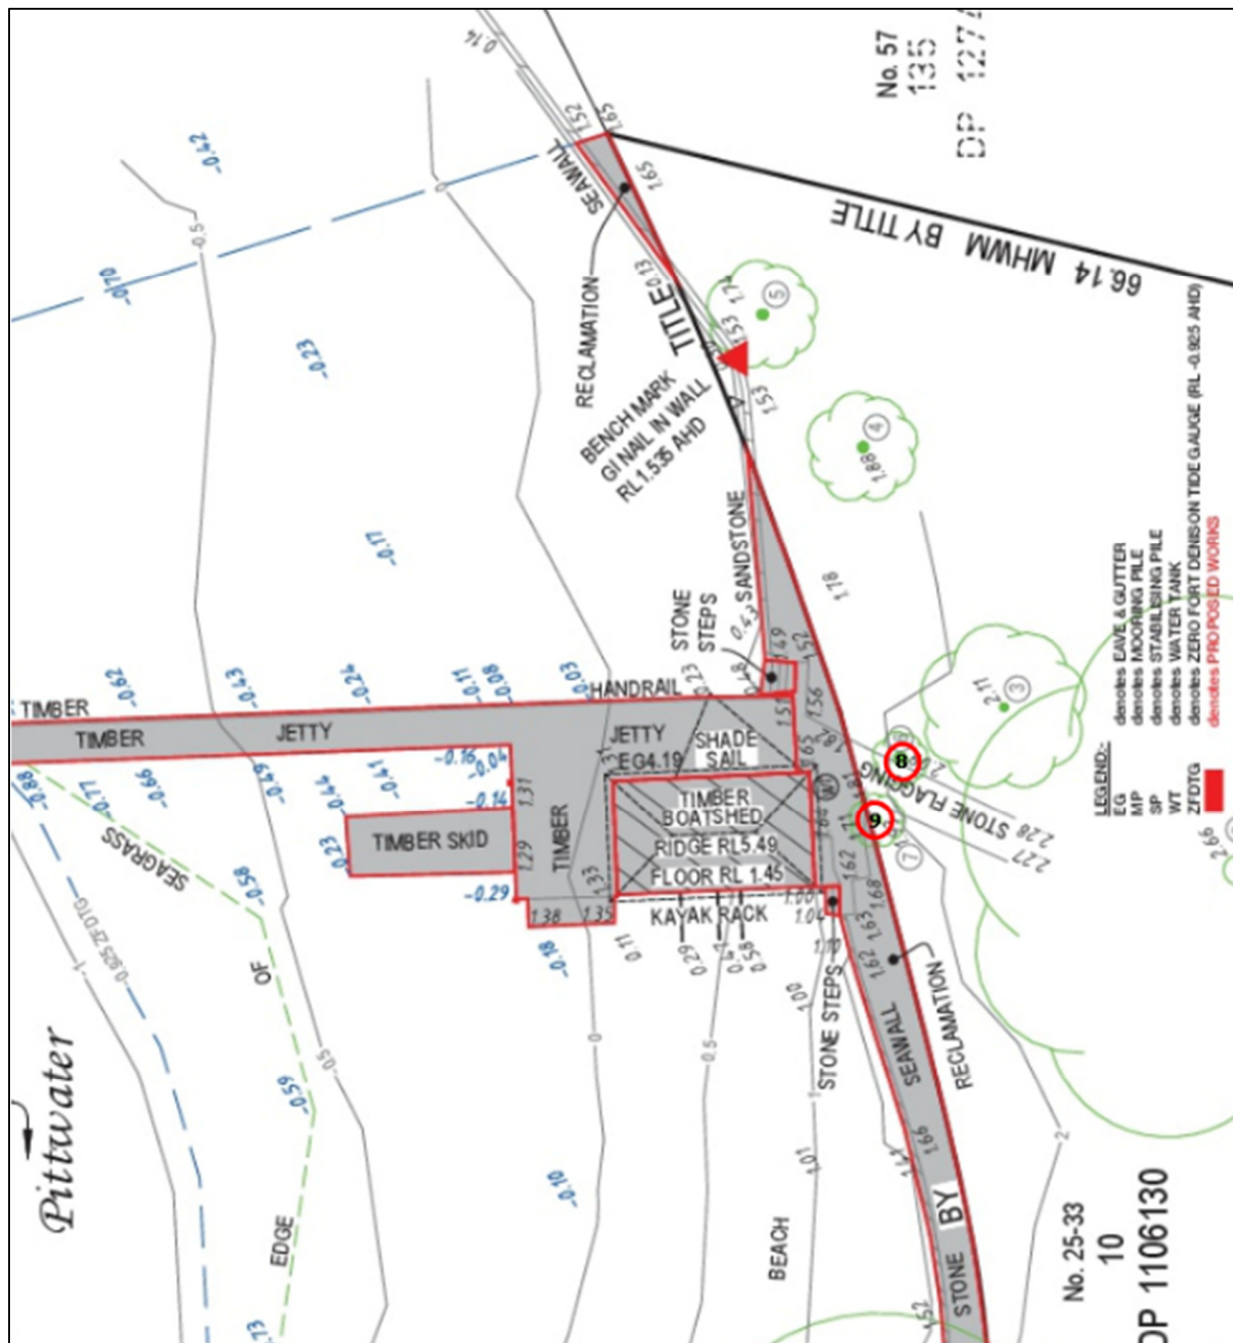
Figure 5: Original site survey (10.10.17) on No: 25-33 showing trees assessed further during the Arborist survey (red circles).

Trees were found near the high-water mark of the subject site. This included *Allocasuarina littoralis* near No: 23 and *Cupressocyparis leylandii* plantings near No: 25-33. Many of the *A. littoralis* trees were growing in the bank itself that was eroding. Further details and site survey records recorded during the assessment of these trees are provided in Table 2.
