Report Title: RISK ANALYSIS & MANAGEMENT FOR PROPOSED DUAL LEVEL COVERED VERANDAH AT 57 ROBERTSON ROAD, SCOTLAND ISLAND – MT 31454
Report Date: 10/4/2018
Author : PETER THOMPSON
Author's Company/Organisation : JACK HODGSON CONSULTANTS PTY LTD

**RISK ANALYSIS & MANAGEMENT  
FOR  
PROPOSED DUAL LEVEL COVERED VERANDAH  
AT  
57 ROBERTSON ROAD SCOTLAND ISLAND**

MT 31455

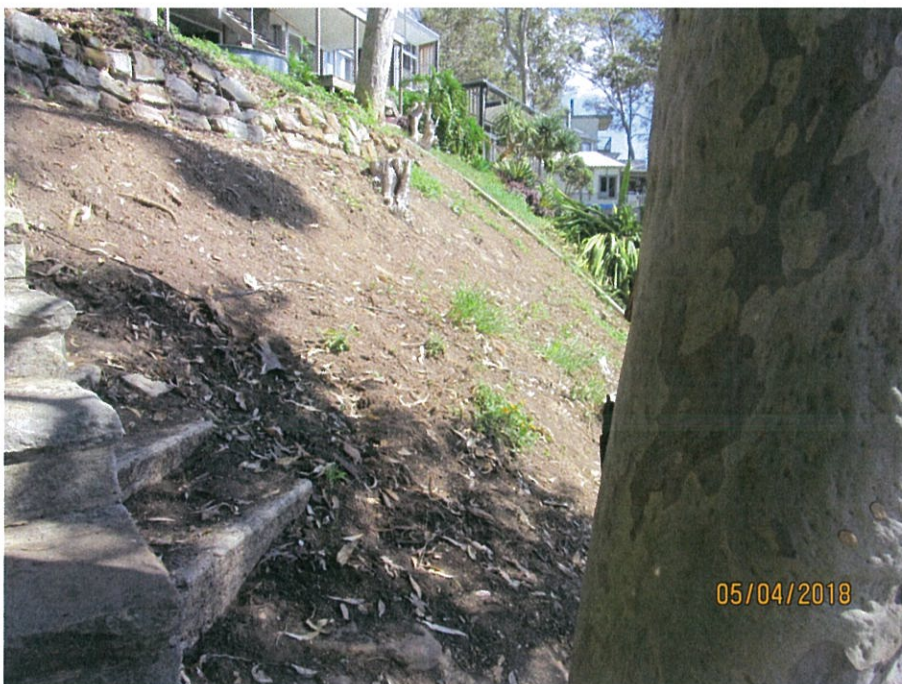
Photo 7

3.4 The two story timber house is in good condition. The supporting brick walls and piers show no signs of movement (Photo 7). No evidence of significant cracking or movement was observed at the time of our inspection.
