GEOTECHNICAL INVESTIGATION:

Alterations and Additions at **101 Woodland Street, Balgowlah Heights**

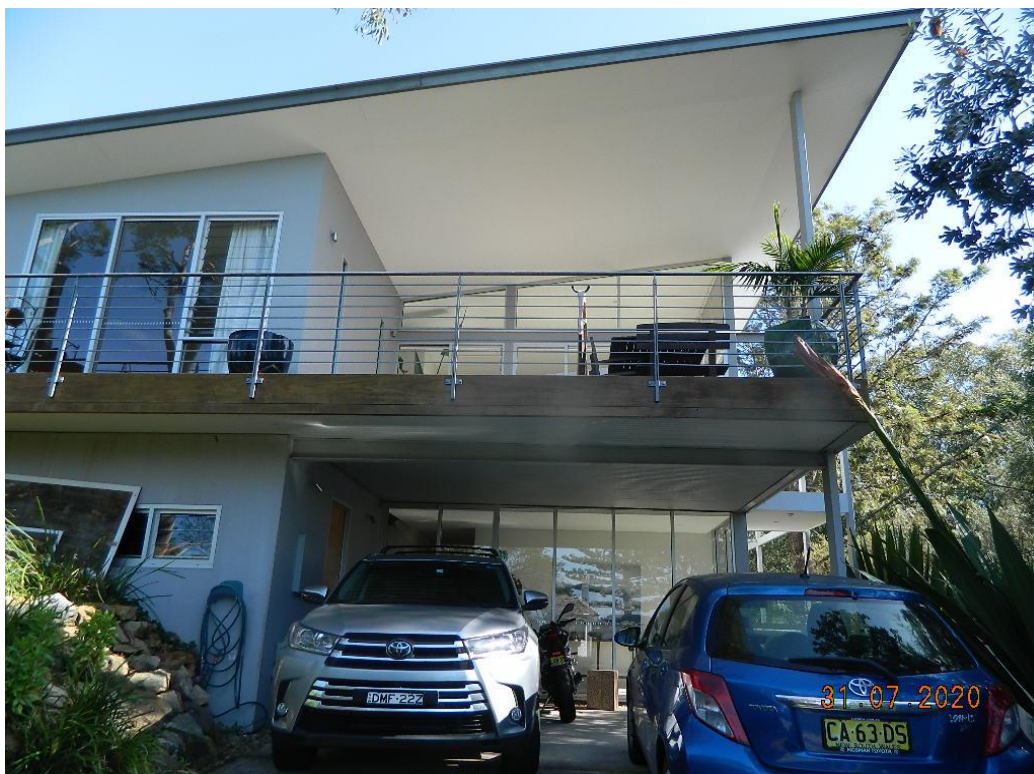
Photo 3

- 2.3** At the road frontage a concrete driveway runs up the slope to a carport on the E side the house (Photo 1). Hawkesbury Sandstone bedrock is outcropping on the S side of the driveway (Photo 2). Sandstone joint blocks are located on the S and N sides of the driveway (Photo 3). The two storey rendered house is supported by rendered masonry walls and a concrete slab (Photos 4 & 5). The external supporting walls show no significant signs of movement. A stable sandstone stack rock wall supports fill along part of the S common boundary (Photo 6). A pool in good condition is located on the W side of the property (Photo 7). A concrete block wall/retaining wall ~1.8m high in
