**RISK ANALYSIS & MANAGEMENT
FOR
PROPOSED SWIMMING POOL &
ALTERATIONS AND ADDITIONS
AT
37 TERAMA STREET, BILGOLA PLATEAU**

Job Number:
PX 00009
6th July, 2019
Page 11

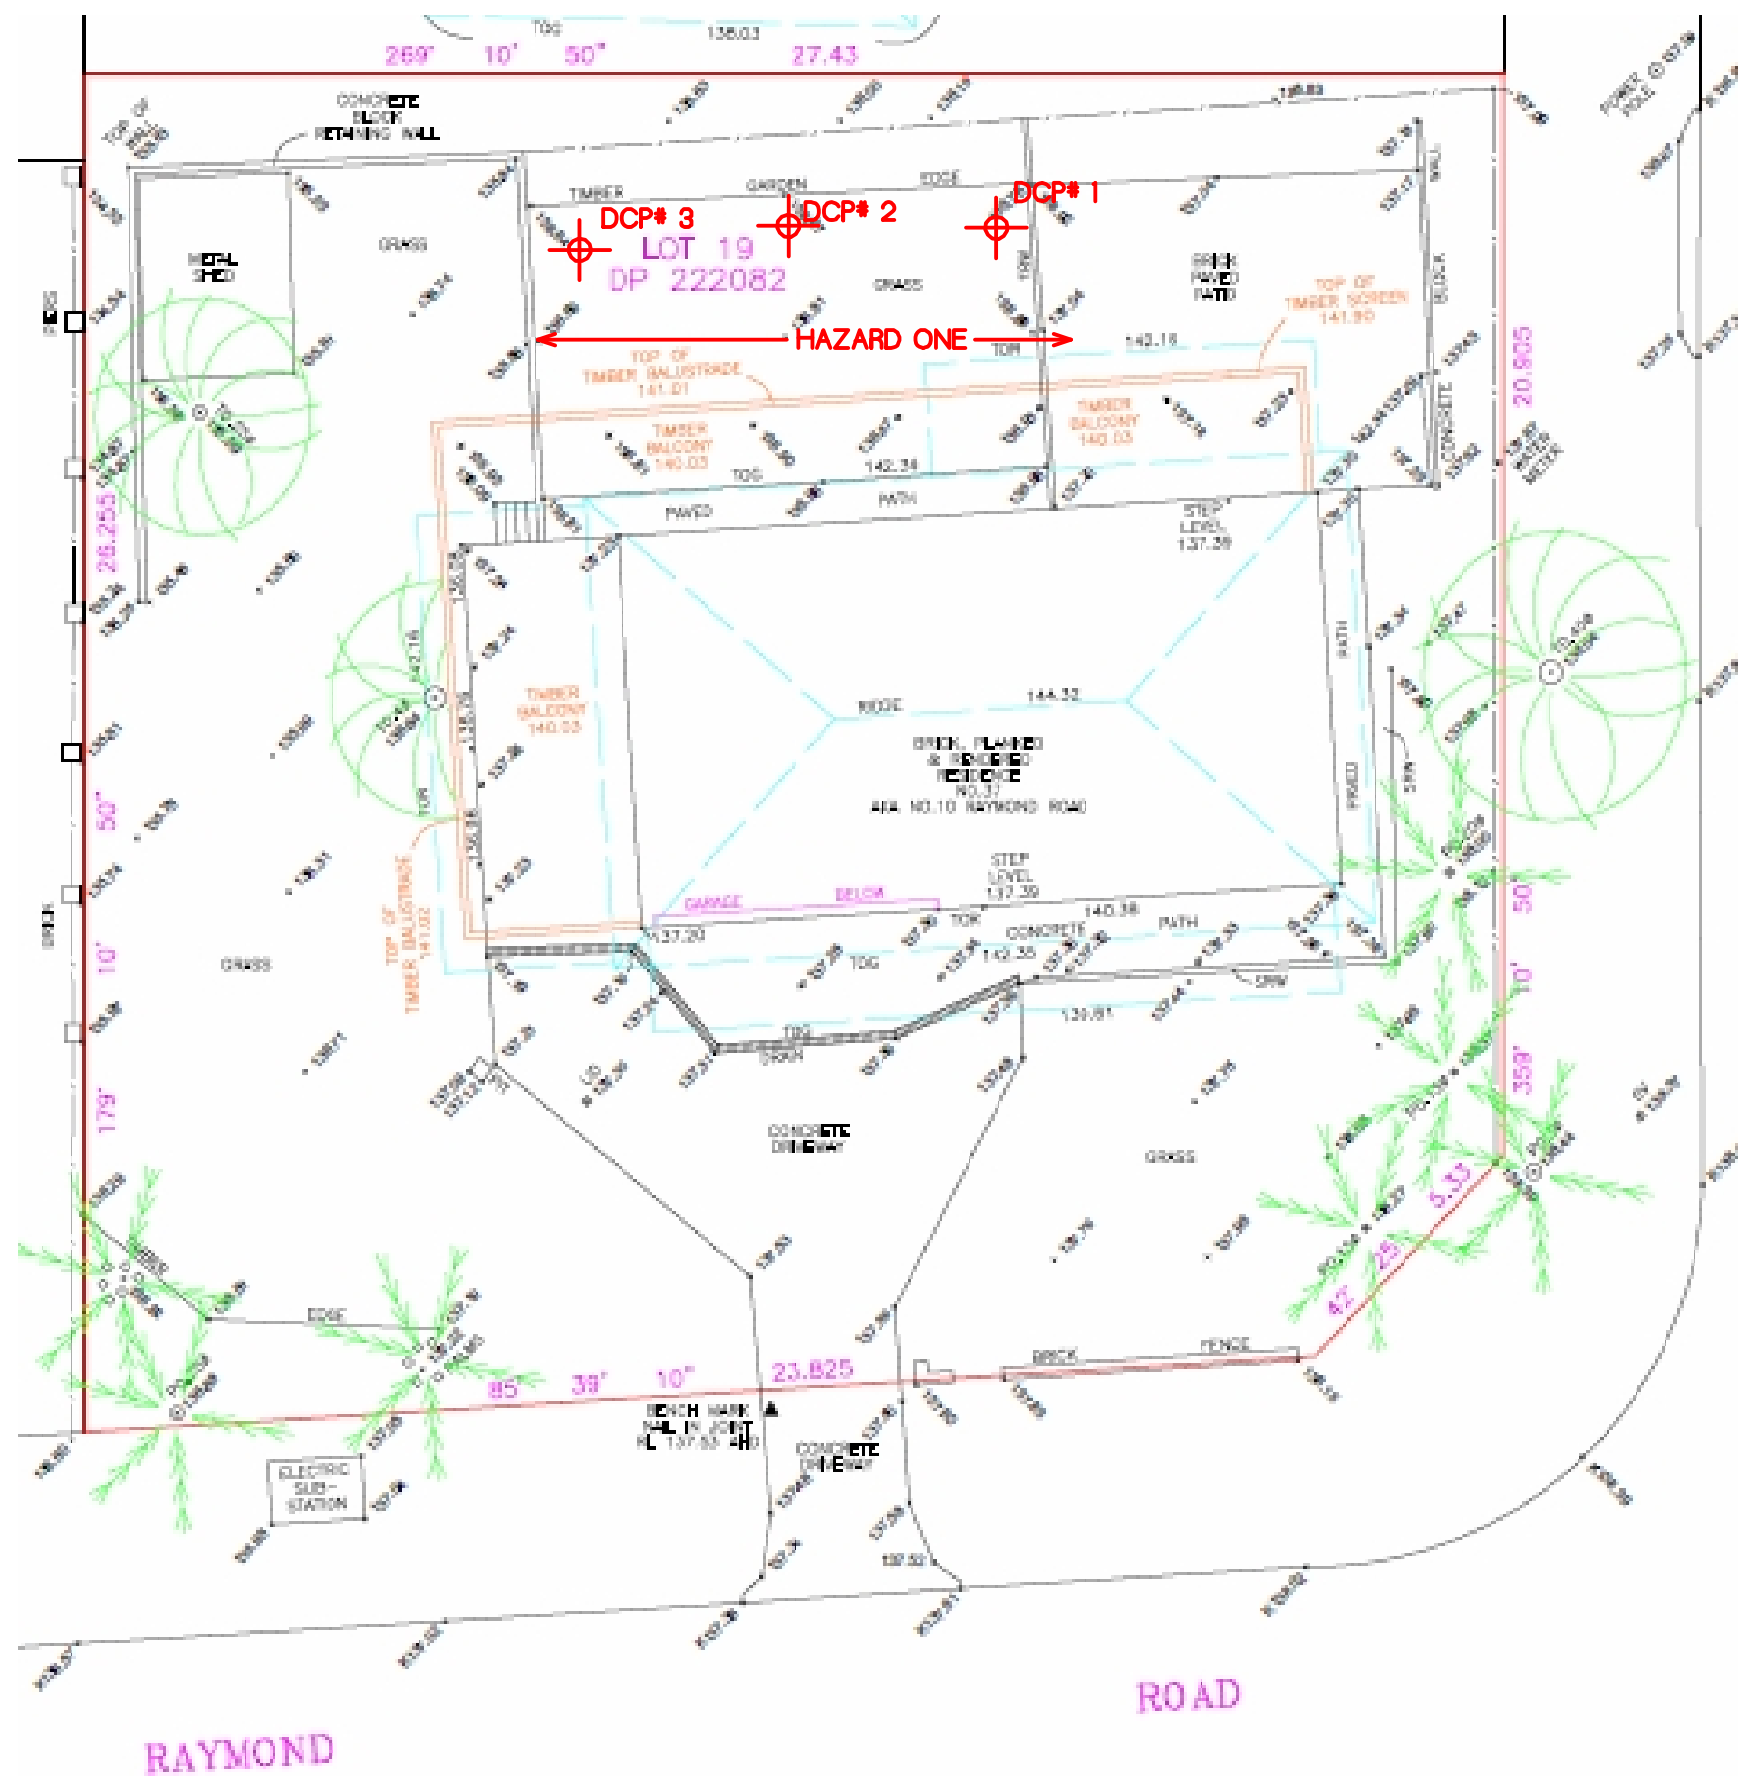
Photo 7

3.3 Access to the property is via the concrete driveway which starts from the edge of the Raymond Road adjacent north western corner of the property, Photo 1. Pedestrian access is also via the driveway where the main entry to the existing residence is on the ground floor level. The ground floor level garage is attached to the existing residence. A masonry retaining wall supports the fill material running along the western side of the existing residence, Photo 2. A lawn area slopes away to the north western corner of the property and is split into three separate levels by two concrete block retaining walls, Photos 3 & 4. A treated timber sleep retaining wall runs along the northern boundary, Photo 5. The above retaining walls were observed to be stable at the time of our inspection. The rear yard directly to the north of the existing residence is a level lawn and paved area that extends to the eastern side of the existing residence, Photo 6. The south eastern corner of the property is landscaped area, Photo 7.
