Address of site 19 WALLUMATTA ROAD, NEWPORT

Report Title: RISK ANALYSIS & MANAGEMENT FOR PROPOSED SWIMMING POOL, DECK AND CABANA AT 19 WALLUMATTA ROAD NEWPORT – MT 31655

**MT 31655.**

## **RISK ANALYSIS & MANAGEMENT FOR PROPOSED SWIMMING POOL, DECK AND CABANA AT 19 WALLUMATTA ROAD NEWPORT**

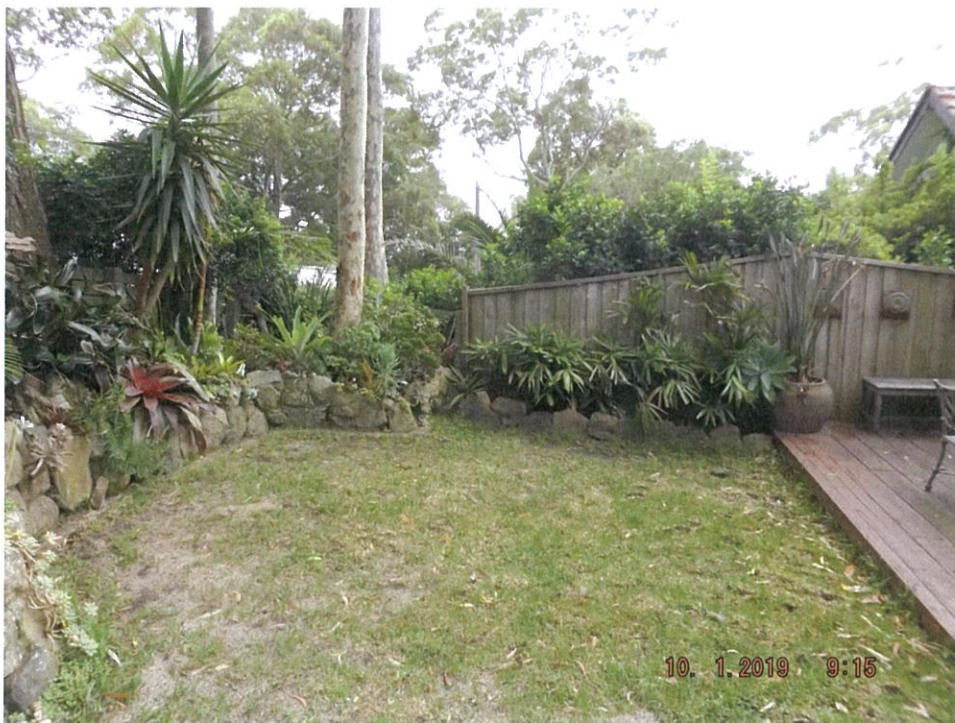
**Photo 1**

**3.3** From the road frontage a paved concrete driveway leads to a double gravel surfaced level car parking area in front of the existing residence, Photo 1. The fill batter for the road above merges into a garden bed in the front yard. The garden bed is supported by a mortared stack rock wall that is in good condition, Photo 2. The northern side of the property is a lawn covered area and a small area of timber deck. The double car parking area is supported by a low keystone retaining wall and shows no evidence of movement, Photo 3. Access to the southern downhill side of the property is via a part soil and part paved concrete path around the western side of the house. A cut in the natural slope has been made to fit the house. The cut batter below the house is supported by a concrete block retaining wall which appears well constructed and shows no evidence of movement, Photo 4. From the southern side of the house a level stone paved area extends into the backyard, Photo 5. Concrete block retaining walls on the western side of the paved area support garden beds and appear well constructed. The paved area is supported by a timber pole retaining wall which appears to be in need of remedial work, Photo 6. South of the paved area stone steps lead down slope to a second level paved area and a studio on the eastern side of the property. The studio is founded on brick piers which were observed to be tilting from vertical. This tilting is attributed to settlement. A fill batter below the studio stands approximately 1.0 to 1.5m high and is currently unsupported, Photo 7. The fill batter appears stable and is covered with some vegetation. A stack rock retaining wall supports the western side of the fill batter and shows no evidence of instability, Photo 8. Down slope from the second paved area, a lawn covered area extends to a brick retaining wall on the southern boundary which appears stable, Photo 9.
