# Geotechnical Assessment

**Project:** Waterfront Improvements  
158B & 158C McCarrs Creek Road, Church Point NSW

**Ref:** AG 24409  
2 October 2024

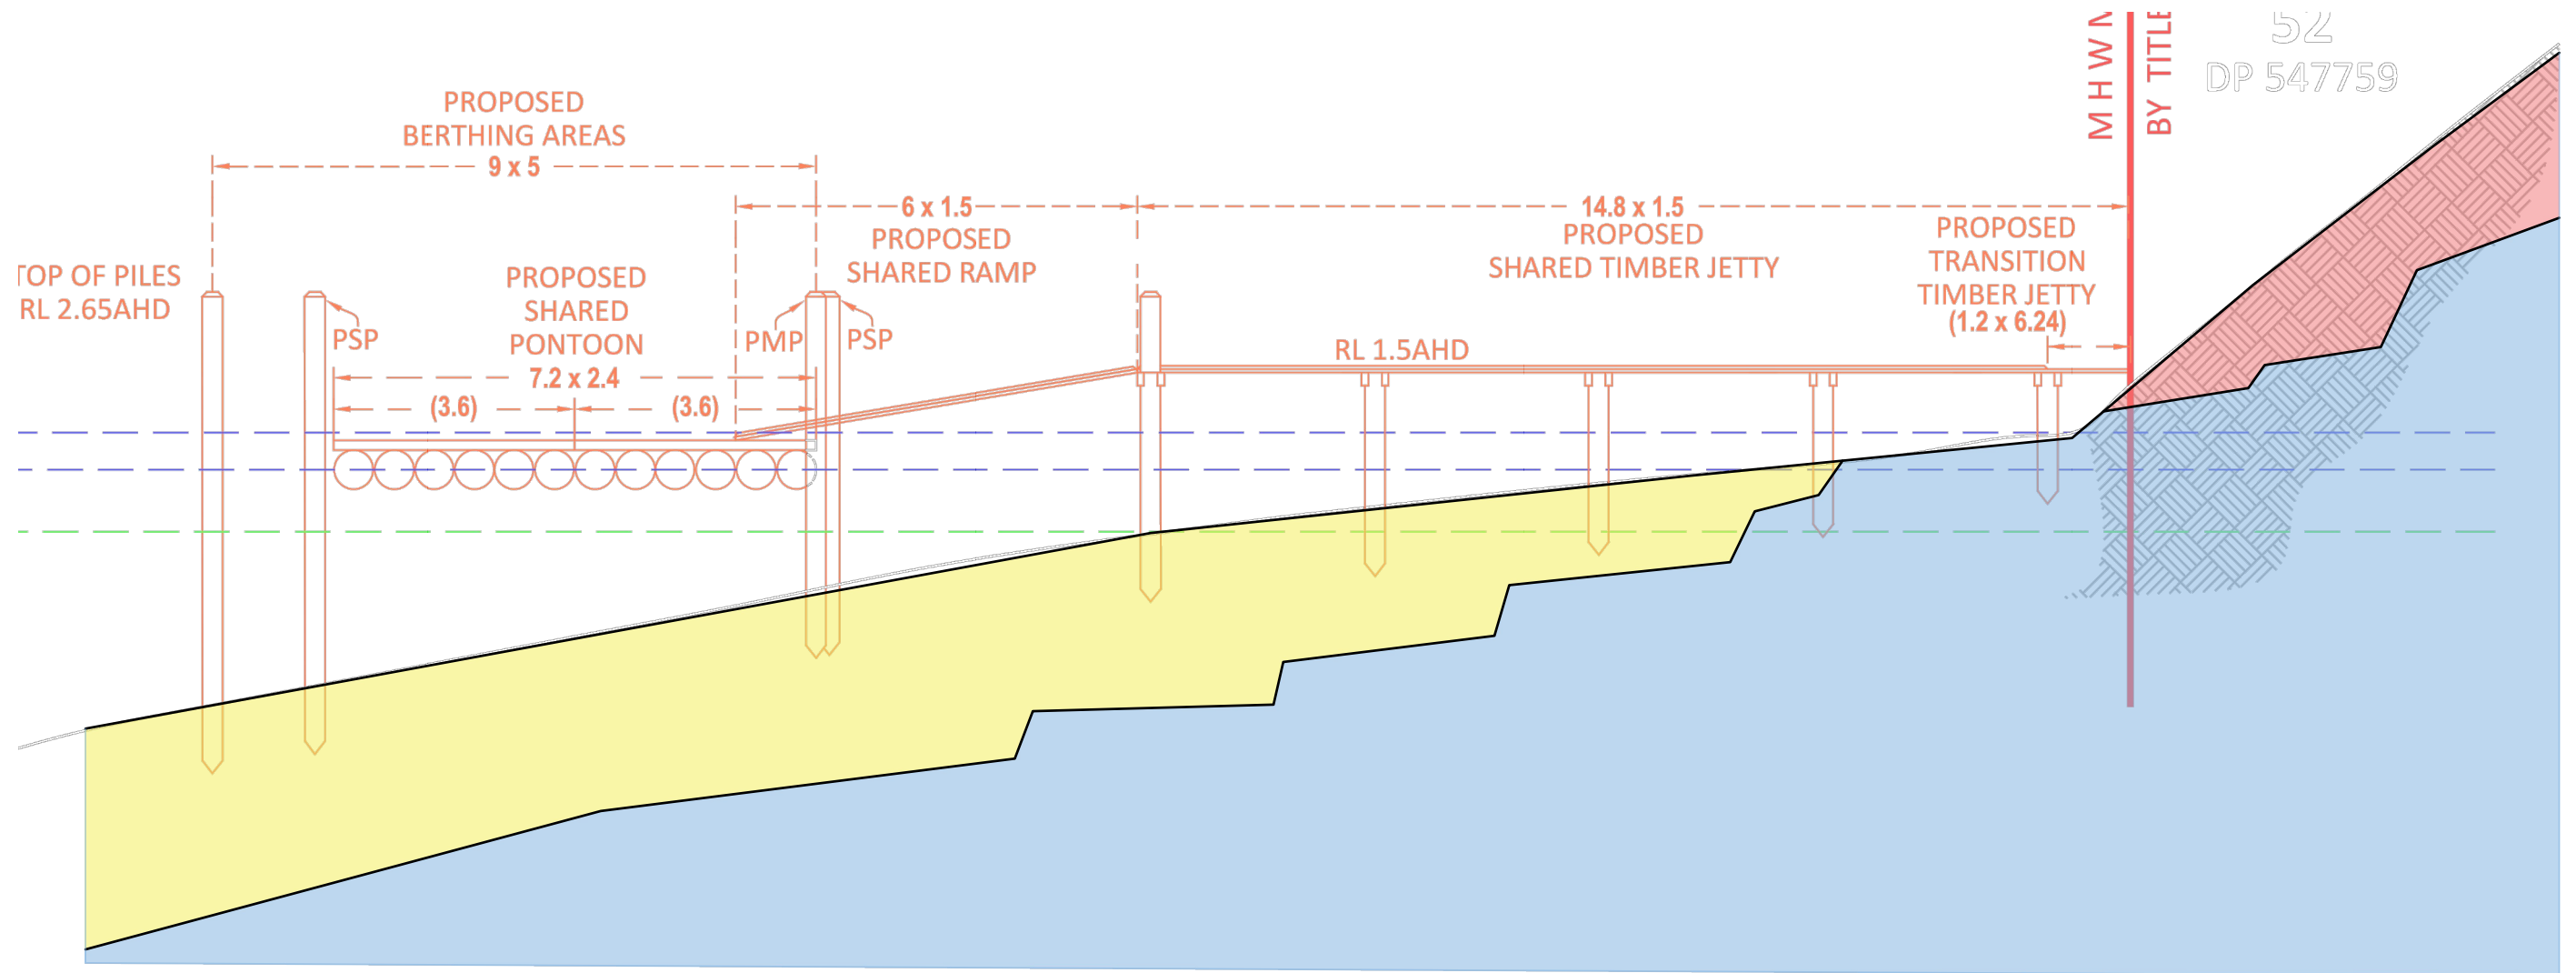
DATE:	29/09/2024
SCALE:	AS SHOWN @ A3
DRAWING TITLE:	<b>SITE PLAN</b>
DRAWING NO.:	<b>AG 24409- S1</b>

INTERPRETED SUBSURFACE SECTION ONLY.  
ACTUAL GROUND CONDITIONS MAY VARY.
