## **42 Beacon Hill Road, Beacon Hill**

### Comments on Updates to Plans

## **PRELIMINARY GEOTECHNICAL ASSESSMENT:**

### **42 Beacon Hill Road, Beacon Hill**

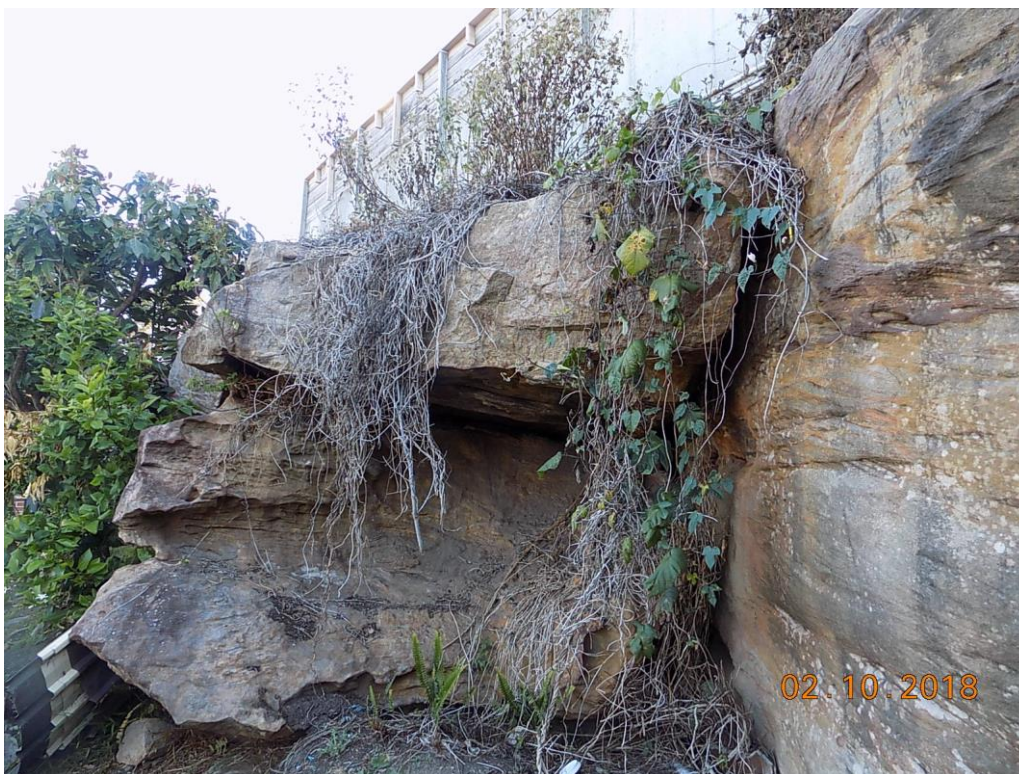
Photo 1

The concrete block retaining wall supporting the fill on the NW neighbouring property is cracked and shows minor settlement (Photo 1). To be prudent, we recommend the retaining wall be inspected by the owners on an annual basis or after heavy prolonged rainfall, whichever occurs first, keeping a photographic record of the inspections. We can carry out these inspections upon request. Should any new movement be observed, the geotechnical consultant is to be engaged to assess the movement and provide remedial advice if necessary.
