Report Title: Geotechnical Report 46A Irrubel Road, Newport
Report Date: 11/2/19
Author: BEN WHITE
Author's Company/Organisation: WHITE GEOTECHNICAL GROUP PTY LTD

GEOTECHNICAL INVESTIGATION:

Proposed Pool at **46A Irrubel Road, Newport**

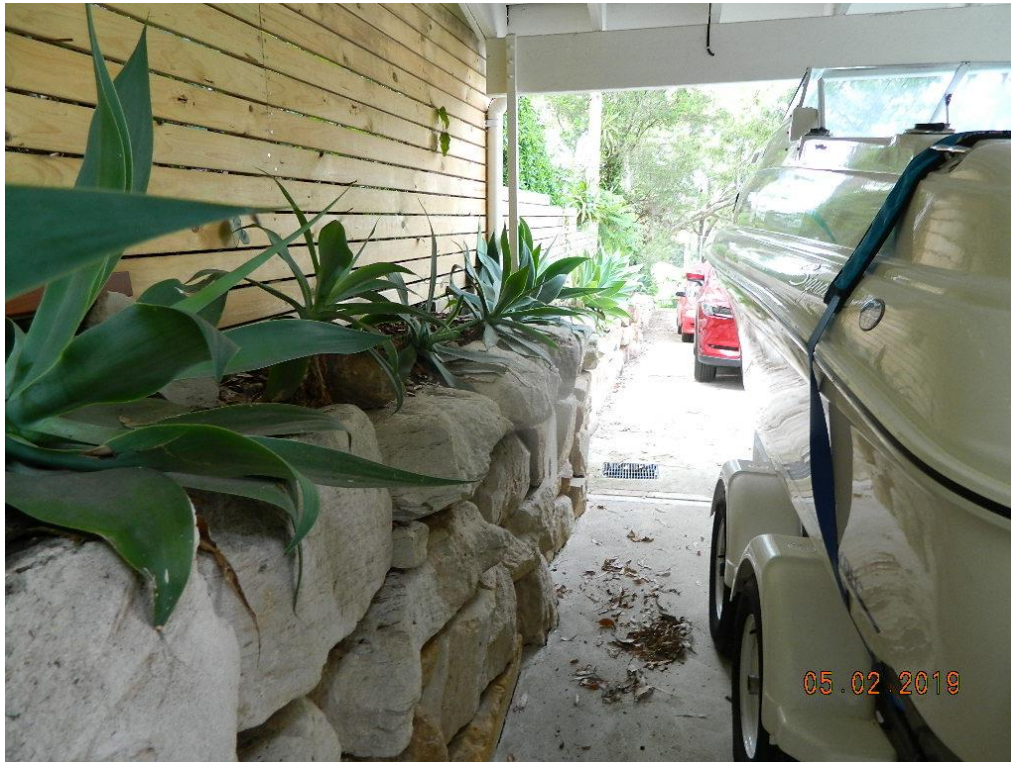
Photo 2

- 2.3** At the road frontage, a concrete driveway runs to a carport attached to the S side of the house (Photos 1 & 2). An excavation has been made along the uphill boundary to level an area for the driveway and house (Photo 3). The cut is supported by a stable sandstone block retaining wall reaching a maximum height of ~1.0m a
