Date: 21st December 2020 **No. Pages:** 3 **Project No.:** 2020-265

Brad Sugar 29 Donegal Road, Killarney Heights N.S.W.

Preliminary Landslip Assessment for 29 Donegal Road, Killarney Heights

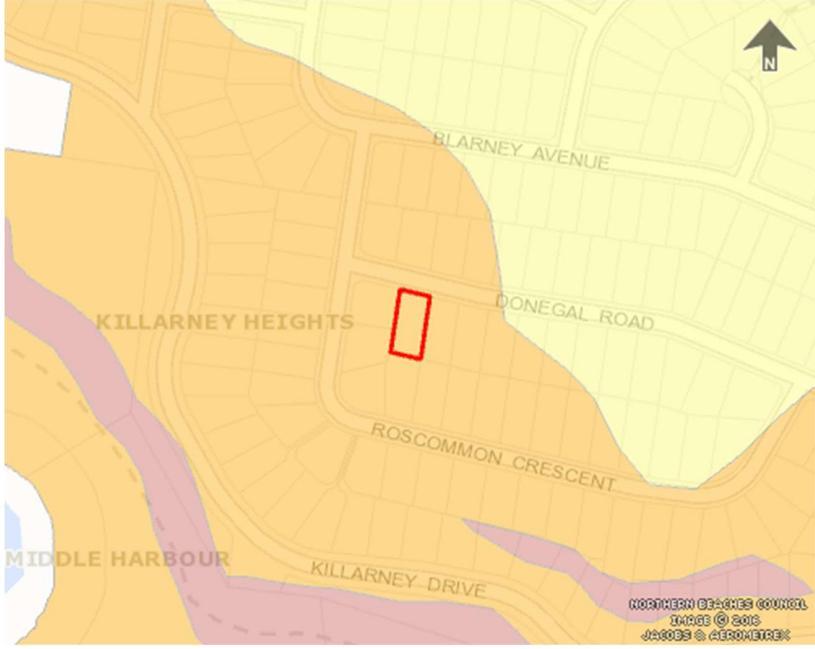
Figure 1: Landslip Risk Map, Warringah LEP 2011

The site is located within Warringah Councils Landslip Risk Class "B" which is classified as 'Flanking Slopes of between 5° and 25° as indicated on Figure 1.
