39 Seaforth Cres, Seaforth

Geotechnical Comments for Section 4.55

GEOTECHNICAL INVESTIGATION:

New Incline Lift and Landscaping at **39 Seaforth Crescent, Seaforth**

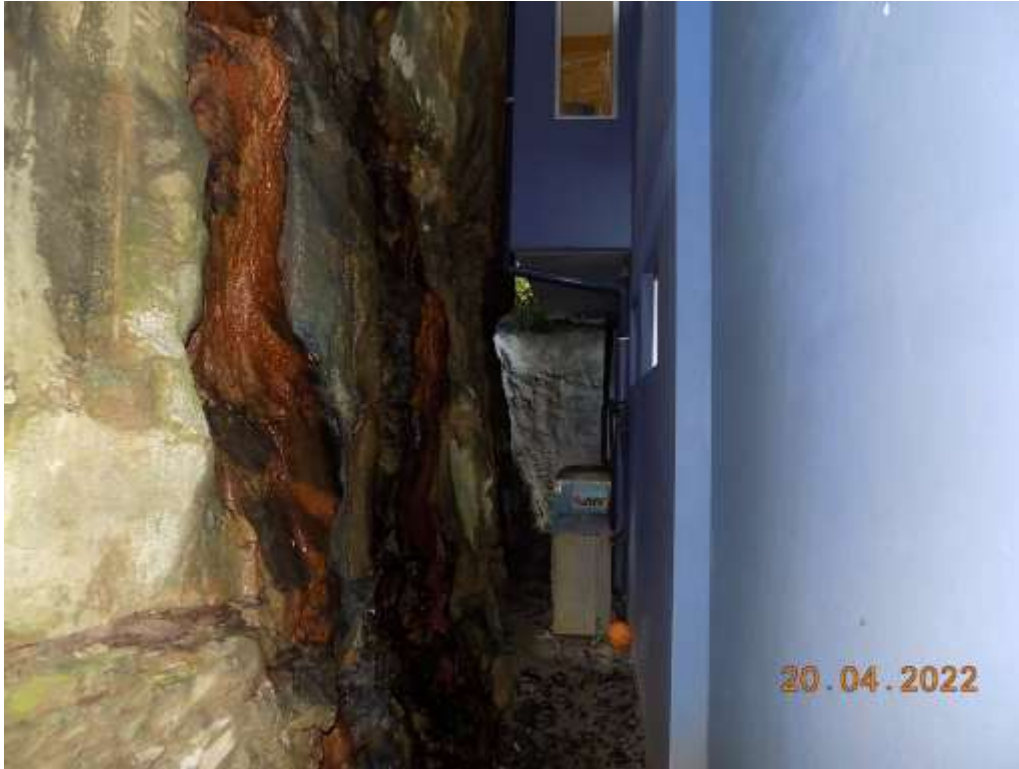
Photo 4

A series of stable sandstone block retaining walls reaching up to ~1.8m high terrace the slope in between the road frontage and the house (Photo 3). A ~9.0m high cut to create a level platform for the house has been taken entirely through outcropping Competent Medium Strength Sandstone (Photo 4). A portion of the cut face has been protected with sprayed concrete (Photo 5). The three-storey rendered masonry house is supported on masonry walls and concrete piers (Photo 6). The masonry walls show no significant signs of movement and the concrete piers stand vertical. A partially suspended pool extends off the downhill side of the house (Photo 7). No significant movement has occurred in the concrete shell of the pool as indicated by the water level against the pool tiles. A series of low sandstone block retaining walls terrace the steep slope that extends to the lower common boundary (Photo 8). A ~1.5m high sandstone block retaining wall supports a fill for a moderately sloping lawn area (Photo 9). The wall is covered in vegetation but from what could be seen, appears to be in good condition. It is supported directly off outcropping Competent Medium Strength Sandstone. Sandstone bedrock outcrops and steps down the property to the waterfront (Photos 10 & 11).

HAZARDS	Hazard One	Hazard Two	Hazard Three
TYPE	The steep slope that falls across the property and continues above failing and impacting on the proposed works.	The existing sandstone cut face that steps ~9.0m down the slope failing and impacting on the proposed works (Photo 4).	The proposed fills failing and impacting the proposed works.
LIKELIHOOD	'Unlikely' (10^{-4})	'Unlikely' (10^{-4})	'Possible' (10^{-3})
CONSEQUENCES TO PROPERTY	'Medium' (15%)	'Medium' (25%)	'Medium' (15%)
RISK TO PROPERTY	'Low' (2×10^{-5})	'Low' (2×10^{-5})	'Moderate' (2×10^{-4})
RISK TO LIFE	9.1×10^{-7} /annum	2.9×10^{-7} /annum	6.0×10^{-5} /annum
COMMENTS	This level of risk is 'ACCEPTABLE', provided the recommendations in Section 7 & 17 are followed.	This level of risk is 'ACCEPTABLE'.	This level of risk to life and property is 'UNACCEPTABLE'. To move risk to 'ACCEPTABLE' levels the recommendations in Section 11 are to be followed.
