Statement of Heritage Impact

Residential Flat Building, "Hilder Lea Flats"

Montreaux, 7 Commonwealth Parade, Manly 2095

Structural Repair and Window Sash Replacement to the Southern External Wall, Façade Painting

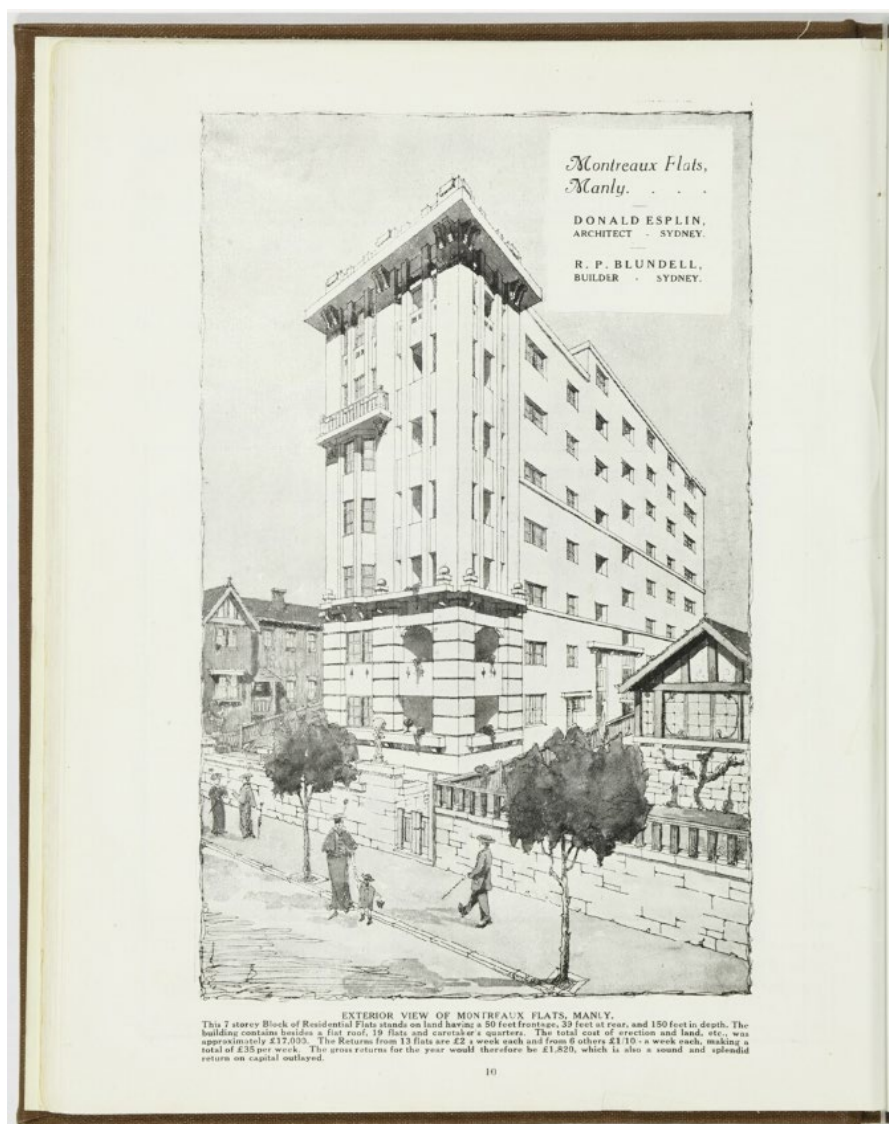
Figure 2 - 1917 - Where to Live ABC Guide to Sydney and Suburbs, featuring: 7 Commonwealth Parade (Montreaux Flats Manly)

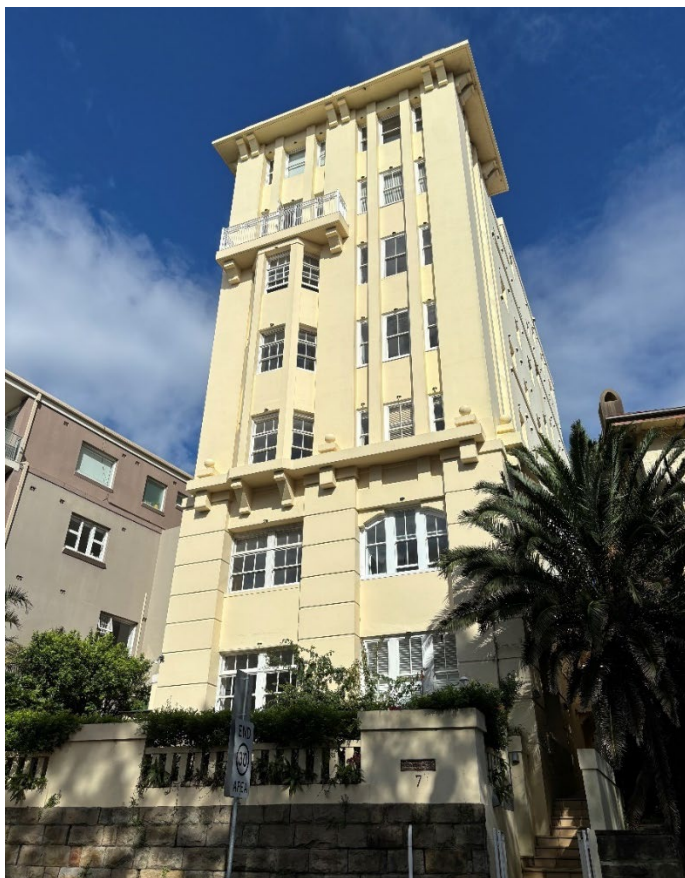
Figure 7 – 7 Commonwealth Parade's front façade (South East facing) Source: Hector Abrahams Architects
