Report Title: Geotechnical Report 61 Dress Circle Road, Avalon
Report Date: 4/9/20

GEOTECHNICAL INVESTIGATION:

Additions and Alterations at **61 Dress Circle Road, Avalon**

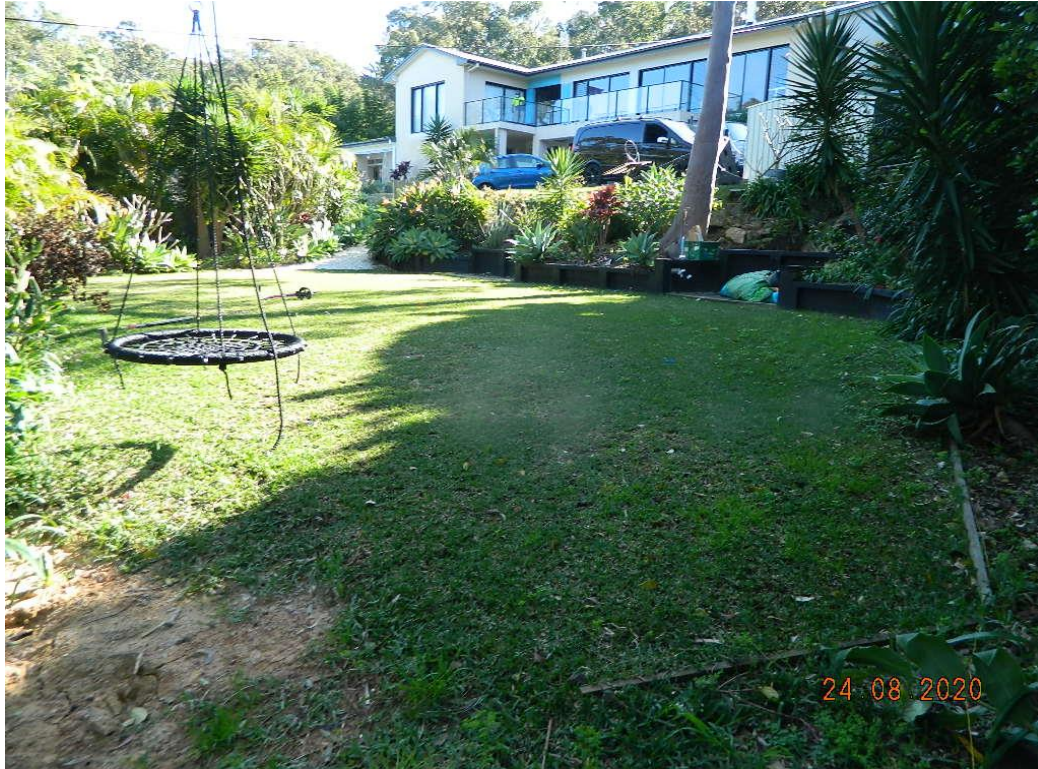
Photo 2

2.3 At the road frontage a concrete driveway runs up the slope to a parking area on the downhill side of the house (Photos 1 & 2). Fill has been placed to form level lawn areas on the NE side of the driveway and below the parking area (Photo 3). The lower lawn fill is unsupported but is battered back at stable angles. Some of the fill was not planted with lawn or other vegetation but we note that this will be removed as part of the proposed driveway excavation (Photo 4). The upper lawn is supported by a low timber retaining wall. SW of the driveway is a swimming pool in good condition (Photo 5). The part two storey rendered brick house is supported by brick walls and a concrete slab (Photos 6 & 7). The house is cut into the slope on the uphill side. The visible portion of the cut for the house is supported by a stable concrete retaining wall reaching ~2.3m high (Photo 8). Garden and lawn areas are located above the cut. No signs of slope instability were observed on the property. The adjoining neighbouring properties were observed to be in good order as seen from the street and subject property.
