Arboriculture Assessment & Hazard Management Statement

March 2021

Site: Lot 1 in DP 571975
48-50 Lawrence Street
FRESHWATER, NSW

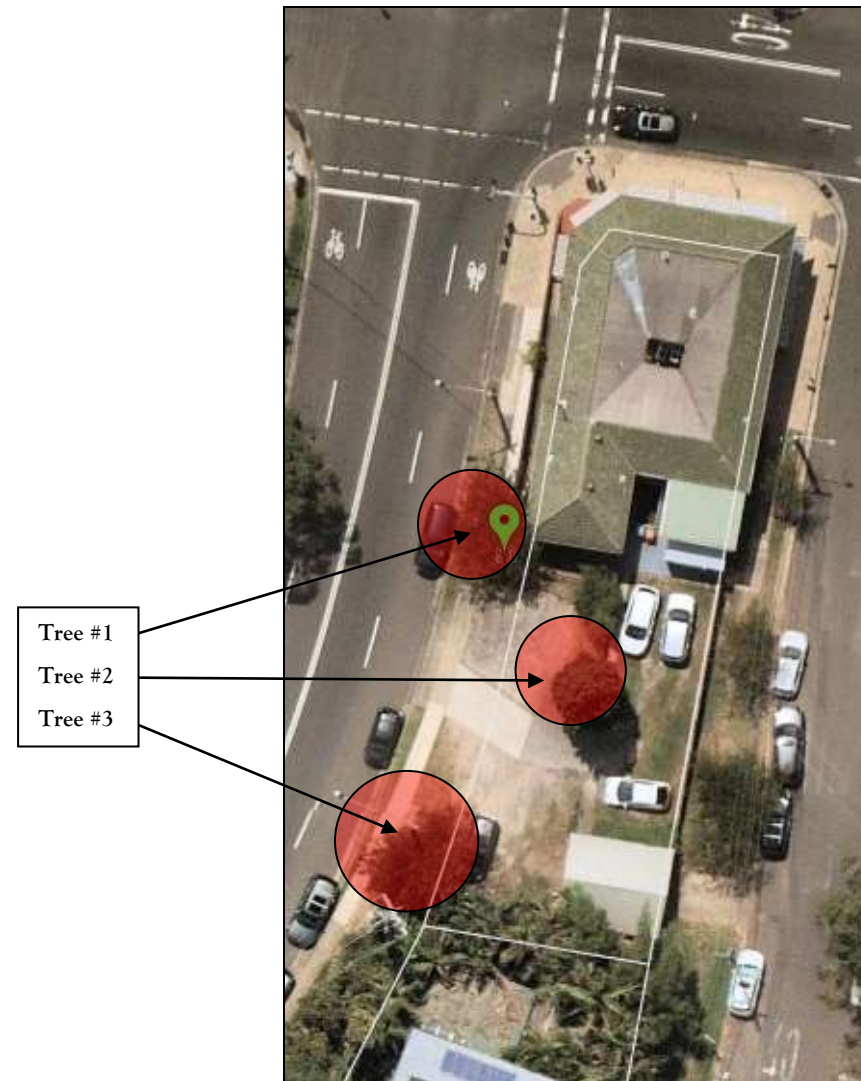
Identification	Height (approx in m)	Crown (approx in m)	DBH (approx in m)	TPZ (approx in m)	SRZ (approx in m)	Age	Health/ Vigour	Retention & Significance Value	Structure/ Form	Comments
1	<i>Gleditsia triacanthos</i> Honey Locust	<7.00	<7.500	<0.24	2.90	1.90	SM	Good & Good	Moderate/ Moderate	Typical	<u>Remove & Replace:</u> Tree is considered as best replaced as canopy pruning required for new built form/canopy separation is considered to likely totally disfigure the tree.
2	<i>Cupressus sempervirens</i> Italian Cypress	<14.50	<5.00	<0.35 x 5	Approx. 6.00	Approx. 2.50	M	Good & Good	Moderate/ Moderate	Typical	<u>Remove & Replace:</u> Tree is located within the middle of the proposed new built form.
3	<i>Gleditsia triacanthos</i> Honey Locust	<6.50	<6.50	0.21	2.50	1.80	SM	Fair & Fair	Moderate/ Moderate	Typical (but displays symptoms of stress)	<u>Remove & Replace:</u> Tree is considered as best replaced as basement level excavation will breach its supporting root, i.e. Structural Root Zone radial distance.

Figure 6: Aerial Map, dated Friday, 28 February 2020, (courtesy of Nearmap) confirms discussed tree locations.

Tree #	Retain, Protect & Manage	Remove	Replace	Comments
Tree #1				Pruning required is assessed to likely permanently disfigure the tree canopy profile
Tree #2				Tree provides Landscape Amenity so should be replaced.
Tree #3				Tree root system will be significantly compromised by the proposed excavation & adjacent new built form.
