Report Title: Geotechnical Report 9 Eungai Place, North Narrabeen

Report Date: 23/12/19

GEOTECHNICAL INVESTIGATION:

Alterations and Additions at **9 Eungai Pl, North Narrabeen.**

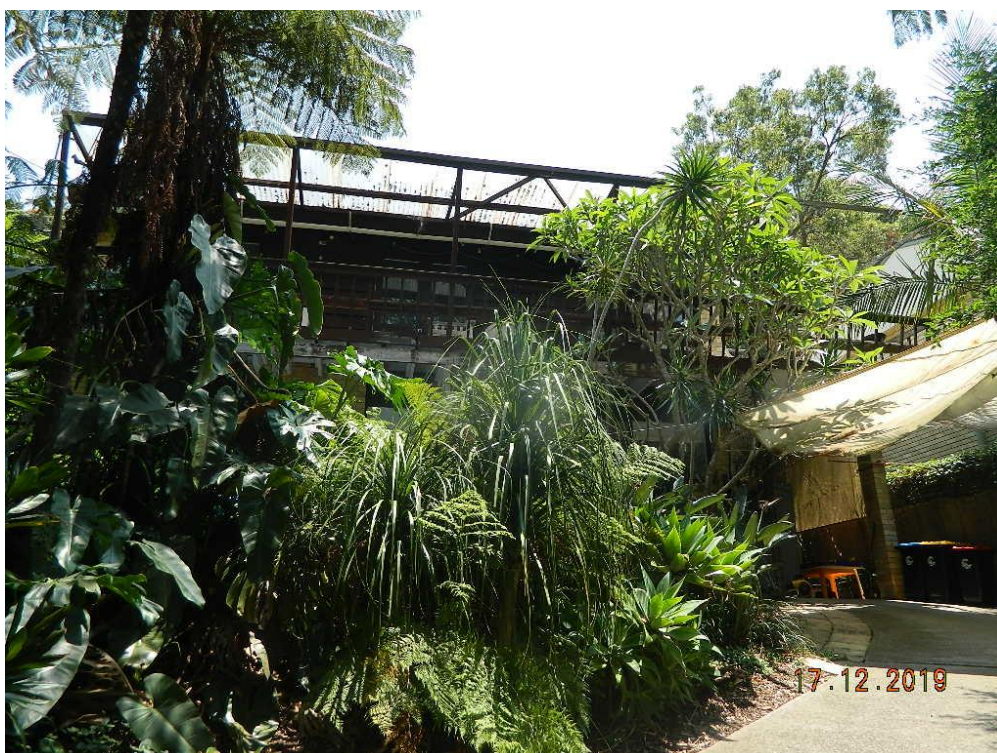
Photo 1

- 2.3** From the road frontage the existing concrete driveway runs up the slope to the house (photo 1). The driveway will be re-routed as part of the development so as to access the proposed garage. The part two storey brick house is supported on brick walls, brick piers and steel posts (photos 2 to 6). The supporting walls, piers and posts appear to be in good condition and show no significant signs of movement. Uphill of the house a sandstone boulder wall up to ~3m high lines the slope to the N and a

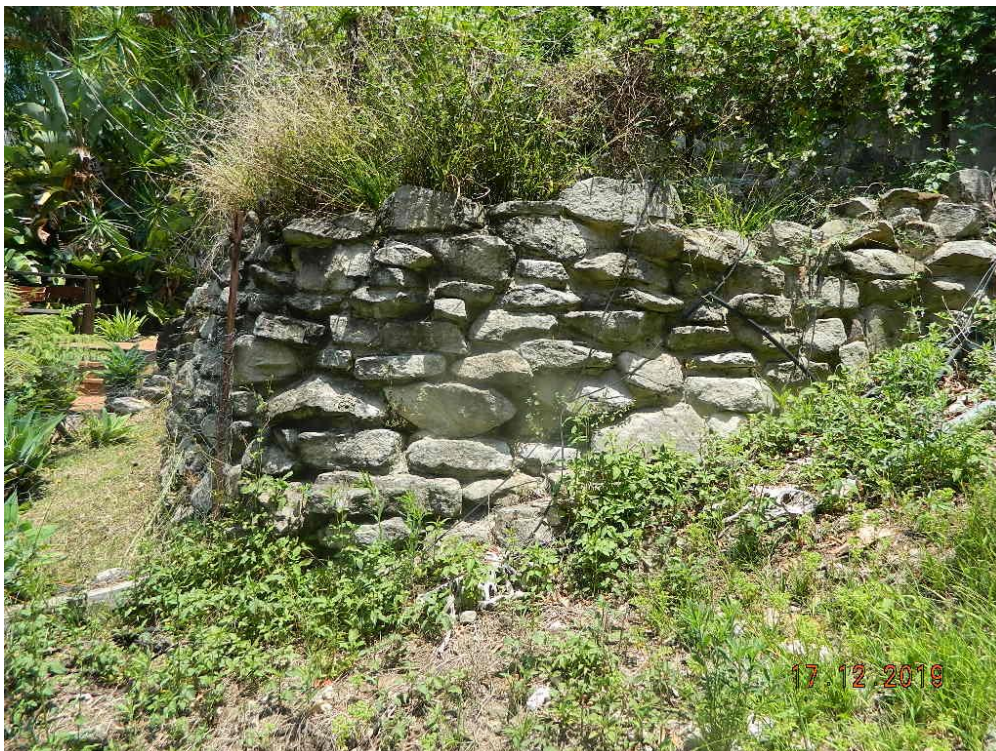
Photo 8

sandstone block wall supports the slope to the S (photos 7 & 8). The boulder wall is battered at an angle of ~40° to ~45°. The wall components are suitably placed and well sized. The sandstone block wall is battered back at ~6° from vertical and appears to be well made. An old ~1.3m mortared stack rock retaining wall supports forms a terrace along the S boundary and in the neighbouring S property (photo 9). At the W boundary loose sandstone boulders are scattered on the slope and are considered to be in stable conditions (photo 10).
