GEOTECHNICAL INVESTIGATION:

New Boat Ramp at 1744 Pittwater Road, Bayview

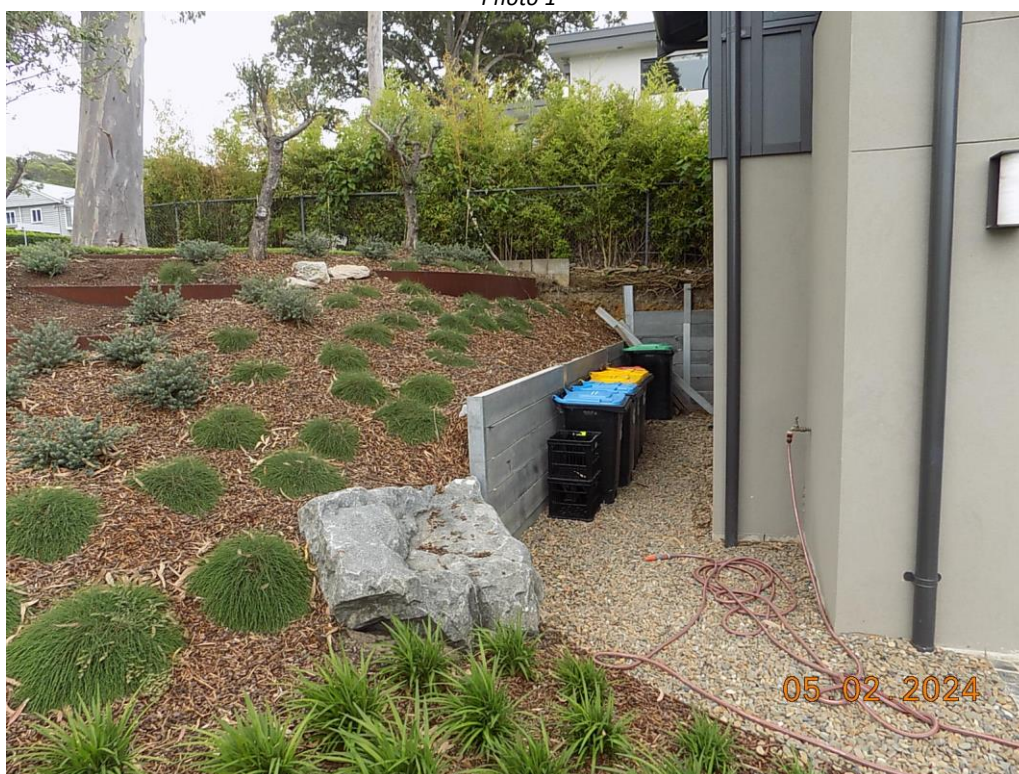
Photo 2

- 2.3** A paved driveway runs down the slope to a garage on the uphill side of the property (Photo 1). In between the road frontage and the house is a moderately sloping garden area. The retaining wall that supports the cut for the garage was not complete at the time of inspection. The materials to complete this wall were on site and we recommend this be completed as soon as possible (Photo 2). The part three-storey house is supported on rendered masonry walls (Photo 3). The walls show no significant signs of movement. A level lawn area extends off the downhill side of the house to a pool. The cut for the level lawn area is supported by a stable ~1.5m high sandstone log retaining wall (Photo 4). The pool shows no significant signs of movement as indicated by the water level against the tiles (Photo 5). A boatshed is cut

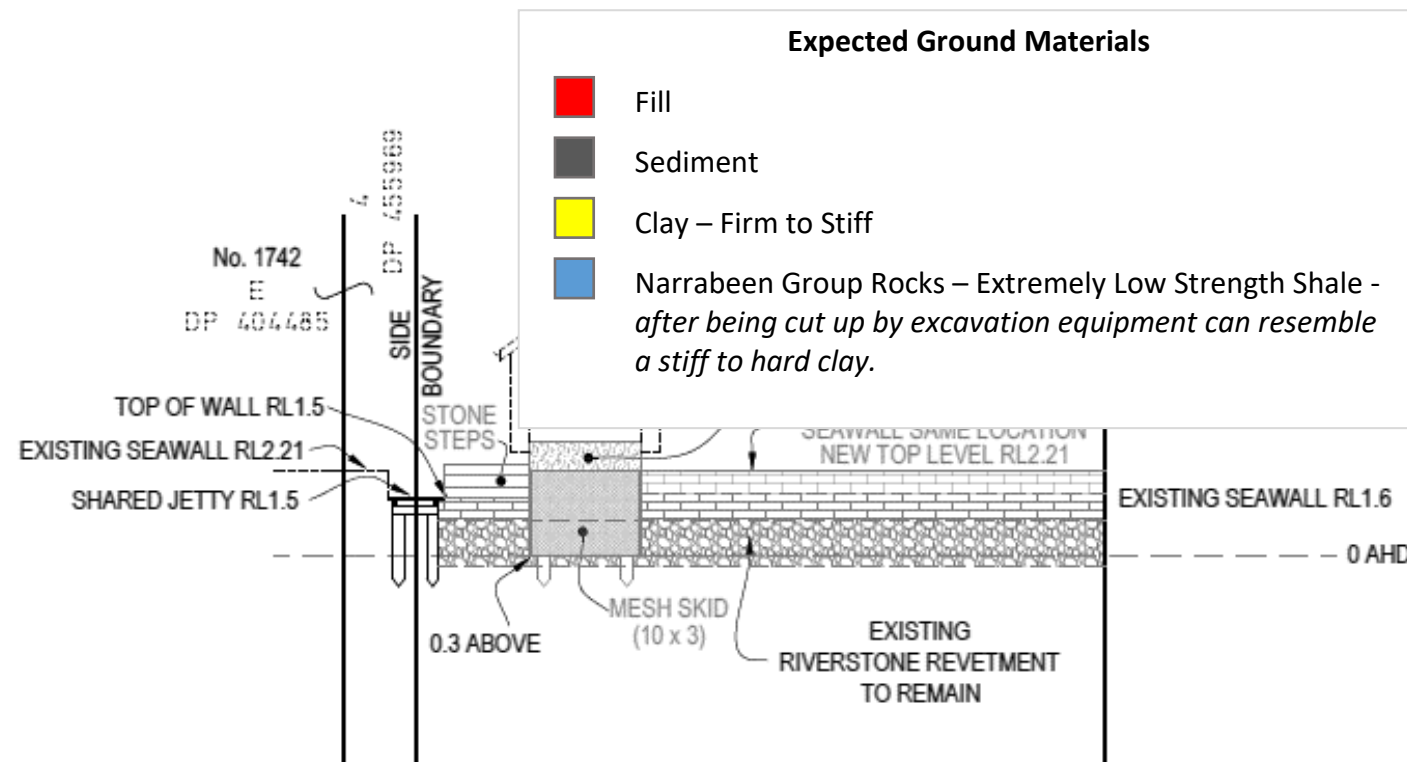
**EASTERN ELEVATION**

PROPOSED REPAIR, REPLACE AND RASING THE EXISTING SEAWALL, MESH SKID RAMP, CONCRETE AND STONE TILE TRANSITION RAMP AND STONE STEPS.
