35 Norma Road, Palm Beach

Comments on Updates to Plans

GEOTECHNICAL INVESTIGATION:

Alterations and Additions at 35 Norma Road, Palm Beach

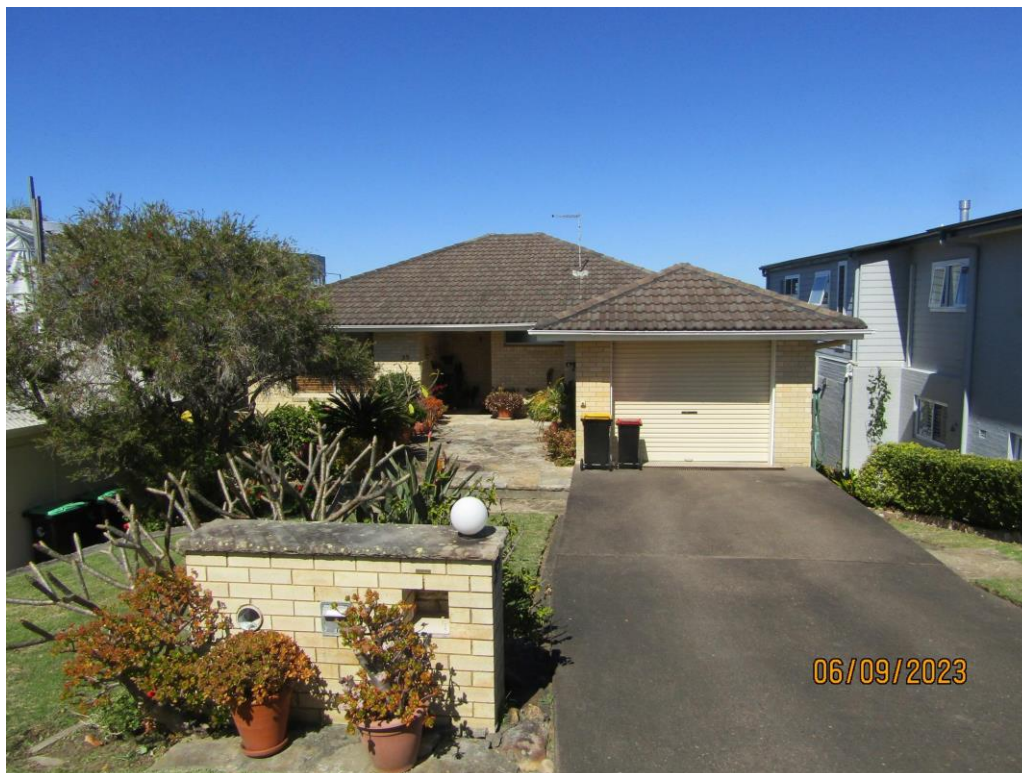
Photo 1

2.3 At the road frontage, a concrete driveway runs to a garage on the upper ground floor of the existing house (Photo 1). Between the road frontage and the house is a gently sloping lawn (Photo 2). E of the lawn is a concrete driveway and fibro garage that will be demolished as part of the proposed works (Photo 3). The cut for the driveway/garage is supported by a stable ~1.0m high sandstone dressed concrete retaining wall. The part two storey brick house is supported on brick walls (Photos 2 & 4). The external brick walls show no significant signs of movement.

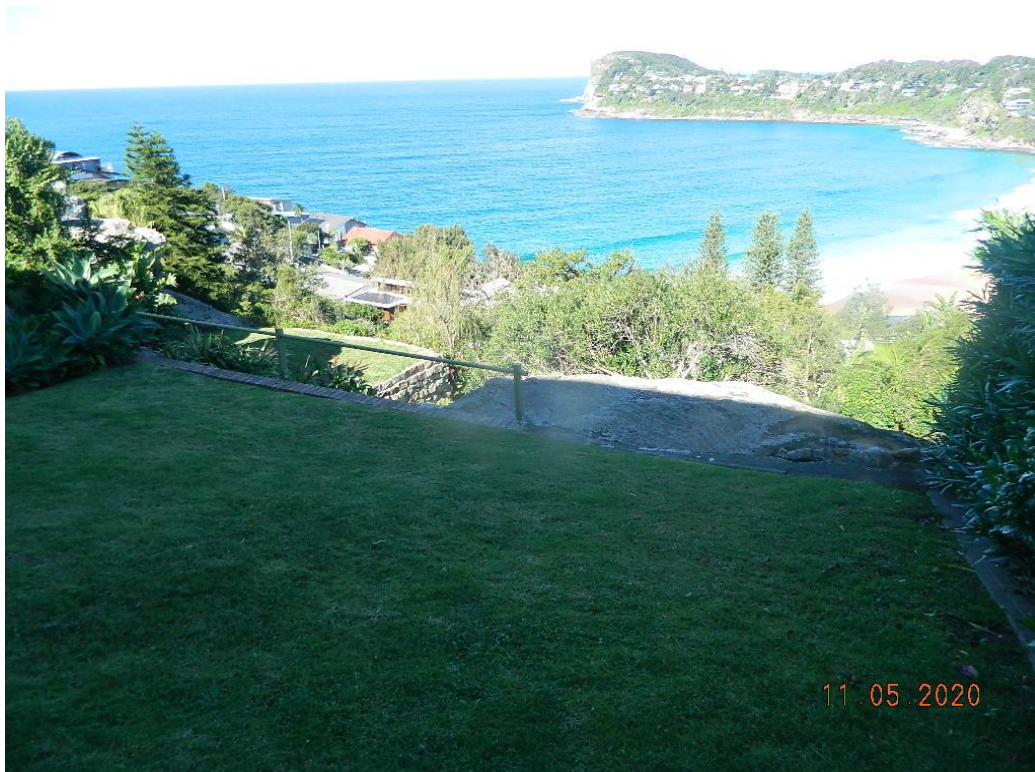
Photo 5

A sandstone pavement extends off the downhill side of the house. A stable sandstone block retaining wall up to ~1.6m high supports the fill underneath the pavement (Photo 5). A moderately sloping lawn extends downhill from the retaining wall. Fill at the SE corner of the lawn is supported by a ~1.3m high brick retaining wall in good condition. Sandstone bedrock is outcropping at the SW corner of the lawn (Photo 6). A portion of the rock is undercut ~1.5m (Photo 7). Given the thickness of the cantilever arm and no visible presence of defects in the arm, the undercut is considered to be stable. The outcropping sandstone bedrock steps down the property (Photos 8 & 9). A lawn extends from the bottom of the outcropping rock to a concrete block retaining wall (Photo 10). The retaining wall supports the lawn fill and is in good condition. Sandstone boulders around and on the lawn are considered to have come to rest in their current positions before the lawn area was developed. They are considered to be in stable positions. The overall slope across the property is considered stable.

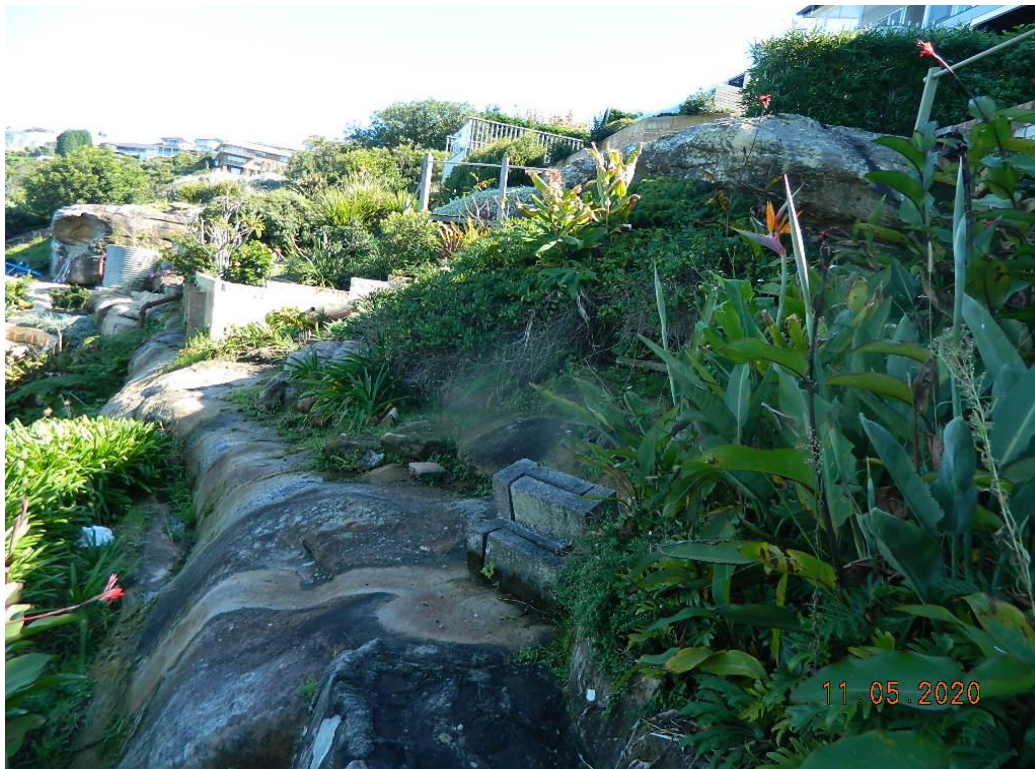
Photo 7

We estimate the foundations for the proposed retaining wall to support the fill on the downhill side of the property will be in the close vicinity to outcropping undercut rock immediately downslope (Photo 7). No foundations are to extend over undercut rock. If this can't be avoided the undercut rock is to be supported with blade walls designed by the structural engineer in consultation with the geotechnical consultant.
