Report on  
Geotechnical Investigation

Proposed New Residence  
9 Ocean Road  
Palm Beach

Project 86970.00  
January 2020

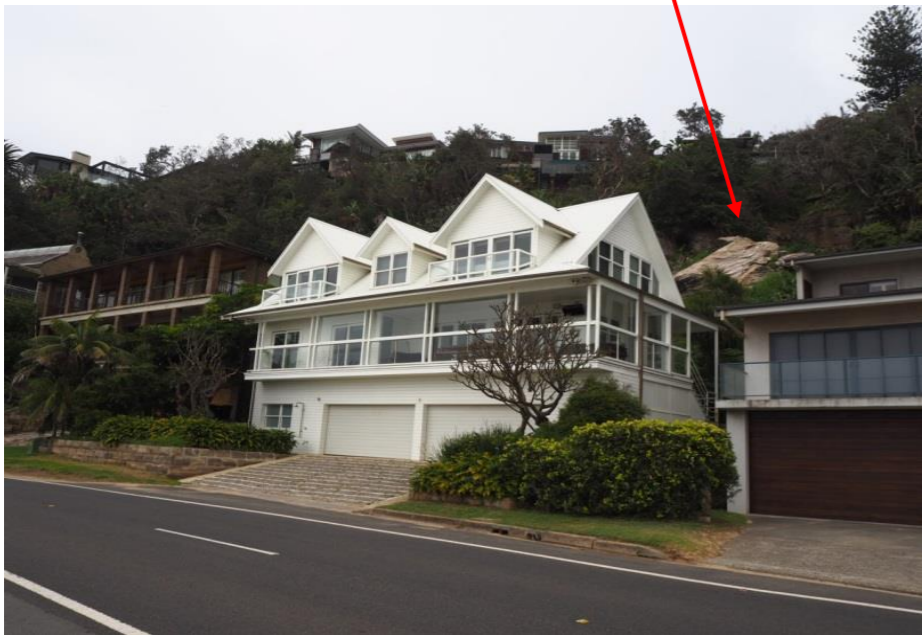
Photo 1: View of existing residence (centre) from Ocean Road

- a two-story weather-board residence with basement garage and metal roof is located directly west of the eastern boundary (refer to Photo 1). The residence has a garage basement cut into the toe of the existing slope. A cemented sandstone flagging wall has been used to support the cut face. Large colluvial float stones are exposed within the sandstone flagging wall ( refer to Photo 6). At the time of the inspection there was no groundwater seepage through the drainage holes in the sandstone flagging wall;

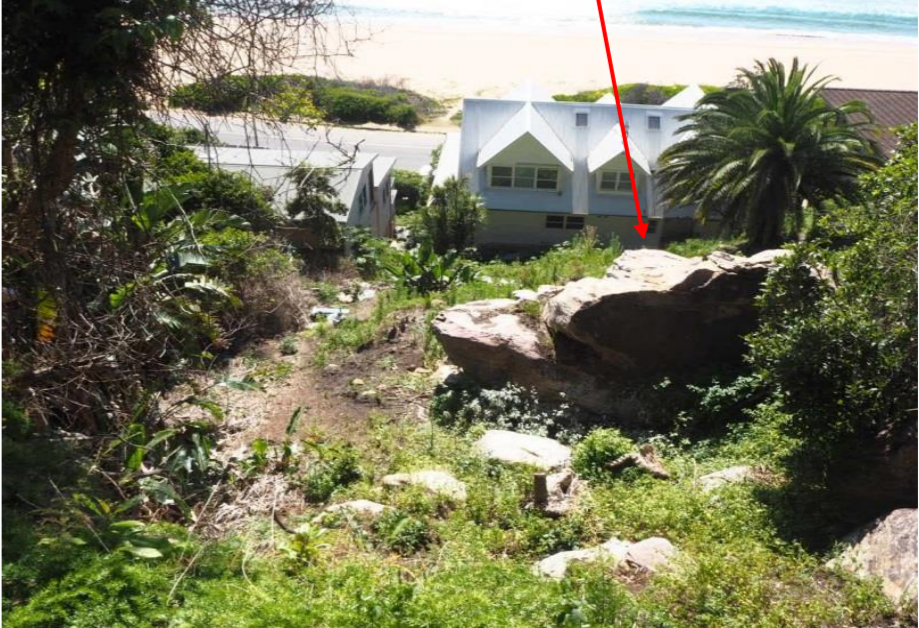
Photo 3: View from crest of clii-line looking east towards Ocean Road

- there are large angular sandstone blocks lying at the base of the cliff-line, on the slope below the cliff-line and above the existing residence (refer to Photos 1 and 3). The largest of these boulders is in excess of 7 m diameter. Heavily weathered surfaces of the boulders suggests that they have been in their present positions for many years, probably centuries;

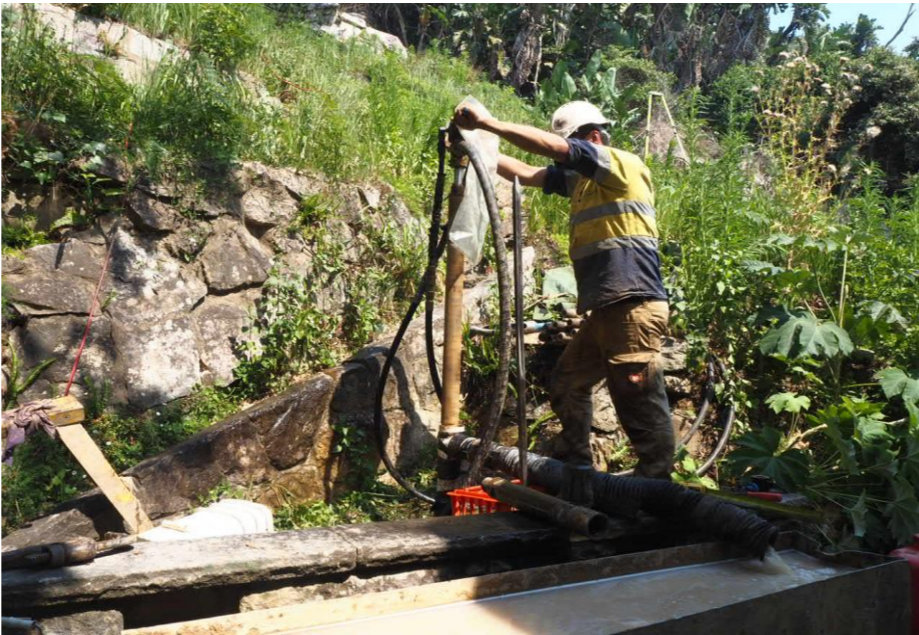
Photo 5: Drilling Bore 03 with portable equipment

- drilling of five boreholes (BH01 to BH05) using a portable Proline geotechnical drilling rig at the locations shown on Drawing 1 in Appendix B (refer to Photo 5);
- boreholes were drilled into medium to high strength bed-rock to total depths ranging from 4.52 m to 11.43 m using diamond core drilling equipment to obtain continuous core samples of colluvial boulders and in-situ bedrock underlying the site;
- geological mapping was carried out by an senior engineering geologist to identify specific geomorphological features and to carry out a slope stability hazard risk assessment.
