REPORT ON GEOTECHNICAL SITE INVESTIGATION

PROPOSED DEVELOPMENT

**41 UPPER CLIFFORD,
FAIRLIGHT
NSW**

Project No.: 2019-212.1

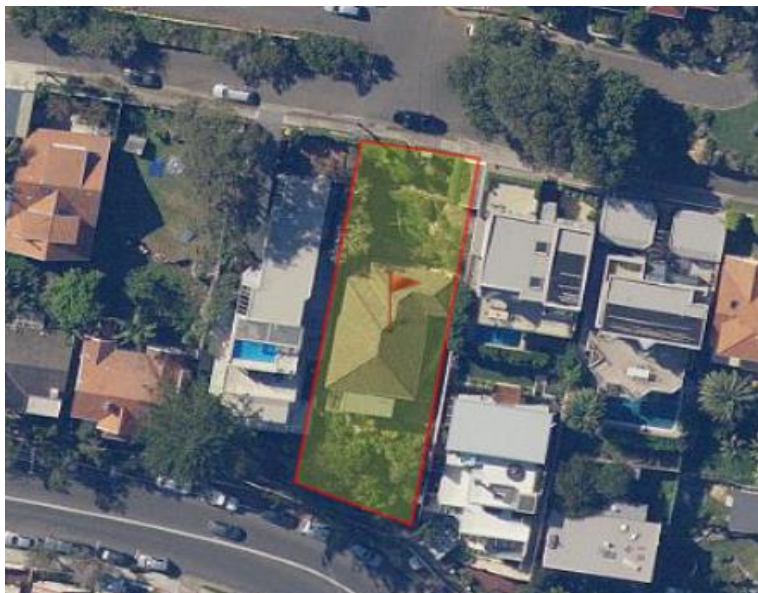
Photograph: 1 – Aerial photo of site and surrounds.

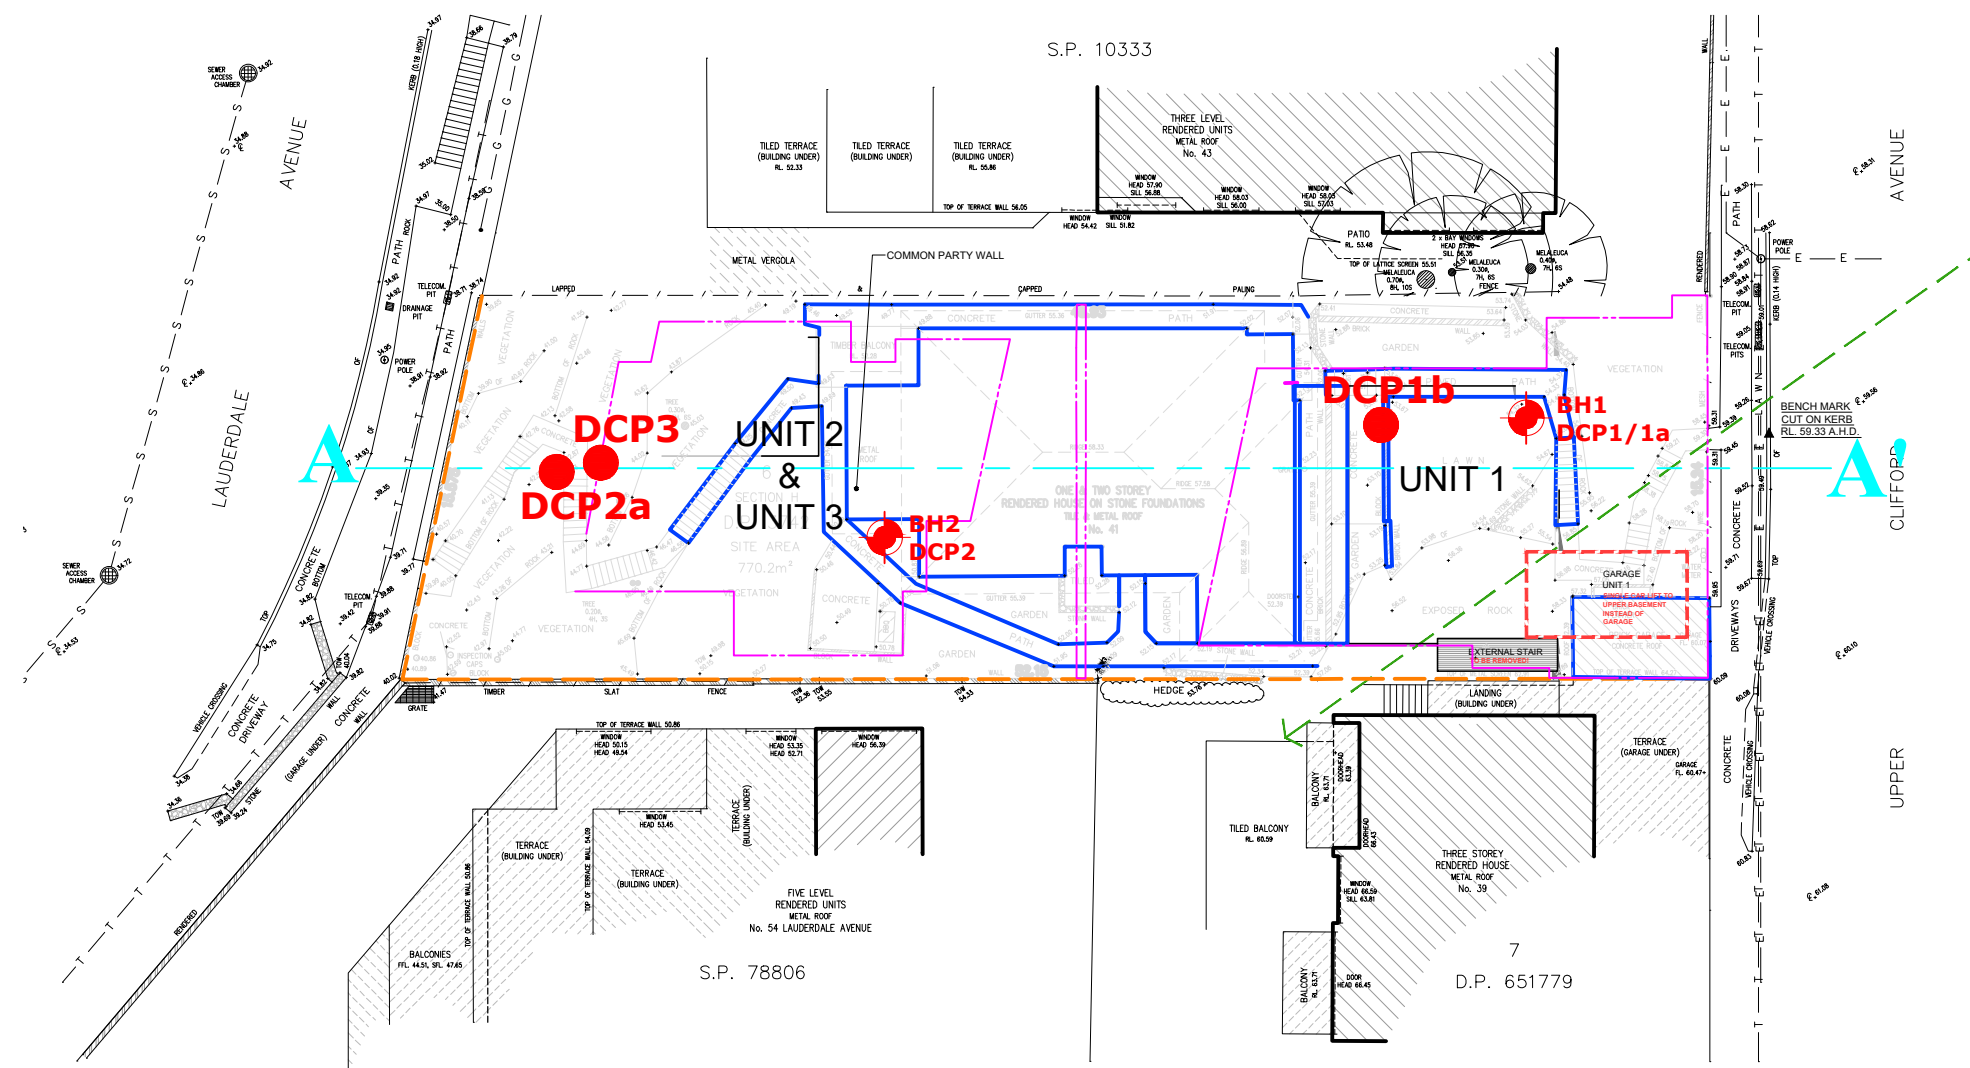
SITE PLAN & TEST LOCATIONS FIGURE 1.

Explanatory notes are included in Appendix: 1. Mapping information and test locations are shown on Figure: 1, along with detailed bore log and DCP sheets in Appendix: 2.
