GEOTECHNICAL INVESTIGATION:

New Inclined Lift at 153 Seaforth Crescent, Seaforth

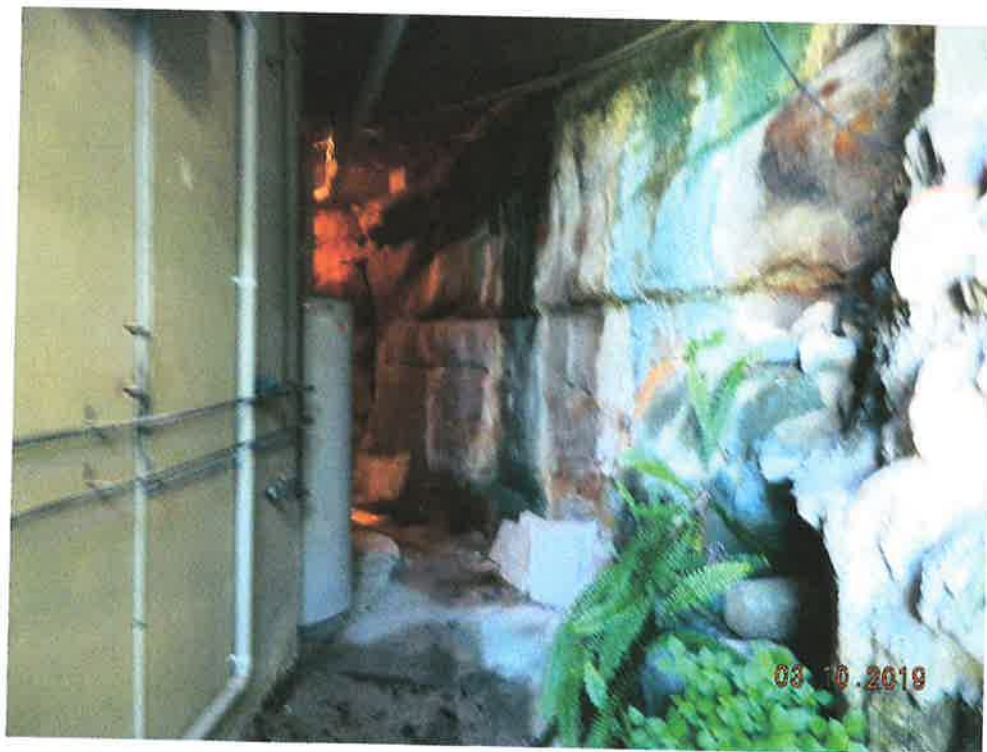
Photo 1

- 2.3 From the road frontage a concrete driveway extends to the garage and house (Photo 1). Outcropping rock was observed across the entire site. The two and three storey cement rendered brick house is supported on piers and walls. The piers stand vertical and are considered stable. The lower levels of the house have been cut 3.0m into sandstone that appears free of defects (Photo 2). On the downhill side of the house there is a suspended pool supported on concrete piers (Photo 3). A timber staircase runs down the slope on the SW side of the house (Photo 4). An inclined lift that runs downslope to the water front is proposed for this location. A ~5.0m rock face falls on the downhill side of the pool. This escarpment is undercut ~3.0m and has been partially supported by concrete piers (Photo 5). The slope below the rock face is
