GEOTECHNICAL RISK MANAGEMENT POLICY FOR PITTWATER
FORM NO. 1 – To be submitted with Development Application

Report Title: Geotechnical Report 56 Crescent Road, Newport
Report Date: 17/12/18
Author: BEN WHITE
Author's Company/Organisation: WHITE GEOTECHNICAL GROUP PTY LTD

GEOTECHNICAL INVESTIGATION:

Alterations and Additions and New Pool at **56 Crescent Road, Newport**

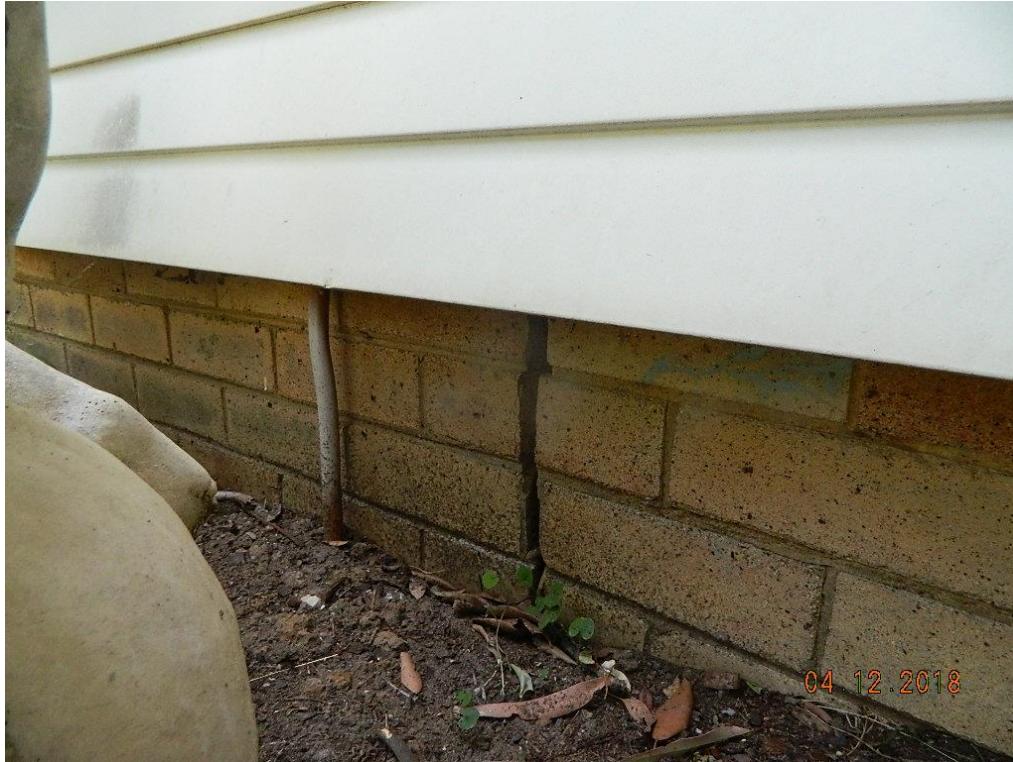
Photo 6

wall continues down a of the N side of the house as a stable treated pine retaining wall (Photo 5). The part two-storey timber framed and clad house is supported on brick walls and brick piers (Photo 6). A large vertical crack observed in the uphill supporting brick wall of the house (Photo 7). We are not sure why the cracking has occurred but it is not considered the result of settlement or an indication of slope instability. The brick piers stand vertical (Photo 8). A stable timber crib wall reaching a maximum height of ~1.5m runs along a portion of the N common boundary below the house. The wall continues on the N neighbouring property and supports a cut and fill for a level lawn area on the N neighbouring property (Photo 9). The slope that falls from the downhill side of the house to the lower boundary has been terraced. The terraces are supported by stable treated timber retaining walls that reach a maximum height of ~1.6m (Photos 10 & 11). No significant signs of movement related to slope instability were observed on the property. No geotechnical hazards that could impact on the subject property were observed on the neighbouring properties as seen from the subject property and the road.
