Report Title: Geotechnical Report 78 Powderworks Road, Narrabeen
Report Date: 01/03/21

GEOTECHNICAL INVESTIGATION:

New Dwelling and Pool at 78 Powderworks Road, North Narrabeen

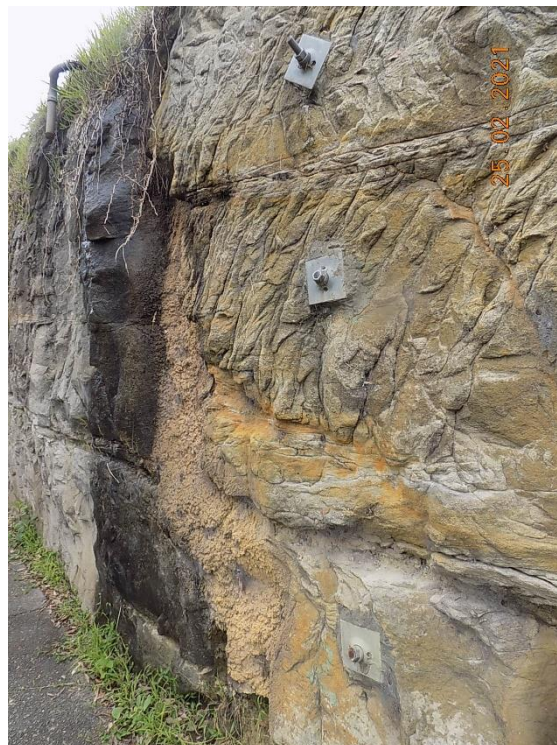
Photo 3

- 2.3** At the road frontage, the concrete driveway runs up past the house to a parking area on the uphill side of the property (Photos 1 & 2). The driveway and road are both cut into the slope. Both excavations are taken entirely through sandstone bedrock. The excavations reach a maximum height of ~3.5m (Photo 3). The majority of the cut face is through Medium Strength Sandstone that displays no significant geological defects. However, there are 3 areas of interest where several rock bolts and sprayed concrete have shored jointed and softer sections of rock (Photos 4 & 5). The existing house (photo 6) is partially supported directly on to outcropping Medium Strength Sandstone (Photo 7). The house will be demolished as part of the proposed works and the remainder of the site will be cleared.
