## ***Construction Impact & Management Statement: Lodged DA2021/1802 November 2021***

**Site:** Lot 10 in DP 233448  
11 Bertana Crescent  
WARRIEWOOD, NSW

**Client:** Mrs. Angela Curgenven  
c/ Mark Hurcum Design Practice Pty Ltd  
271 Alfred Street North  
NORTH SYDNEY, NSW 2060

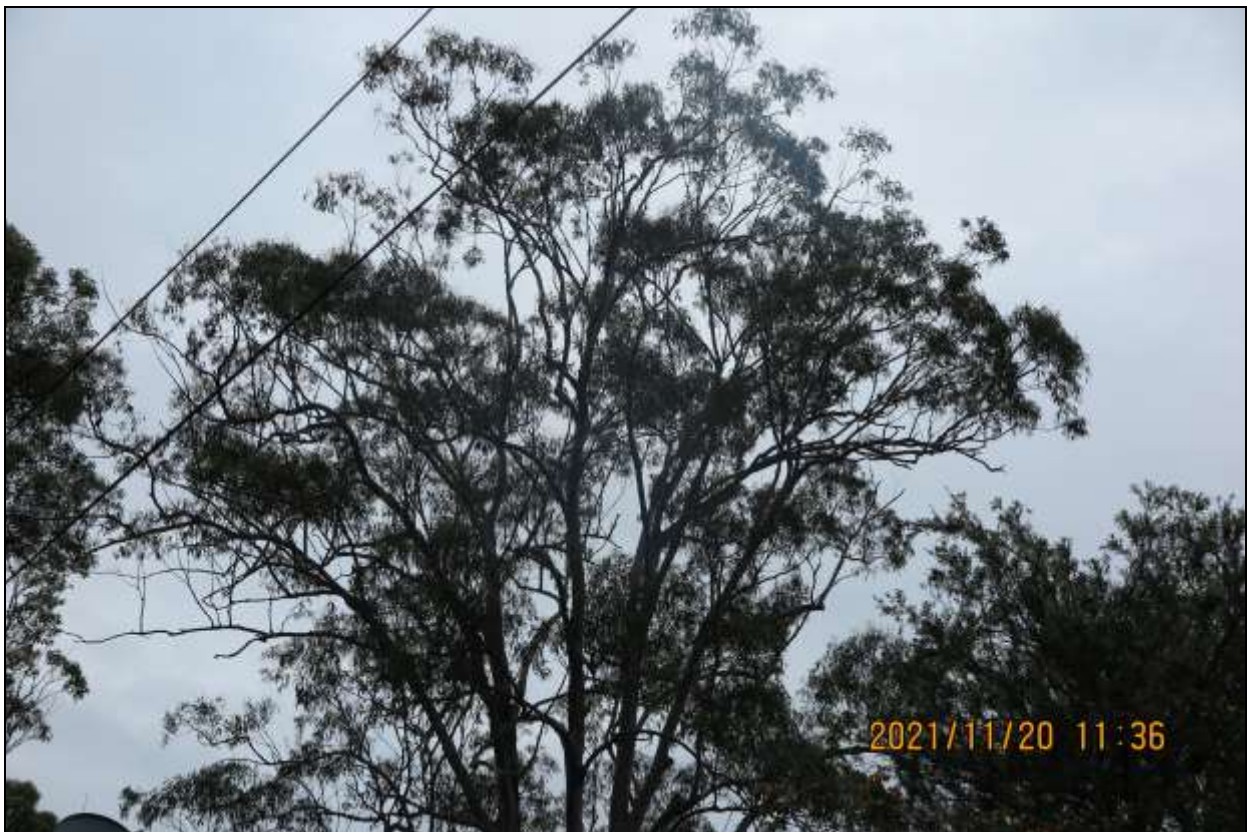
By intensive VTA ground level assessment from multiple locations it is evident the discussed tree drops both 'live' & 'dead branches' of a significant diameter (i.e., greater than 100mm). Client discussion confirms the failure of 'live branches' during both 'storm incidents' as well as on 'still weather days'. (Dead/dying branch failures are not discussed in detail as they are generally considered to be a management issue.)

The following photographs confirm dead/dying branches throughout the tree canopy as well as multiple previous 'branch failure sites'. Of greatest concern relative to tree health, vigour & risk is that the tree displays many dead/dying branch tips which is usually linked to 'root dysfunction'.

Figure 9: Previous page photographs illustrates dead/dying branches/branch tips plus branch failure sites. Above arrow points towards dysfunctional tissue consistent as an indicator of internal fungal pathogen activity.

- **Relative to the information as presented the GMW Consultancy supports the replacement of the discussed tree in a location where it can develop with no conflict to exiting built fom. proposed works as presented in documentation reviewed.**
- **The DA submission be re-assessed for determination by council officers taking into account the contents of this document.**
