Development Application for <u>Reform Projects Pty Ltd</u>	Name of Applicant
Address of site <u>1102-1106 Barrenjoey Road, Palm Beach, NSW</u>

**REPORT TO
REFORM PROJECTS PTY LTD**

**ON
SEEPAGE ANALYSIS AND GEOTECHNICAL
ASSESSMENT
(In Accordance with Pittwater Council Risk
Management Policy)**

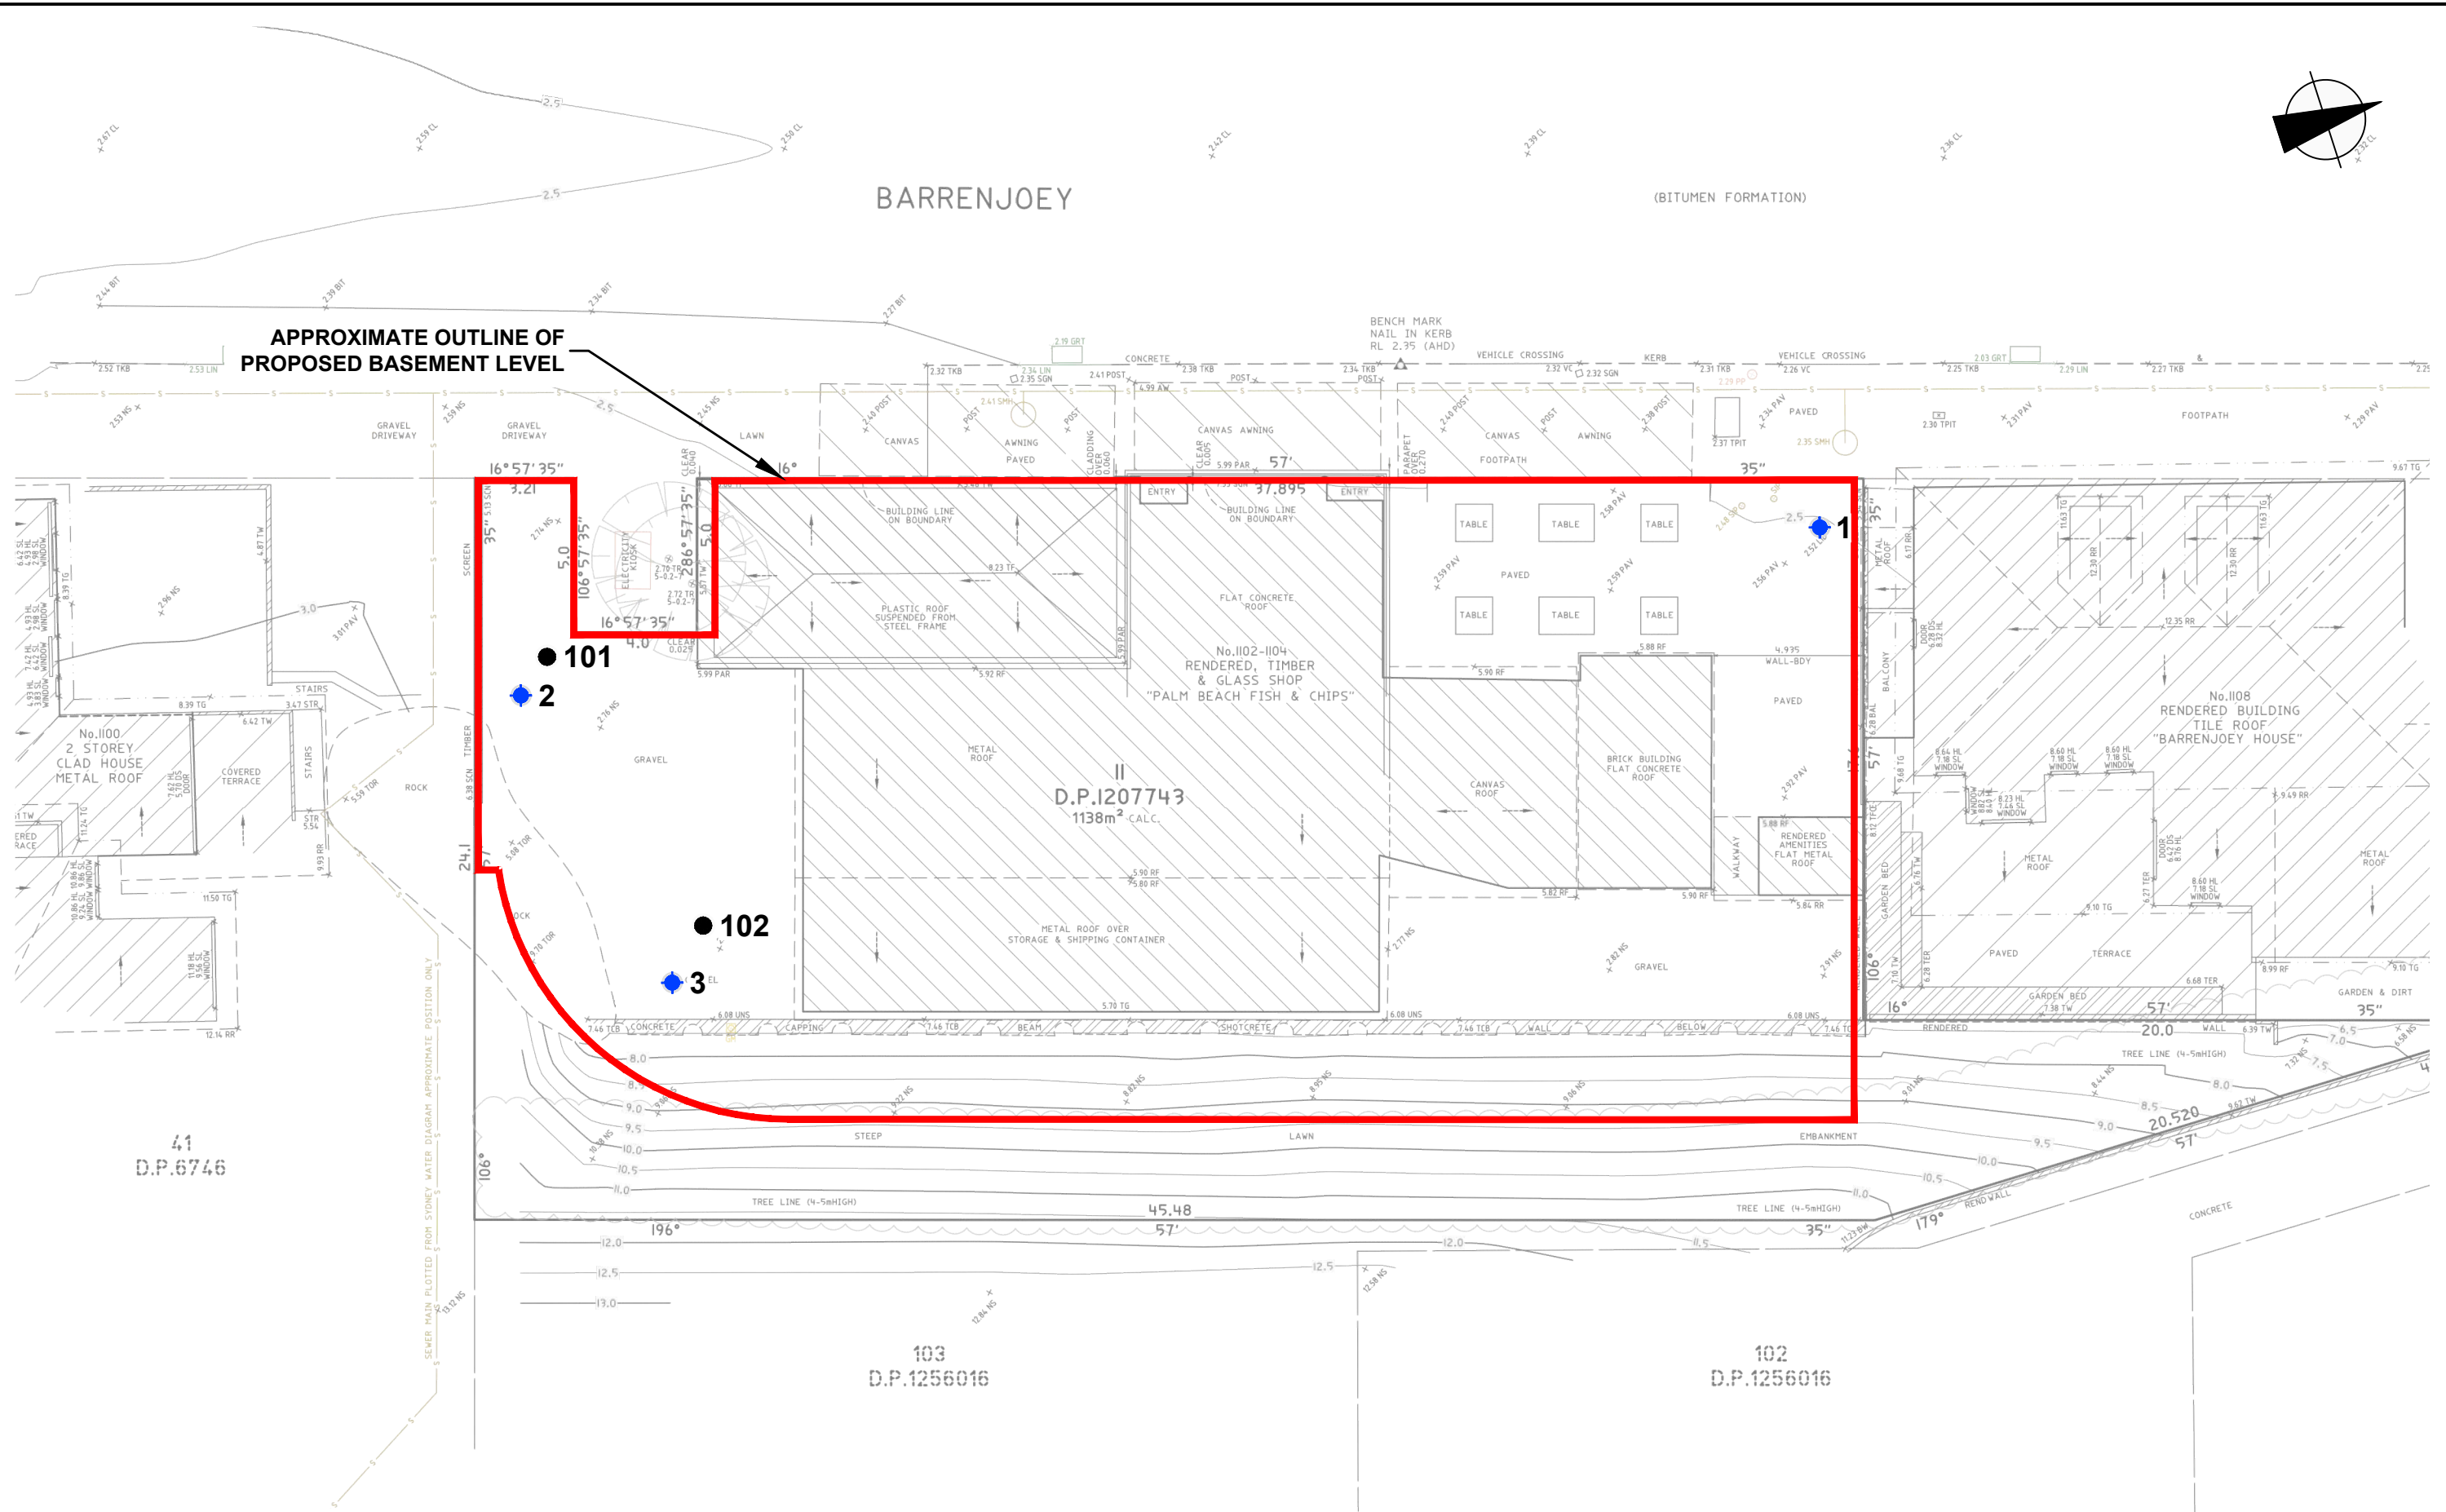
Figure 3: Plan of Notable Geotechnical Features and Geotechnical Hazards

The attached Figure 3 presents a plan showing notable geotechnical site features and geotechnical hazards. Figure 3 is based on the survey plan prepared by CMS Surveyors Pty Ltd (CMS, Ref: Drawing No. 19783detail, Issue 1, date of survey as 3 November 2020). We also received an older survey plan by Adam Clerke Surveyors Pty Ltd (Ref: 20688L, dated 26 April 2012), which we used to review former levels at the site. Additional features on Figure 3 have been measured by hand held clinometer and tape measure techniques and hence are only approximate. Should any of the features be critical to the proposed development, we recommend they be located more accurately using instrument survey techniques. Figure 6 defines the geotechnical mapping symbols adopted and used in Figure 3. Figures 4 and 5 present typical cross-sections (Sections A-A' and B-B', respectively) through the site based on the survey data augmented by our mapping observations. These sections include potential landslide hazards.

These potential hazards are indicated in schematic form on the attached Figure 3.

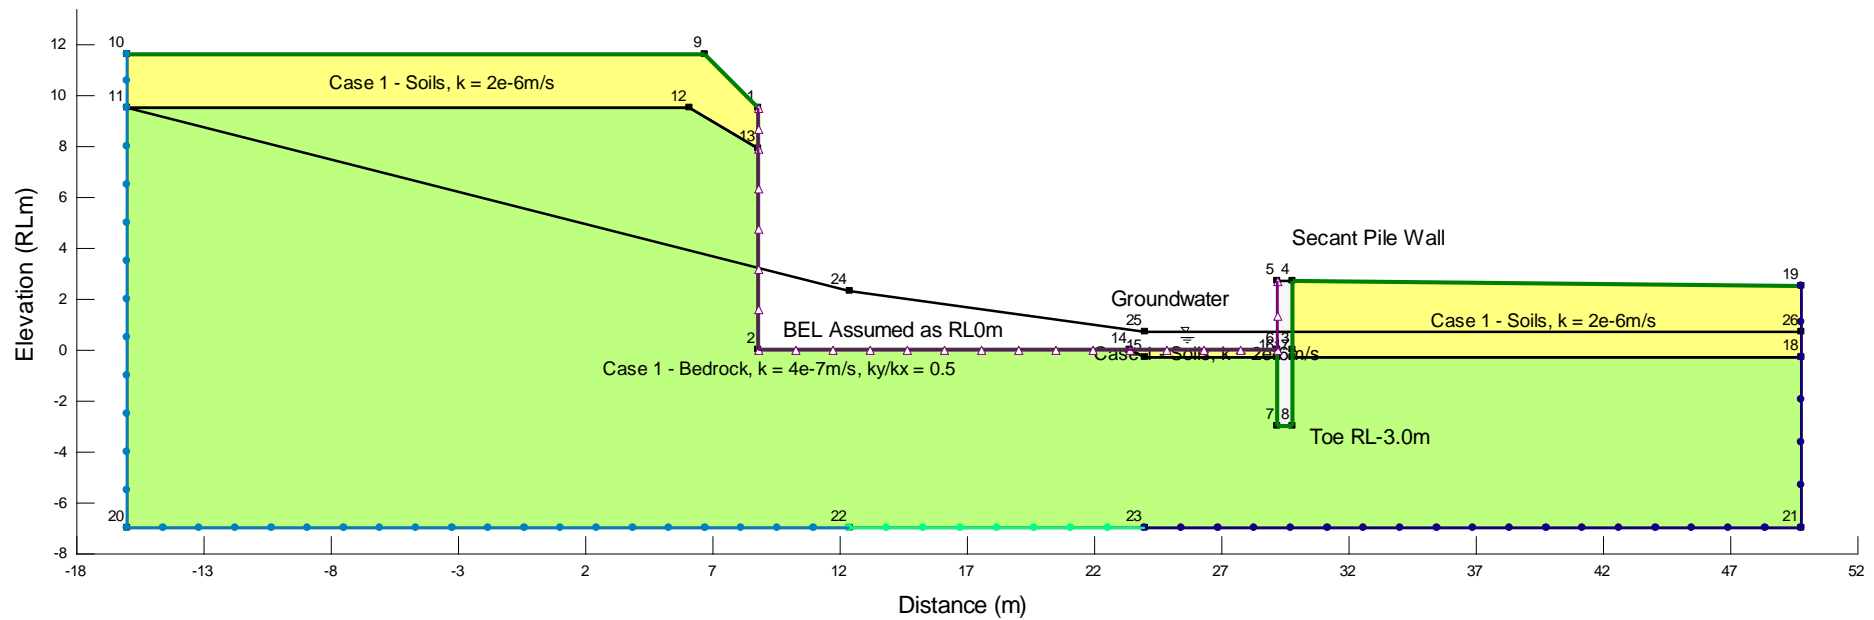
SEEP/W - GEOTECHNICAL MODEL

Steady state seepage analysis has been carried out on one section, Section A-A', which is shown on the attached Figure 3. The purpose of the modelling was to provide an estimate of extraction rates required during construction. The section is based on the survey plan by CMS and was chosen as it represented a 'typical' section through the site in terms of the proposed boundary set-backs, depth of proposed excavations, gradient of the existing ground and groundwater and subsurface conditions.

Color	Name	Model	Sat Kx (m/sec)	Ky'/Kx' Ratio
Light Green	Case 1 - Bedrock, k = 4e-7m/s, ky/kx = 0.5	Saturated Only	4e-07	0.5
Light Yellow	Case 1 - Soils, k = 2e-6m/s	Saturated Only	2e-06	1
