GEOTECHNICAL INVESTIGATION:

Additions and Alterations at **56 Peronne Avenue, Clontarf**

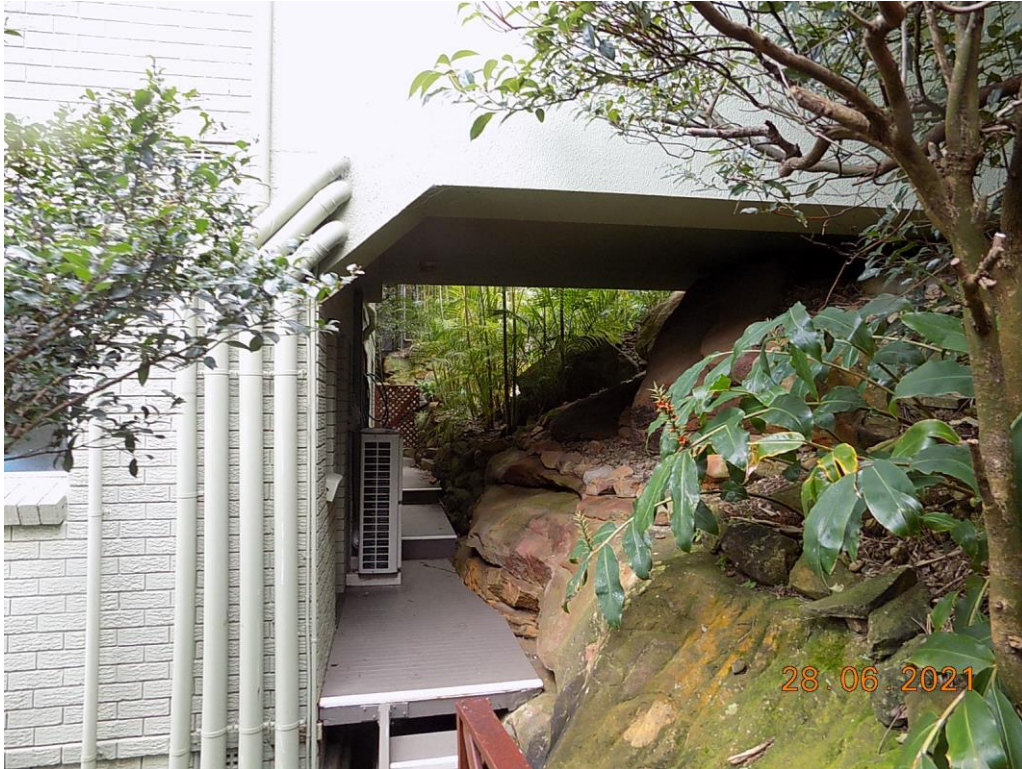
Photo 6

Normal ground water seepage is expected to move over the buried surface of the rock and through the cracks. This type of seepage was observed at the rock exposure immediately behind the garage (Photo 6). Due to the slope and elevation of the block, the water table is expected to be many metres below the base of the proposed excavation.
