51 PLATEAU ROAD, AVALON
ADDENDUM TO ACCOMPANY GEOTECHNICAL REPORT

MT 31454
20^h April, 2018
Page 1

RISK ANALYSIS & MANAGEMENT FOR PROPOSED CARPORT RELOCATION AT 51 PLATEAU ROAD AVALON

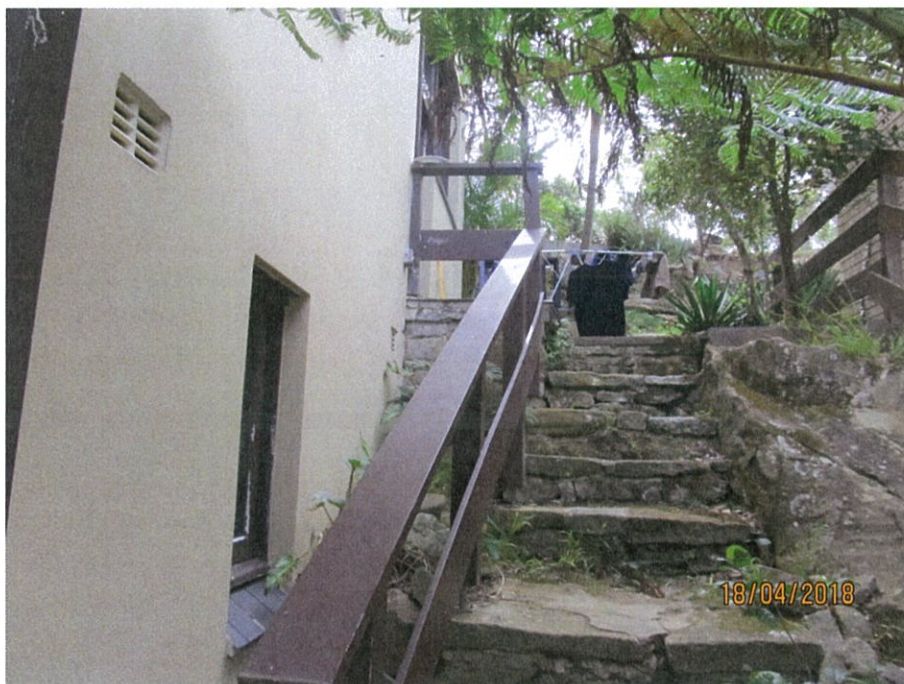
Photo 1

3.3 Vehicular entry is via a steep concrete driveway that arcs around from the road frontage to a carport that runs along the northern side of the residence (Photo 1). Pedestrian access is also via the driveway. Rock steps (Photo 2), along the eastern side of the residence lead down to a lower deck area (Photo 3). From the deck area steps formed by wooden sides (Photo 4) lead from the south western corner of the residence through a heavily vegetated area to a level grassed area running along the southern boundary (Photos 5 & 6). Under the deck area there is an area of stacked rock and soils (Photo 7). This area was stable at the time of the inspection, but attention will need to be paid to ensure its long term stability in the future. There is a wooden retaining wall on the southern boundary of the adjacent property to the west. This wall is showing signs of failure and will need attention in the near term. The stability of this wall is not considered a risk to the stability of the subject property. Rock steps extend up past the wooden steps on the western side of the residence (Photo 4), and lead to a large sandstone outcrop (Photo 9). Sandstone outcropping is abundant in the garden area between the residence and the road frontage (Photos 10 & 11). Between the northern boundary and the road kerb is a low wooden wall in good condition (Photo 12). At the time of our inspection the house and grounds were found to be in good condition with no signs of significant movement related to slope instability.
