## **Geotechnical Assessment**

**Project:** Alterations & Additions  
25 Carrington Parade, Freshwater NSW

**REF: AG 21402**  
2 December 2021

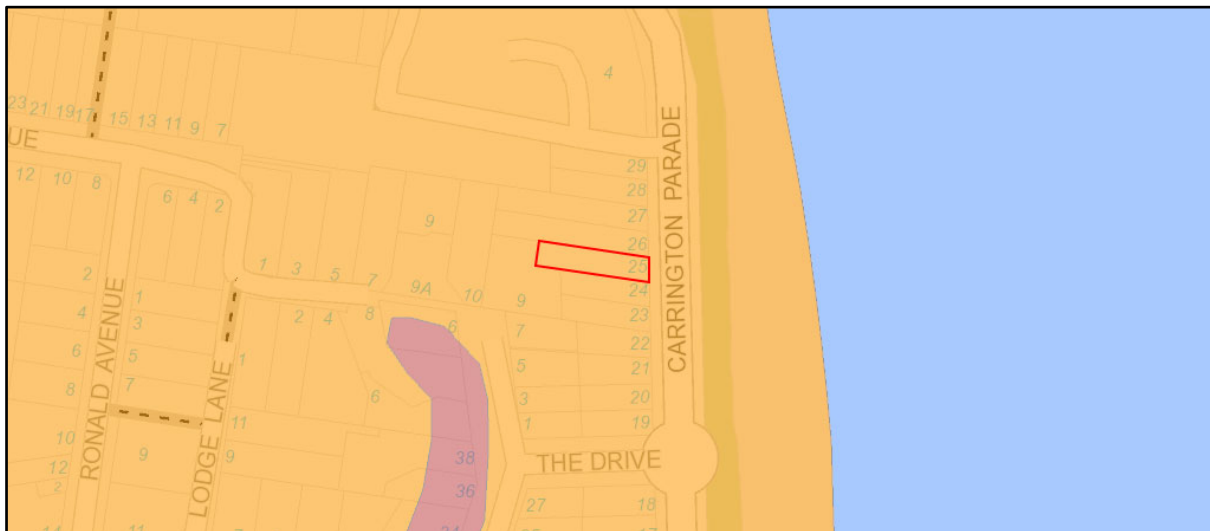
**Image 2.** WLEP Landslip Risk Map – 25 Carrington Parade, Freshwater NSW (NBC Maps)

- No evidence of significant soil creep, tension cracks or landslide instability were identified across the site or on adjacent properties as viewed from the subject site at the time of our inspection.
- The property is classified as **Areas A** with reference to Northern Beaches Council WLEP – Warringah Landslip Risk Map (**Image 2**).

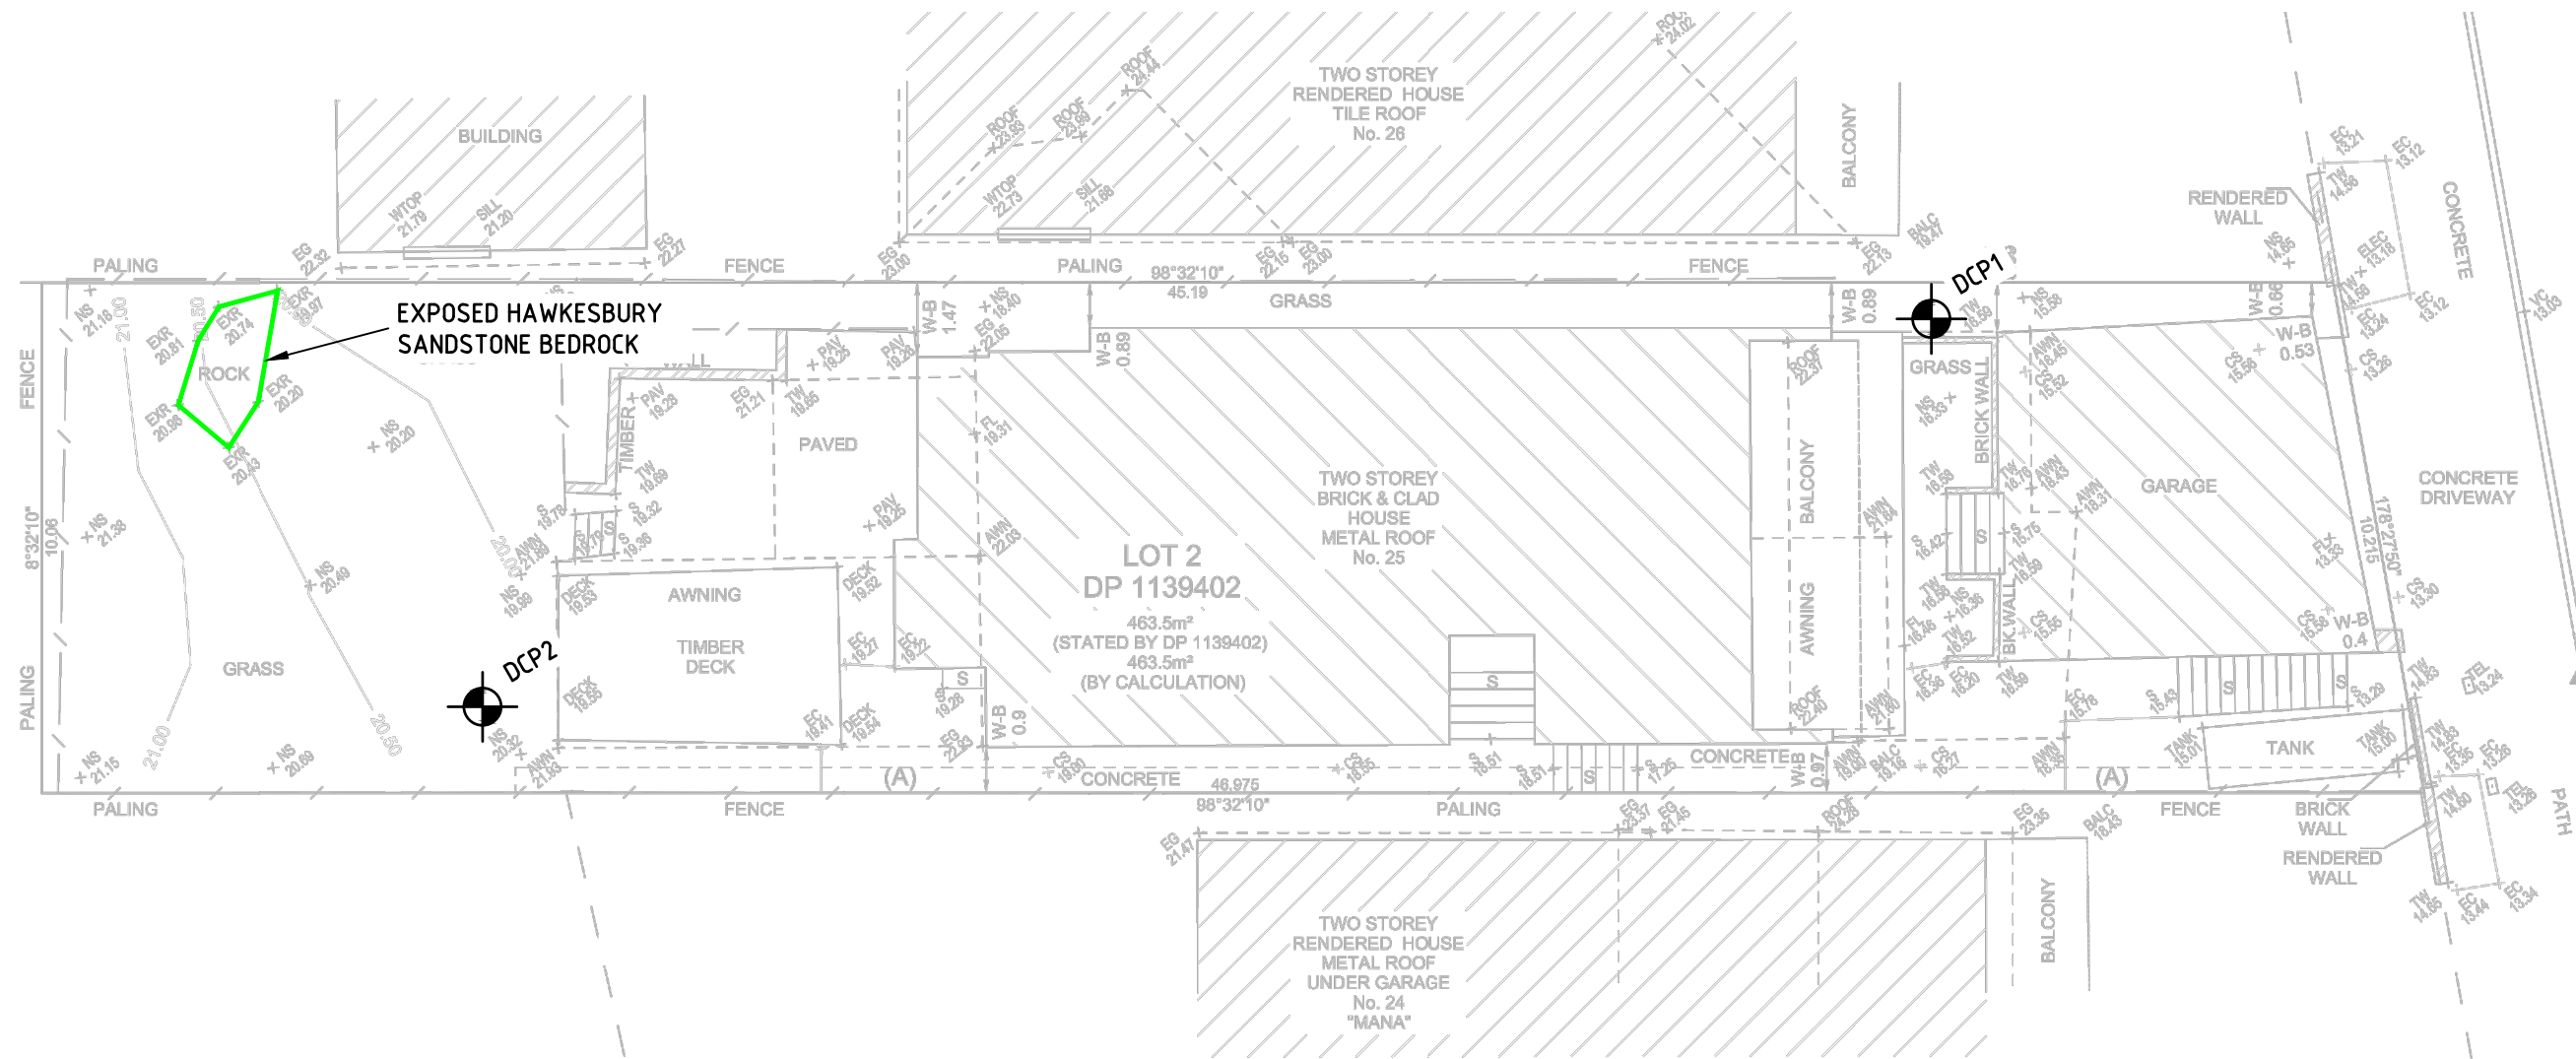
**SITE PLAN/GROUND TEST LOCATIONS**  
SCALE NTS

DCP LOCATIONS
