Construction Impact & Management Statement

July 2021 UPDATED January 2022

Site:	Lot 152 in DP 29335 1 Kanimbla Crescent BILGOLA PLATEAU, NSW
Client:	John & Helen Wood 1 Kanimbla Crescent BILGOLA PLATEAU, NSW 2107
Author:	Kyle A Hill Registered (Arb Aus #1884) Practising & Consulting Arborist Post Graduate Certificate in Arboriculture, Uni of Melb Diploma of Horticulture-Arboriculture TAFE, Grow SA Certificate of Horticulture, TAFE Certificate Advanced Tree Care TAFE Founder -Growing My Way Tree Services (1977) Member of International Society of Arboriculture Member of Arboriculture Australia

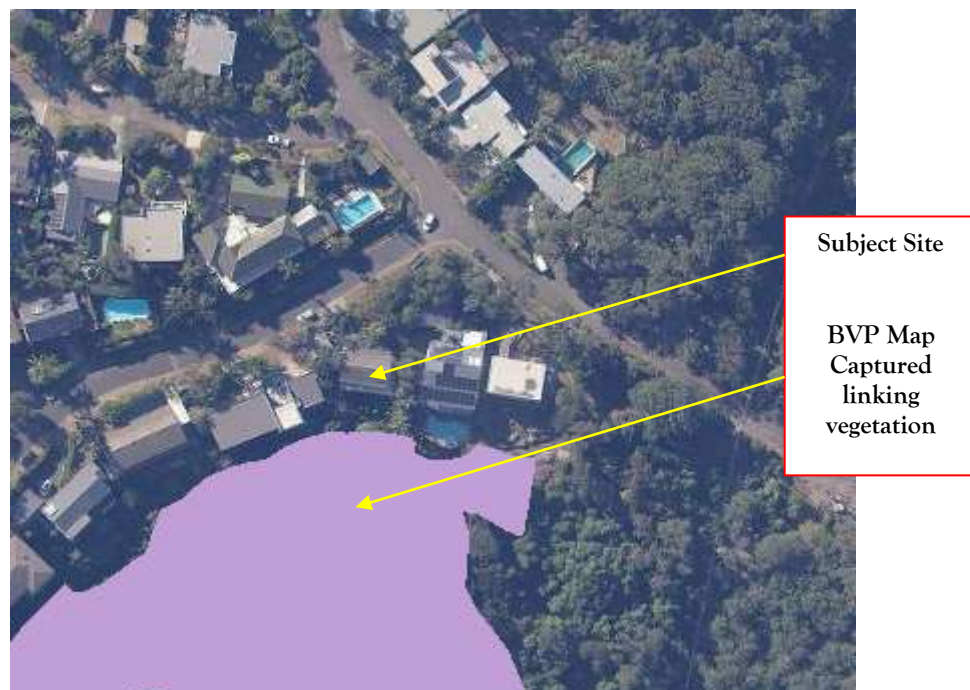
The very bottom portion of the site is captured by the NSW Government “Department of Planning, Industry & Environment” Biodiversity Values Map. No vegetation disturbance other than footings for the as proposed on existing ground level southern new boundary retaining wall. Simply, no vegetation captured by the BVM will be damaged or destroyed. (See below portion of BVM.)

Figure 8: Confirms linking BVM vegetation. Note; the proposed works do not impact in any manner upon the highlighted area of vegetation.
