Report on Geotechnical Investigation

Approved Mixed-Use Development 231 Whale Road, Whale Beach

Prepared for Leslie Cassar

Project 45636.02 November 2023

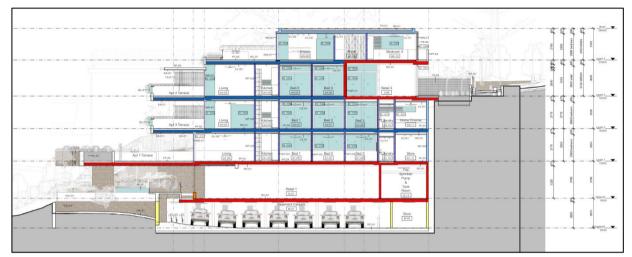
Figure 1: Cross section view looking south (taken from RCA drawing No. CC16, dated July 2023)

comprising six levels, with the lower basement level constructed at about RL 6.53 m. The excavation will be between about 3 m and 12 m deep (refer Figure 1) and within about 3 m to 4 m of the western (Whale Beach Road) boundary, about 2 m of the southern boundary and about 0 m to 9 m of the northern boundary. Figure 2 shows the basement level footprint.
