REPORT ON GEOTECHNICAL SITE INVESTIGATION

30 FAIRLIGHT STREET, FAIRLIGHT NSW

Project No.: 2019-200

**GEOTECHNICAL REPORT FOR PROPOSED FOUR STOREY RESIDENTIAL DEVELOPMENT
30 FAIRLIGHT STREET, FAIRLIGHT, NSW**

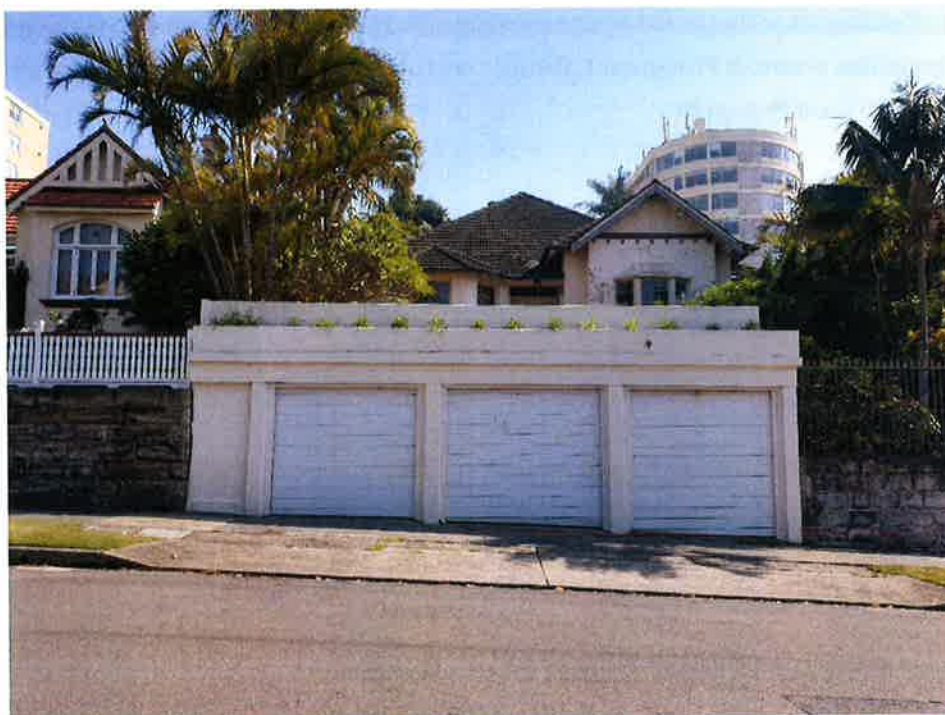
Photograph-2: Front view of the site from Fairlight Street, facing north

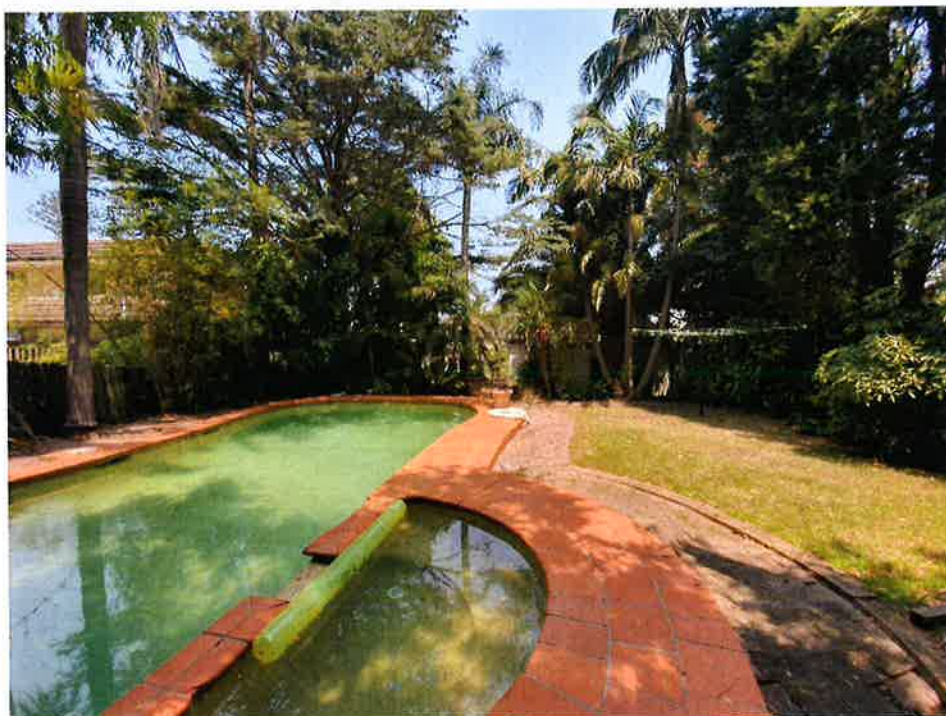
Photograph-3: Rear view of the site from rear lawn, facing south.

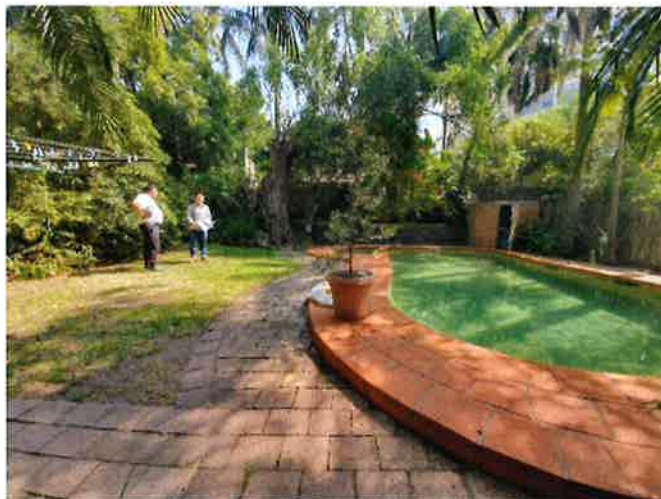
To the north of the rear patio is the rear end portion of the site, which is accessed via a gate, followed by a timber staircase. The rear end portion of the site contains a lawn at the western portion, an inground pool at the eastern portion and a raised garden (along the north boundary) which is retained by a concrete tiled retaining wall of approximately 1.5m height. To the base of the retaining wall and a tree is a minor rock outcrop comprising low to medium strength sandstone at approximately R.L.47.54m (Photograph 12&13). To the east of the sandstone outcrop (adjacent to the inground pool) is another rock outcrop (Photograph 14&15) comprising of similar composition at approximately R.L.47.41m.

Photograph-11: Lawn and inground pool. View looking north

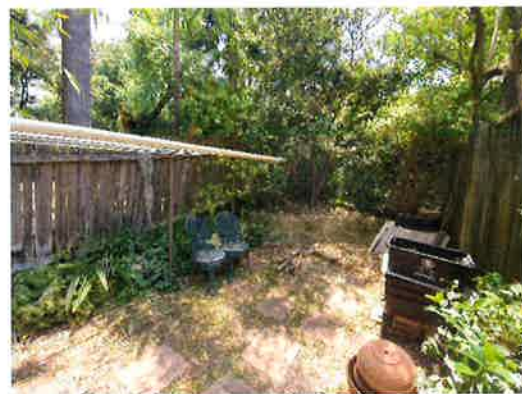
The neighbouring property to the east of the site, No. 28, contains a driveway and a four-storey brick apartment building. The concrete driveway extends north along the site's eastern boundary to a raised lawn (approximately 3m height) adjacent to the site's (Photograph 16 & 17) north-east corner. The boundary contains a brick retaining wall which appears to be in good condition with no significant cracks or rotation. The building is located approximately 4.2m off the boundary, appears formed at above ground surface levels and appears in good condition with no sign of cracking or settlement on the external walls.

Photograph-17: Raised lawn. View looking north

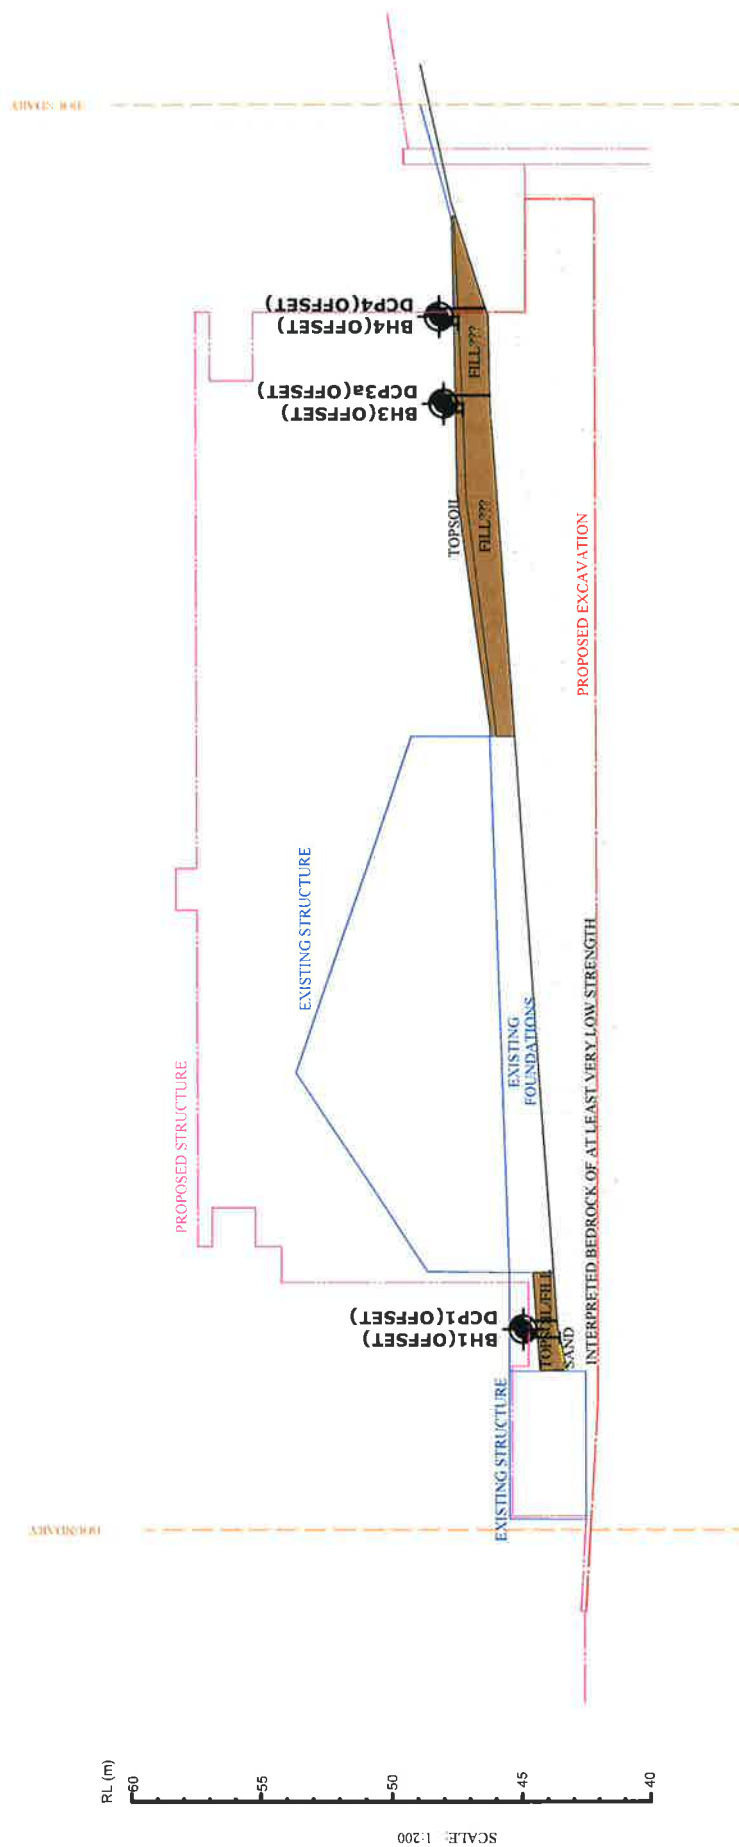
The site investigation identified topsoil/fill ($\leq 1.35\text{m}$) (DCP4) underlain by a thin layer of silty sand (BH1), overlying sandstone bedrock. Fill soil depth will vary across the site and increase to the rear of retaining walls and to the west of the inground pool. The surface of the bedrock was identified as dipping towards the south from a high of approximately R.L.= 46.16m (DCP4) to R.L.= 43.62m(DCP1). Some outcrop was observed in the north east corner of the site and the bedrock surface is expected to undulate with minor weathered/weak bedrock over low to medium strength bedrock expected. No groundwater table or significant seepage was encountered during the investigation. However, minor seepage is expected at the soil rock interface. Seepage is also likely along defects in the bedrock.
