GEOTECHNICAL REPORT

**PROPOSED
NEW RESIDENTIAL DEVELOPMENT**

6 MITCHELL ROAD, PALM BEACH

Project No: 2018-145

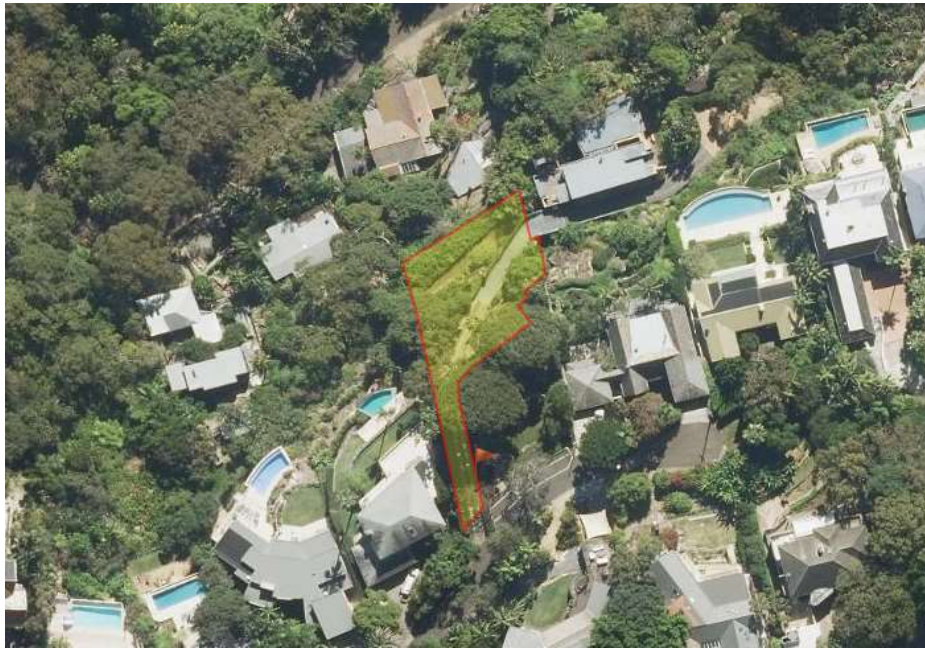
Photograph 1: Aerial photo of site and surrounds

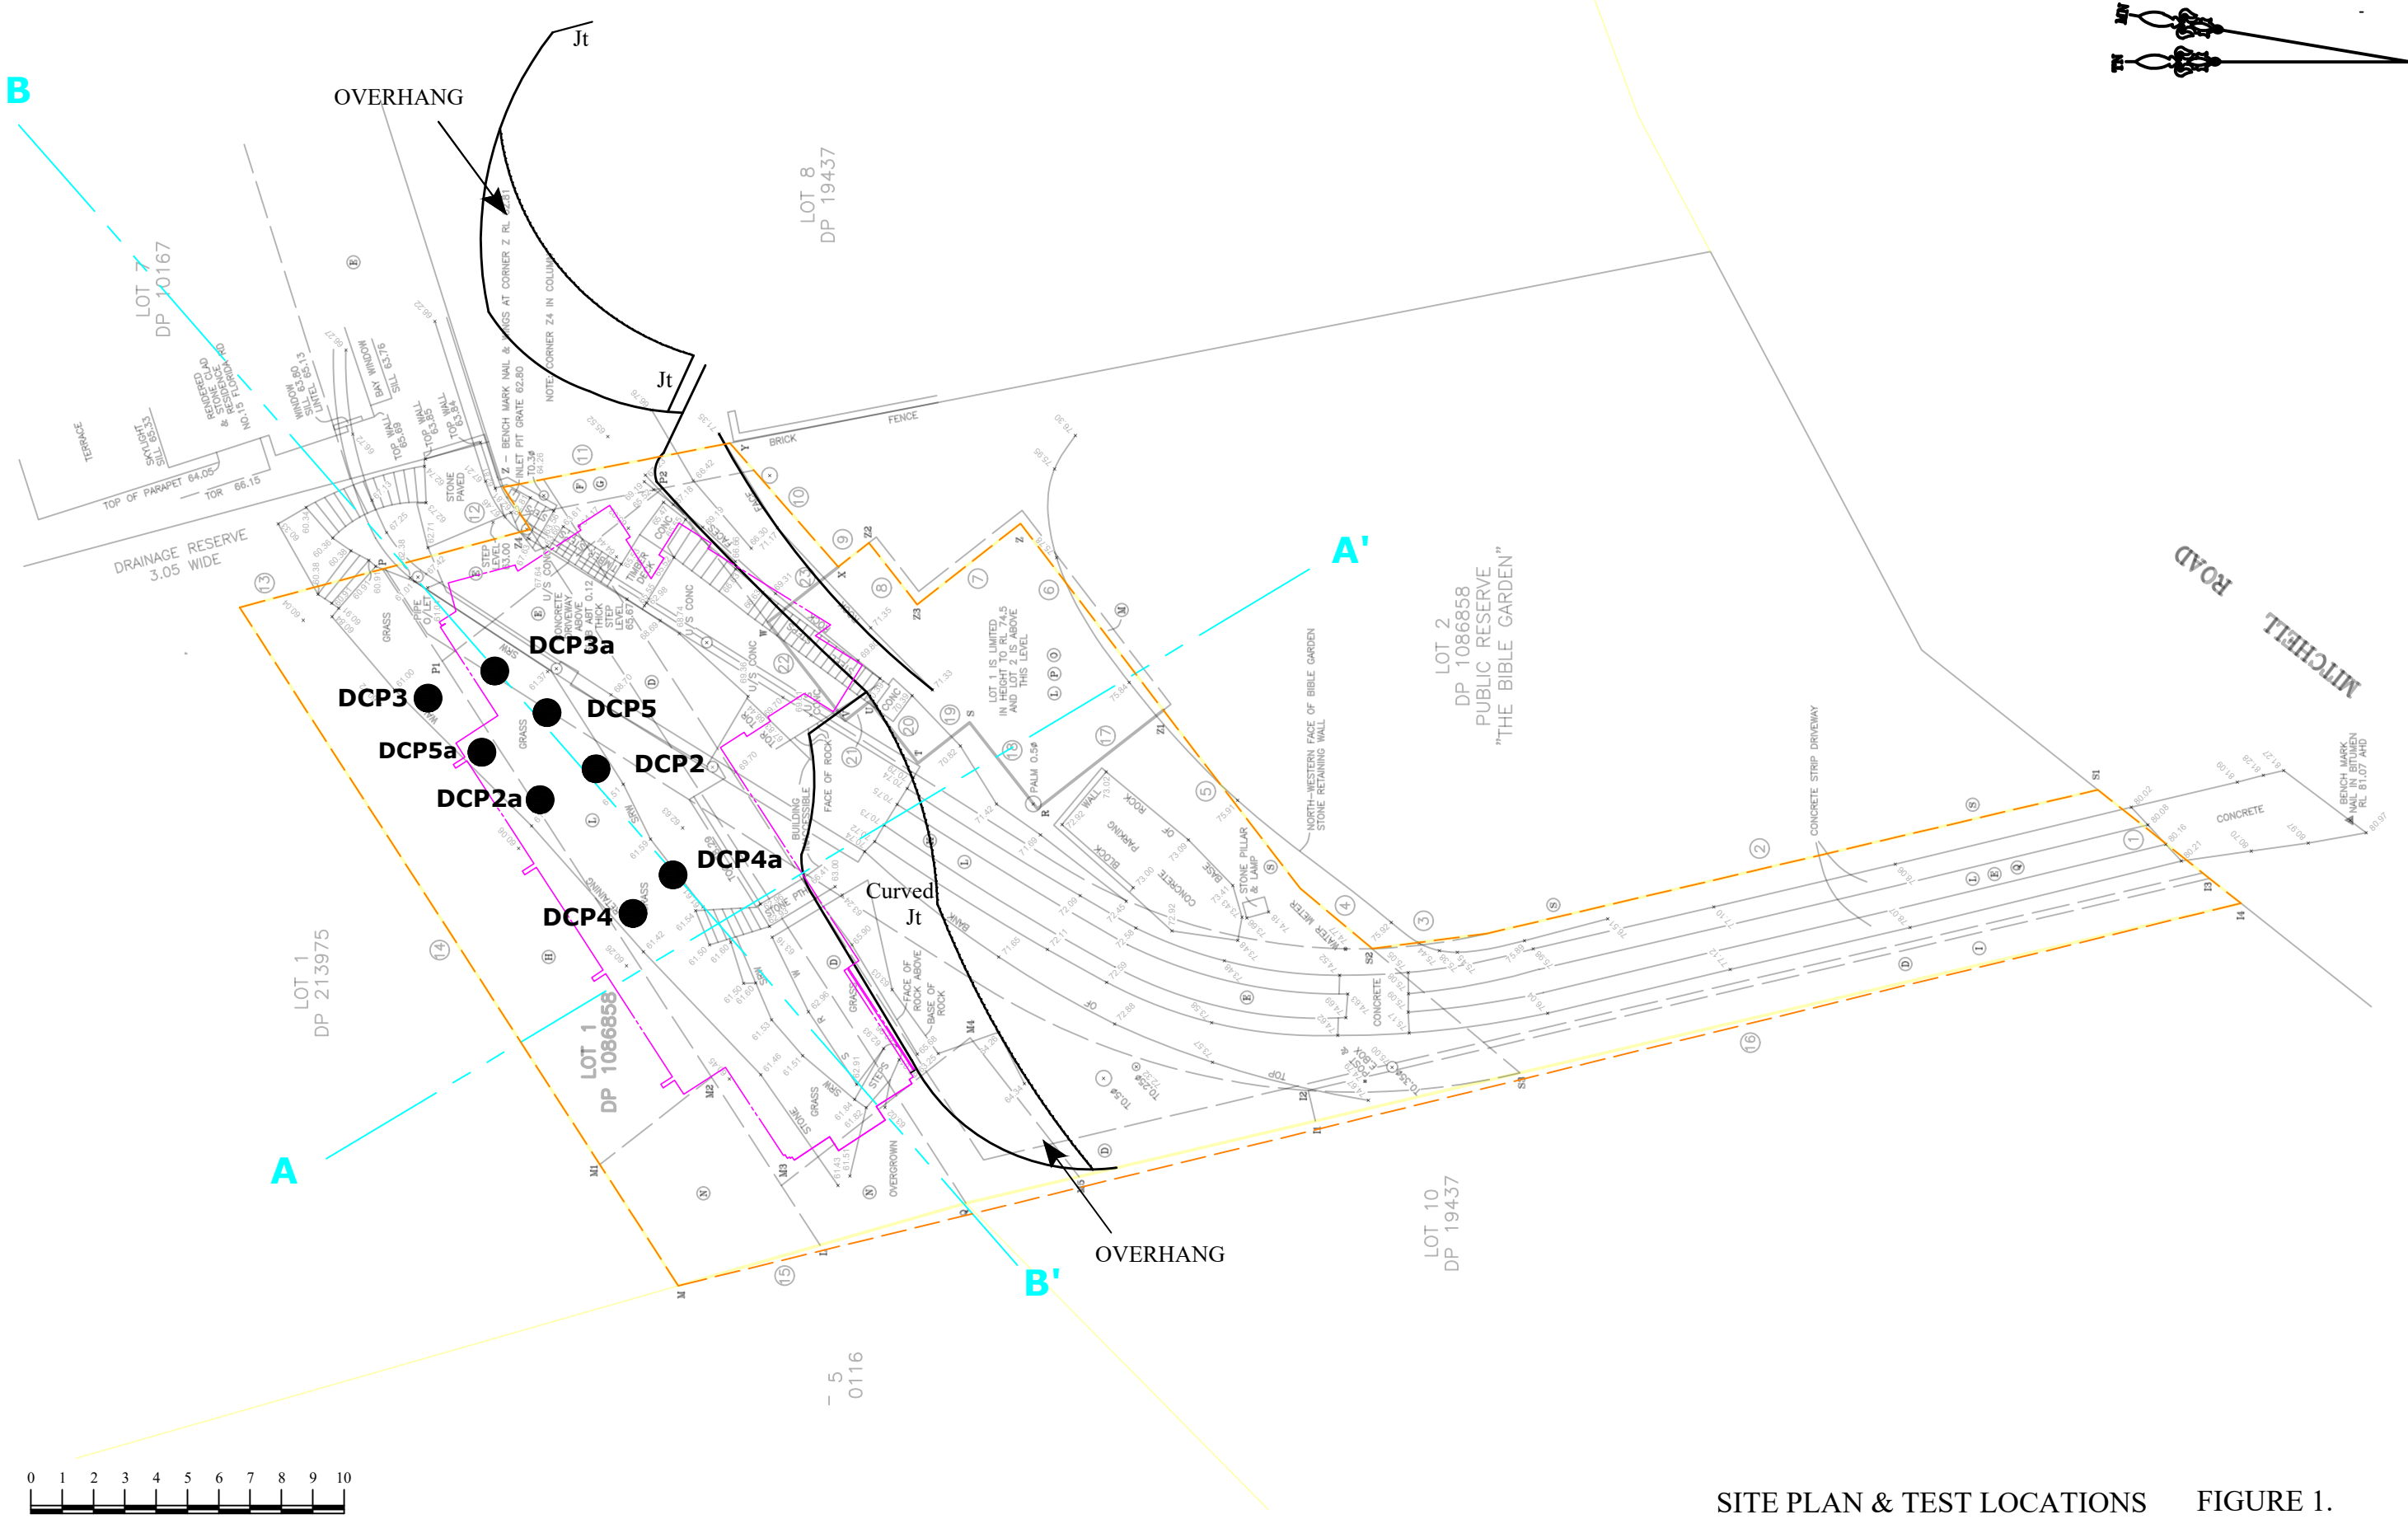
SITE PLAN & TEST LOCATIONS FIGURE 1.

Explanatory notes are included in Appendix: 1. Mapping information and DCP test locations are shown on Figure: 1, along with detailed Borehole log sheets and Dynamic Penetrometer Test Sheet in Appendix: 2. A geological model/section is provided as Figure: 2 and 3, Appendix: 2. Borehole locations have been omitted from Figure: 1 for clarity however they were drilled in similar locations as the corresponding DCP tests.
