**RE: CONSERVATION MANAGEMENT STRATEGY & STATEMENT OF HERITAGE IMPACTS
FOR 3 BILGOLA AVENUE - BILGOLA BEACH 2072**

**Conservation Management Strategy &
Statement of Heritage Impacts
3 Bilgola Avenue, Bilgola Beach
NSW 2072**

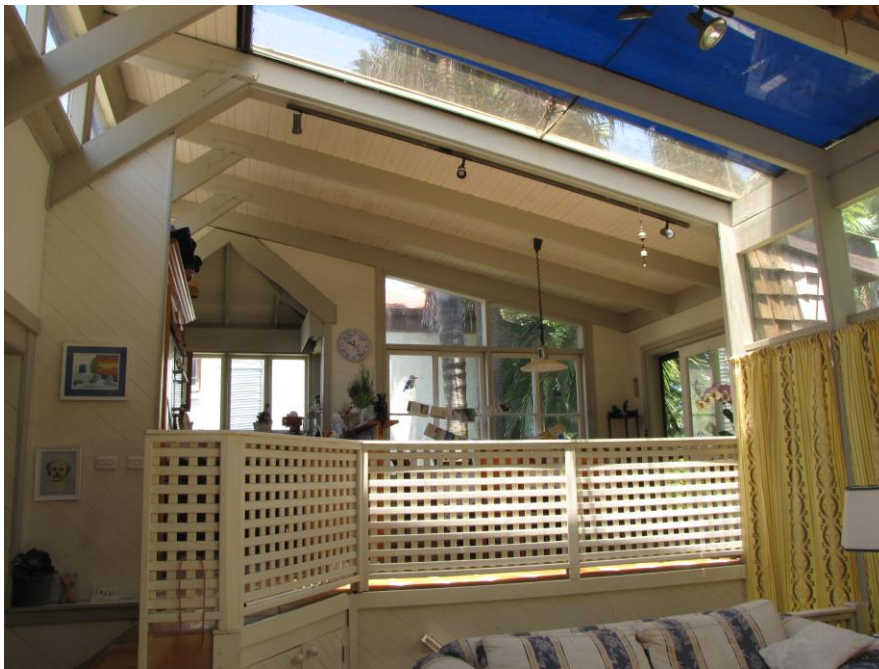
The 1970’s addition has been clad partly in shingles and has an exposed timber structure internally with an extensive area of glass roof. Timber framed windows generally facing south, have also deteriorated in the environment of the palm grove with its exposure to the offshore

winds. While moderately sympathetic in terms of materials, this structure has not stood the test of time and has several design flaws including leaking glass roof and localised termite damage.

Figure 6: Internal view looking from the informal living area towards the eastern side of the 1970's addition on a raised level. The informal dining area with lattice balustrade.

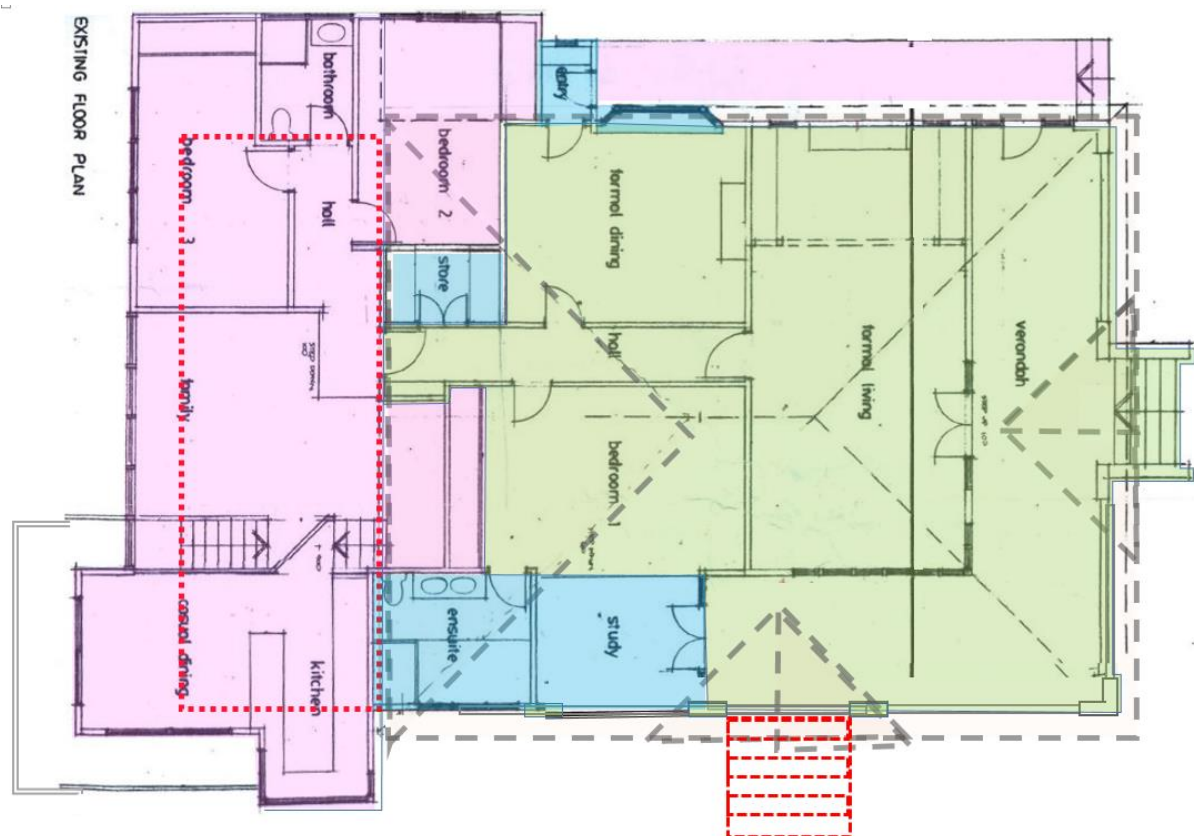
Figure 7: Existing Floor Plan based on previous DA drawings. Summarises grading of significance for the spaces and fabric. Original spaces & features tinted green; sympathetic alterations tinted blue; unsympathetic / intrusive spaces & features tinted pink. Lost parts dotted red – conjectural.

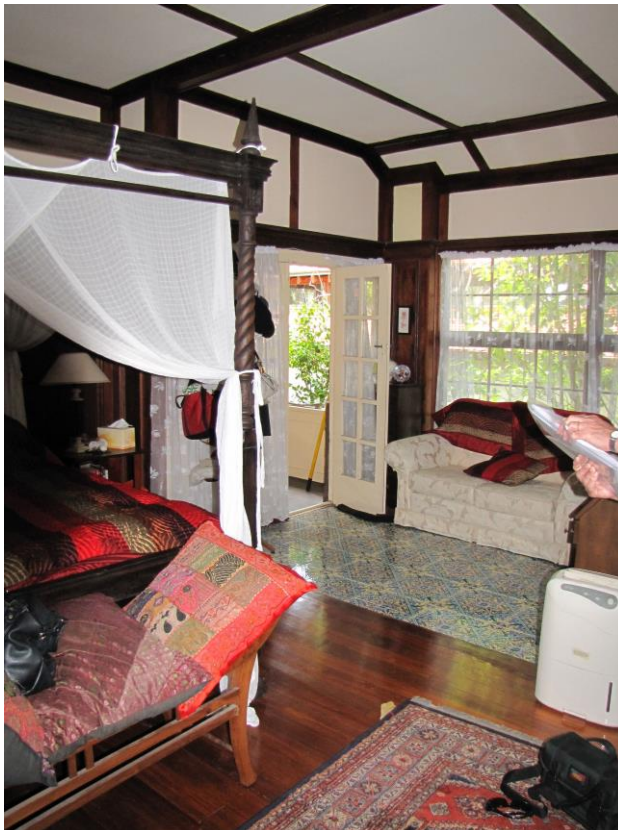
Figure 27: Main Bedroom with step down to tiled part enclosure of south eastern verandah – part of 1970's alterations.
Source: Colin Israel – Heritage Advice 2015

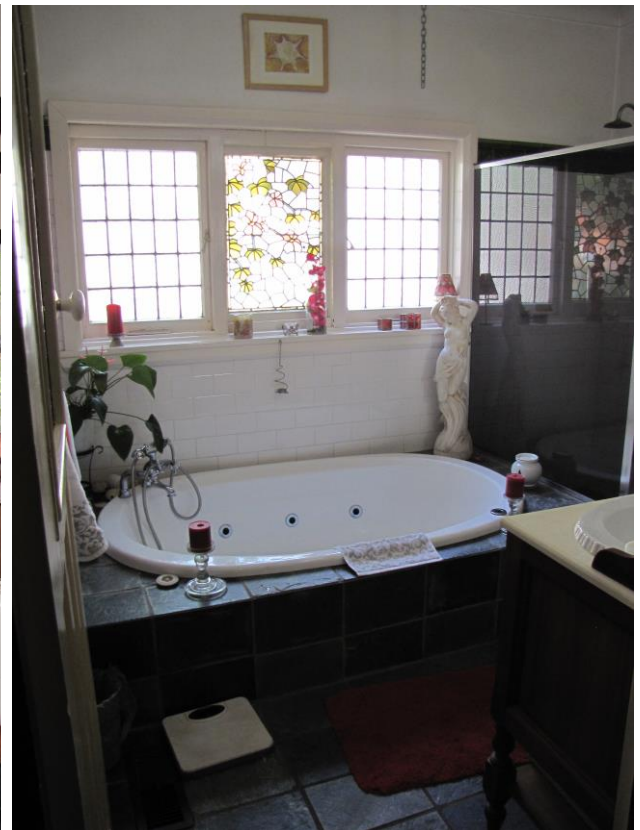
Figure 28: Interior of main bathroom adapting earlier enclosure of part of south eastern verandah. Late 20th century fittings and finishes.

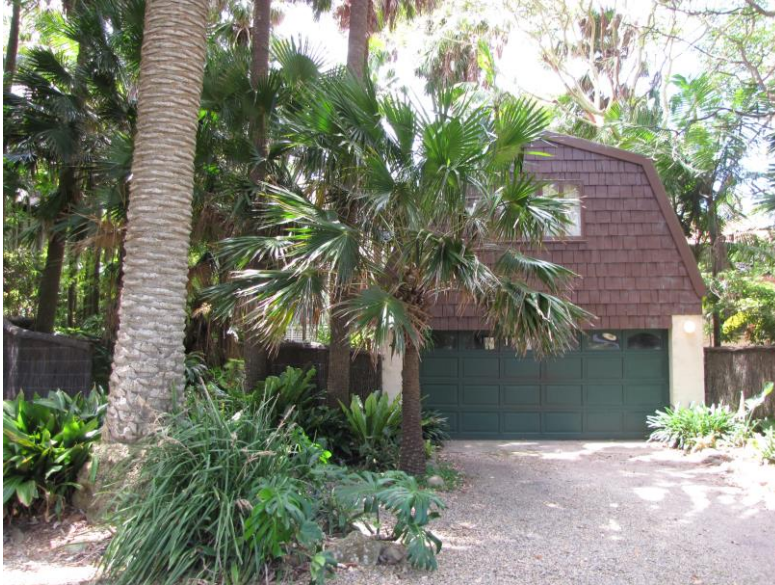
- No significant original features
- Intrusive mansard roof form with applied shingle cladding.

Figure 32: View of brick Garage and shingled Loft at lower end of the site.
Source: Colin Israel – Heritage Advice 2014
