GEOTECHNICAL RISK MANAGEMENT POLICY FOR PITTWATER
FORM NO. 1 – To be submitted with Development Application

Address of site 62 Palm Beach Road, Palm Beach

GEOTECHNICAL INVESTIGATION:

Alterations and Additions at **62 Palm Beach Rd, Palm Beach**

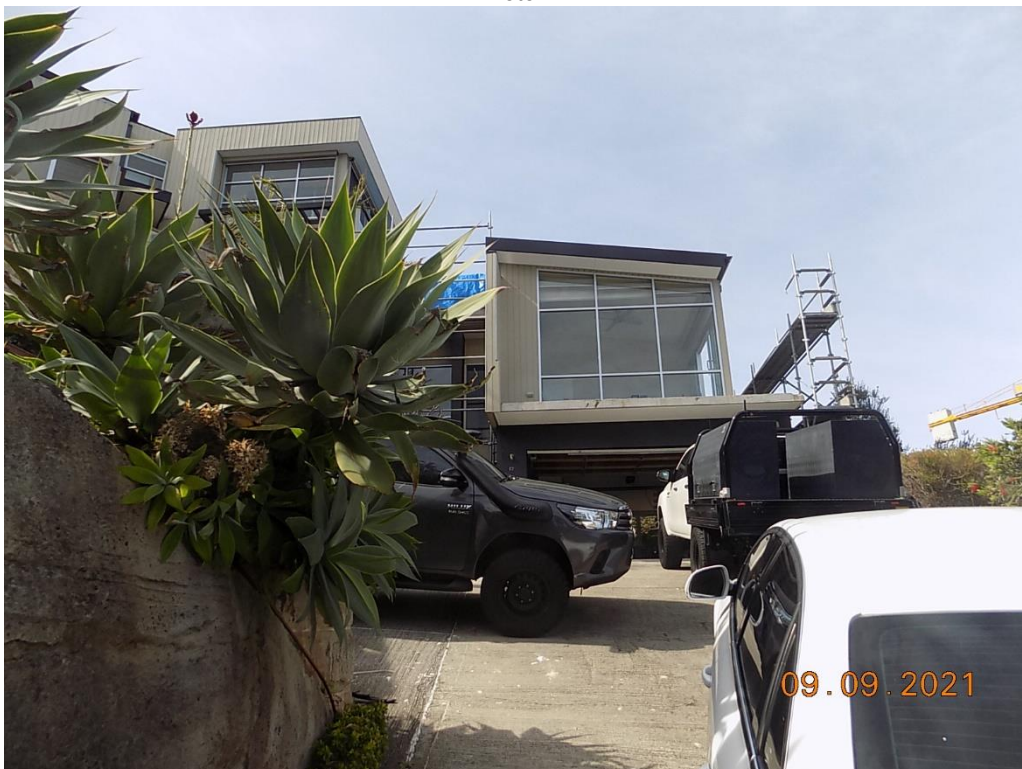
Photo 1

- 2.3** The property is accessed by a Right of Carriageway (ROW) off the uphill side of the road. The cut for the ROW is supported by stable sprayed concrete walls (Photo 1). A concrete driveway continues from the ROW to a parking area and garage underneath the downhill side of the house (Photo 2). The house is currently undergoing renovation works as part of a separate approved application. A stable ~1.5m high sandstone clad, concrete block retaining wall supports the fill for a garden immediately upslope of the parking area (Photo 3). Competent Medium Strength Sandstone can be seen outcropping in several locations across the property. Several of the Sandstone outcrops are undercut and are supported with sprayed concrete

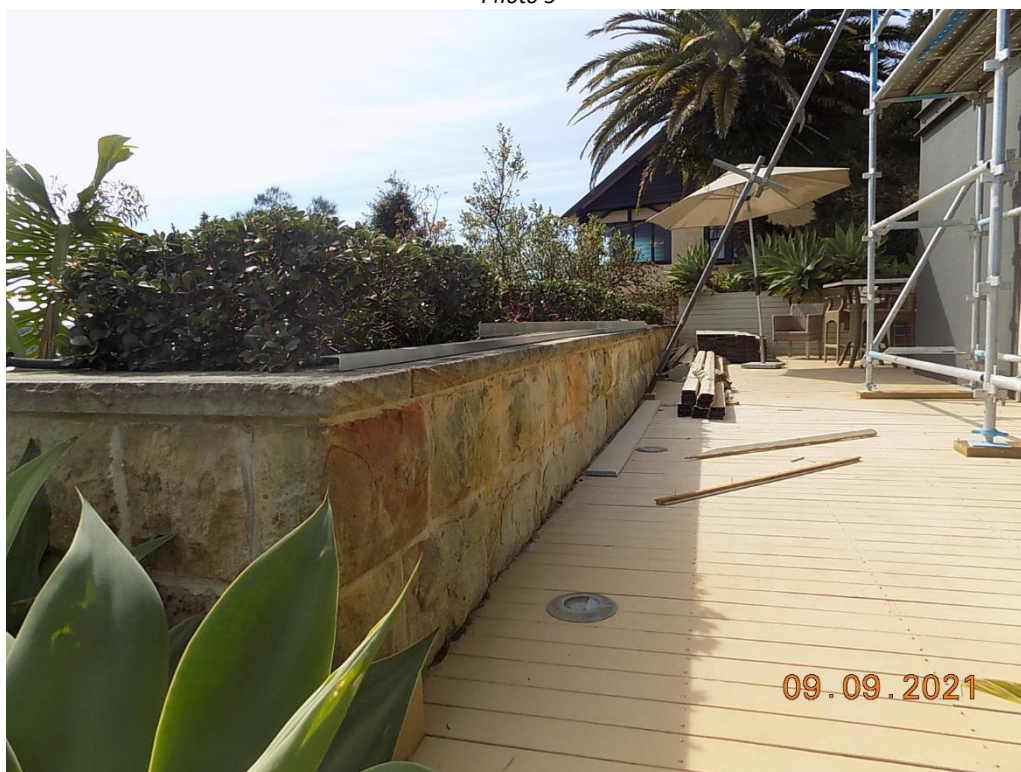
Photo 5

(Photo 4). Some of the external walls of the house can be seen directly supported off of the outcropping rock (Photo 5). The part three-storey rendered brick house is supported on brick walls. The external brick walls show no significant signs of movement. A level patio area extends off the uphill side of the house (Photo 6). A large sandstone floater is resting on the slope on the N side of the property. It has 5 rock bolts securing it to the slope and is supported by two brick piers underneath. This floater is considered stable (Photo 7 & 8). A cut for the level patio area is supported by a ~0.9m high, stable, rendered brick retaining wall. This wall is to be removed as part of the proposed works.
