Report on
Geotechnical Investigation

Proposed Development
46 Prince Alfred Parade, Newport

Prepared for
Adams Consulting Engineers Pty Ltd

Project 212173.00
July 2023

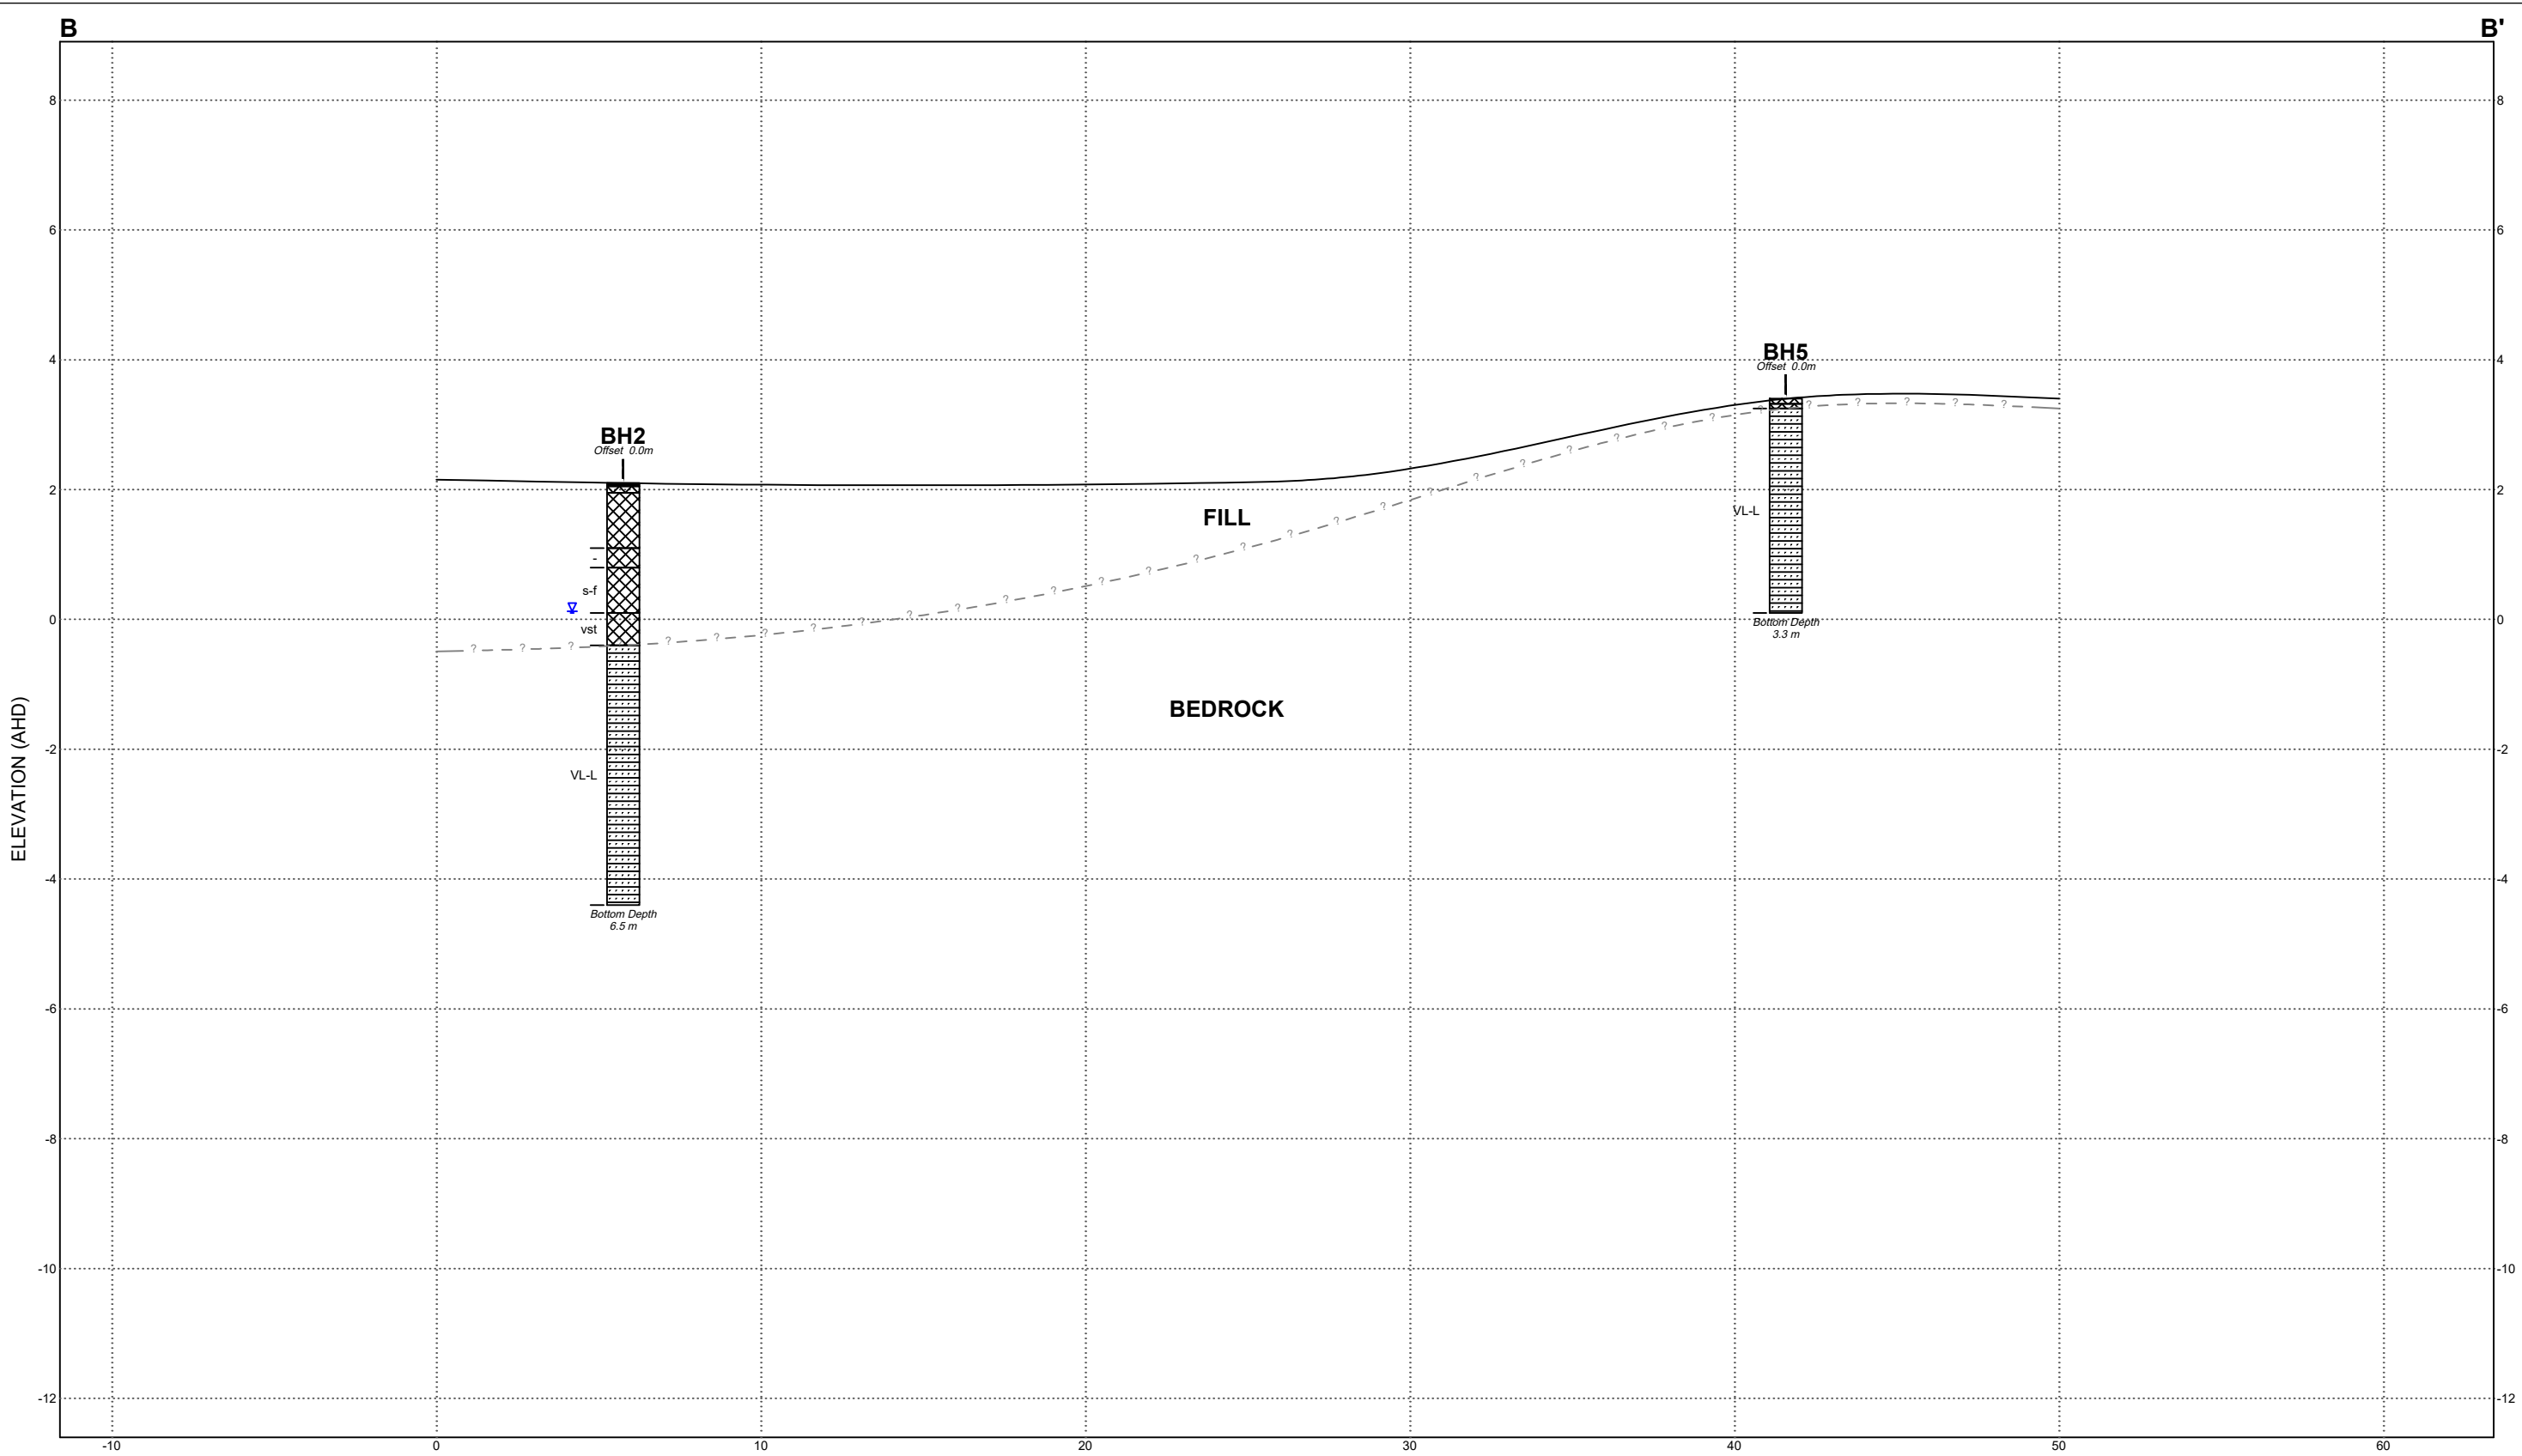
Geotechnical cross-sections (Sections A-A' to C-C') showing the interpreted subsurface profile, are shown on Drawings 2 to 4 in Appendix B. It should be noted that the interpreted boundaries shown on the sections are accurate at the borehole locations only.

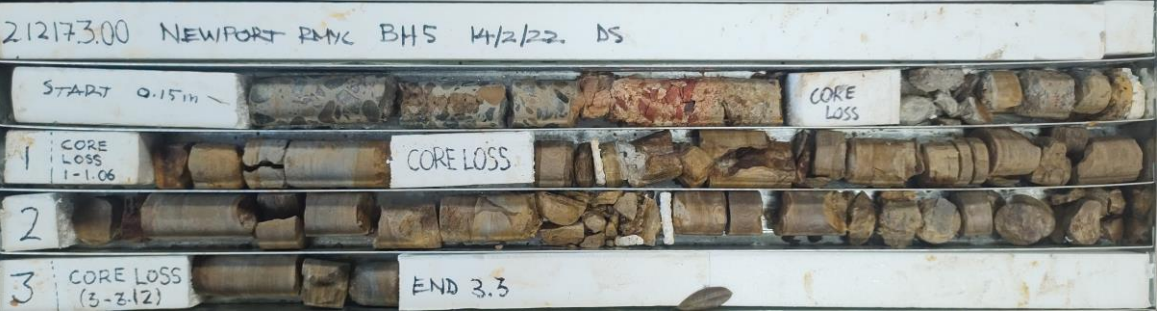
Project No: 212173-00
BH ID: 5
Depth: 0.15 - 3.30
Core Box No.: 1/1

Due to access conditions, boreholes BH5 was drilled using a 100 mm diameter 'Diacore' barrel to penetrate the concrete (slab) near the surface. Following the initial coring, the underlying material was drilled was continued to 3.3 m depth using a 50 mm 'Diacore' barrel in an attempt to obtain continuous core samples of the laminite bedrock.
