Report Title: Geotechnical Report 14 Cheryl Crescent, Newport

Report Date: 30/06/20

GEOTECHNICAL INVESTIGATION:

Additions and Alterations at **14 Cheryl Crescent, Newport.**

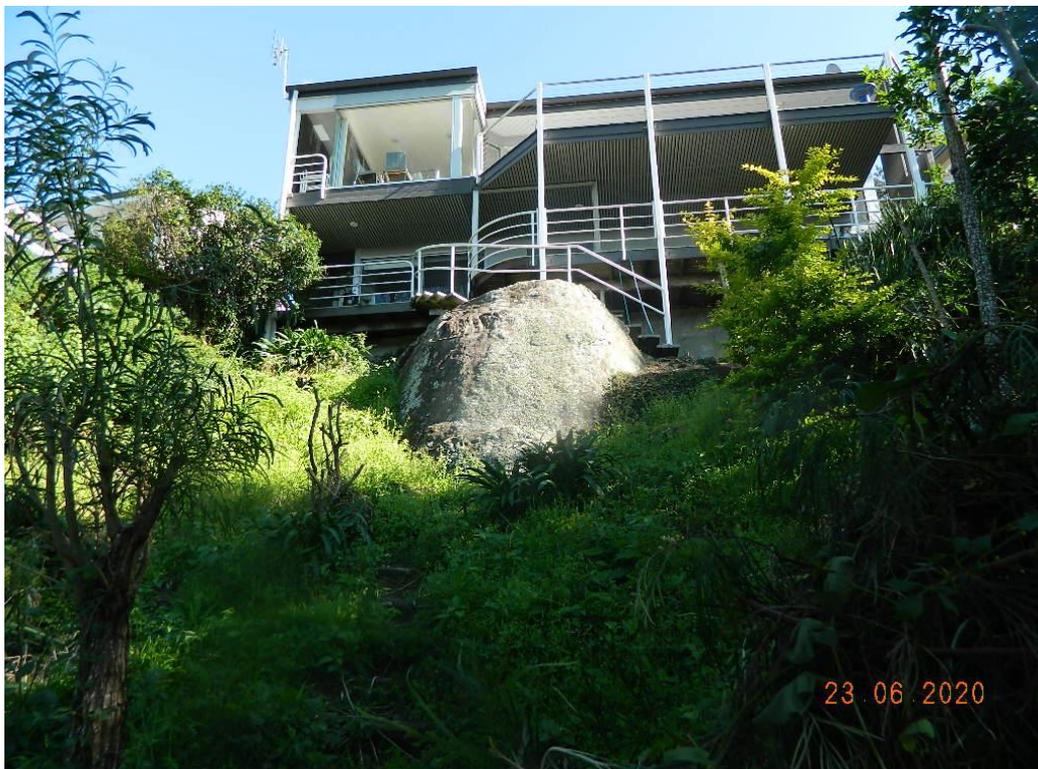
Photo 7

a ~2.4m high concrete block retaining wall. The wall displays minor stepped cracking through the mortar but is considered stable (Photo 9). Medium Strength Sandstone is outcropping on the downhill side of the house (Photos 7 & 10). No signs of slope instability were observed on the property. The adjoining neighbouring properties were observed to be in good order as seen from the street and subject property.
